**SUBJECT:** Tree Trimmer Dies When He is Pulled into a Wood Chipper

**SUMMARY**  
**California FACE Report #08CA005**

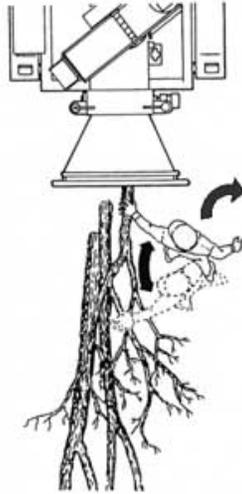
Discussion: In this particular case, a witness observed the victim standing directly behind the feed table in front of the chute as he fed tree branches into the wood chipper. The feed table provides an important measure of safety by increasing the distance between the feed rollers and the operator. The wood chipper was equipped with a safety stop and reversing feed control bar located across the top and down each side of the feed chute. The operator could easily activate this safety device while standing at the side of the feed table. However, if standing directly in front of the feed table, the operator is out of reach of this safety device. Also, if an operator should place any part of his/her body on the feed table, the risk of getting snagged or dragged into the chipper blades is greatly increased and a worker caught by the hands could not activate the quick stop device. The correct and safe feeding pathway is from the side, and the operator should walk away immediately following feeding as depicted in the following illustration.

**Recommendation #2: Ensure that all employees stand to the side of the feed table when feeding trimmings into the brush chipper.**

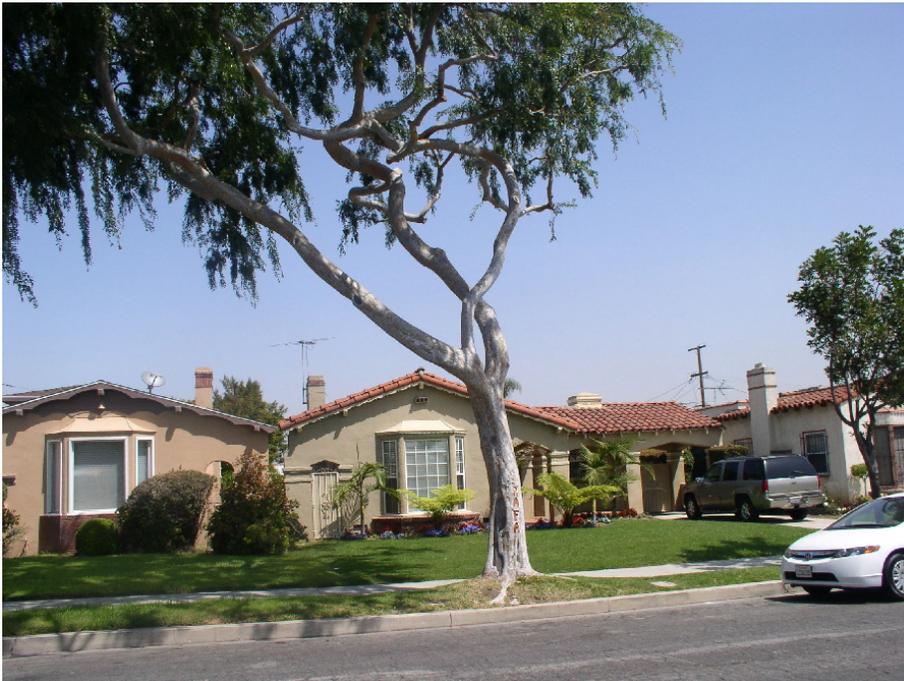
**Exhibit 1. The street where the incident occurred and the tree that was being trimmed.**

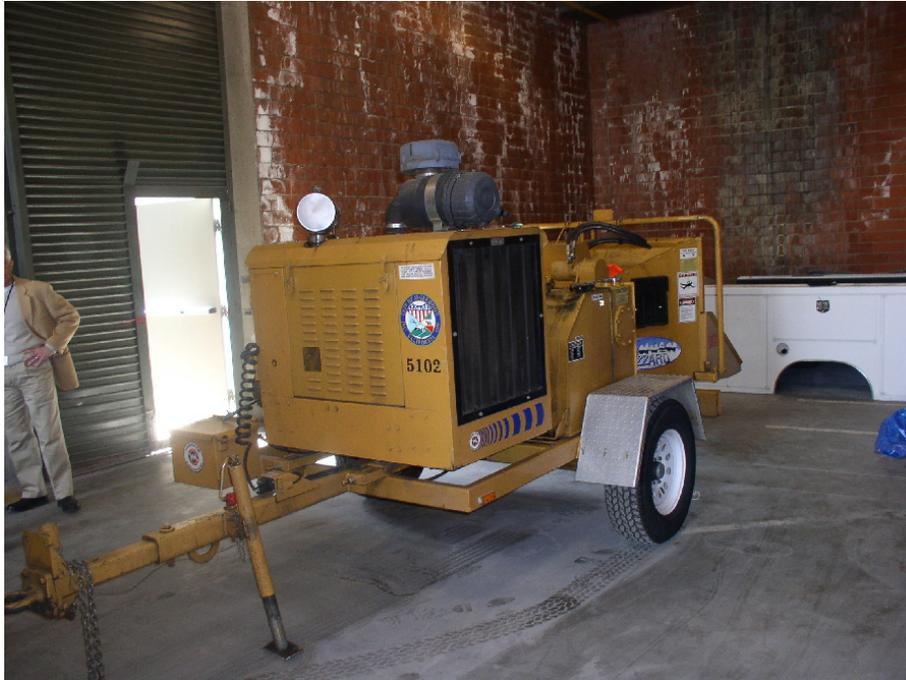
**Exhibit 2. The brush chipper involved in the incident.**

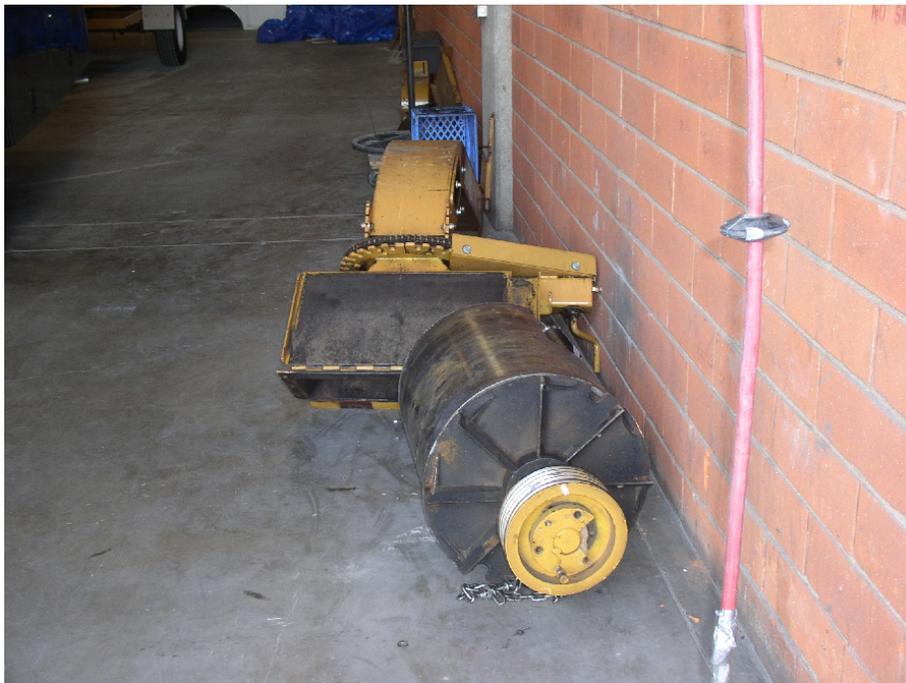
**Exhibit 3. The discharge chute and drum that were removed from the brush chipper during the initial investigation.**

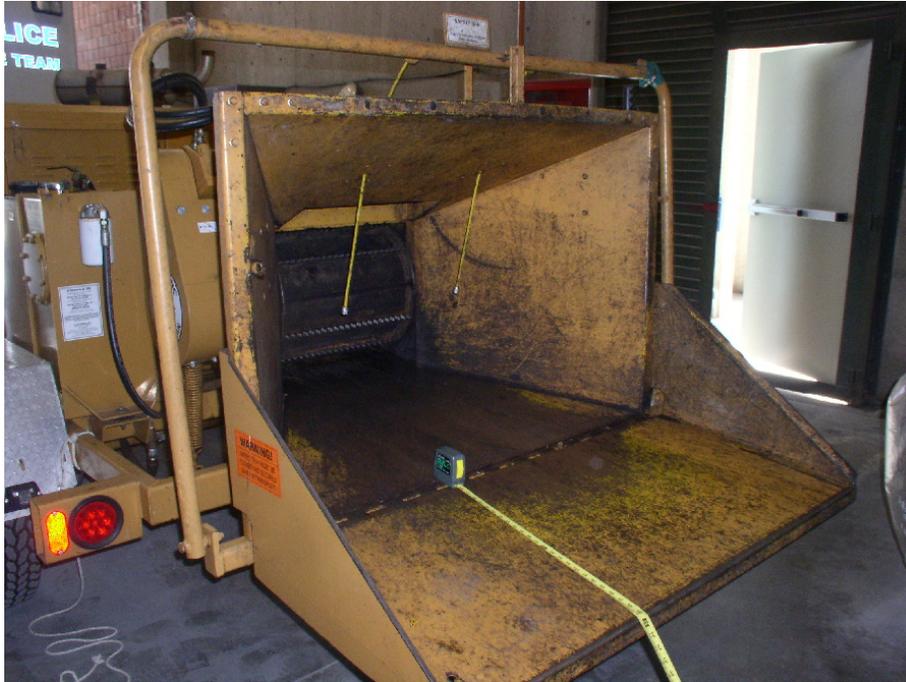
**Exhibit 4. The in-feed chute and shroud that feeds the tree limbs into the feed wheel.**

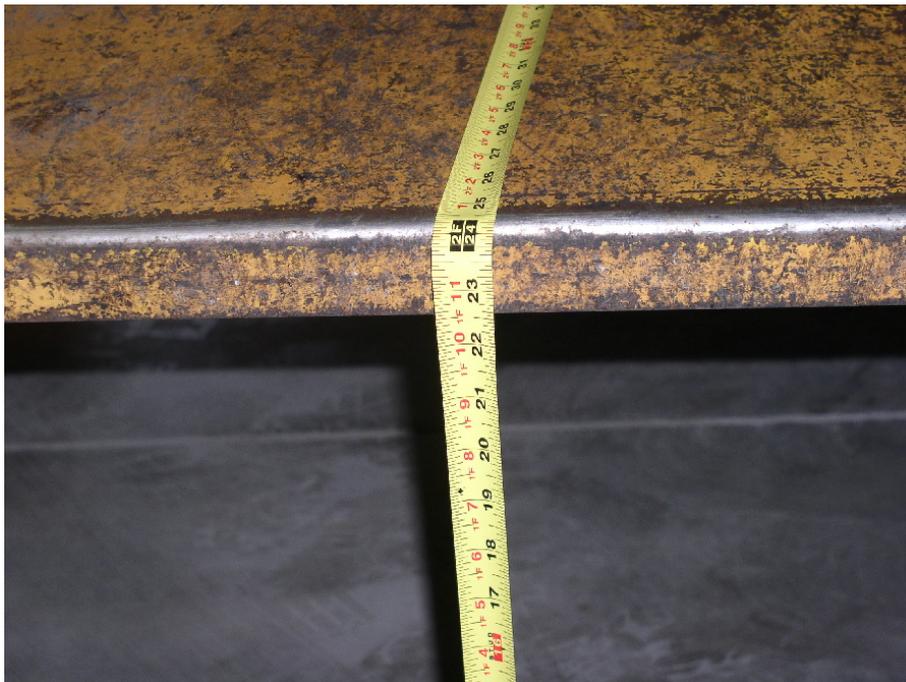
**Exhibit 5. The measurement of the in-feed table in relation to the ground.**

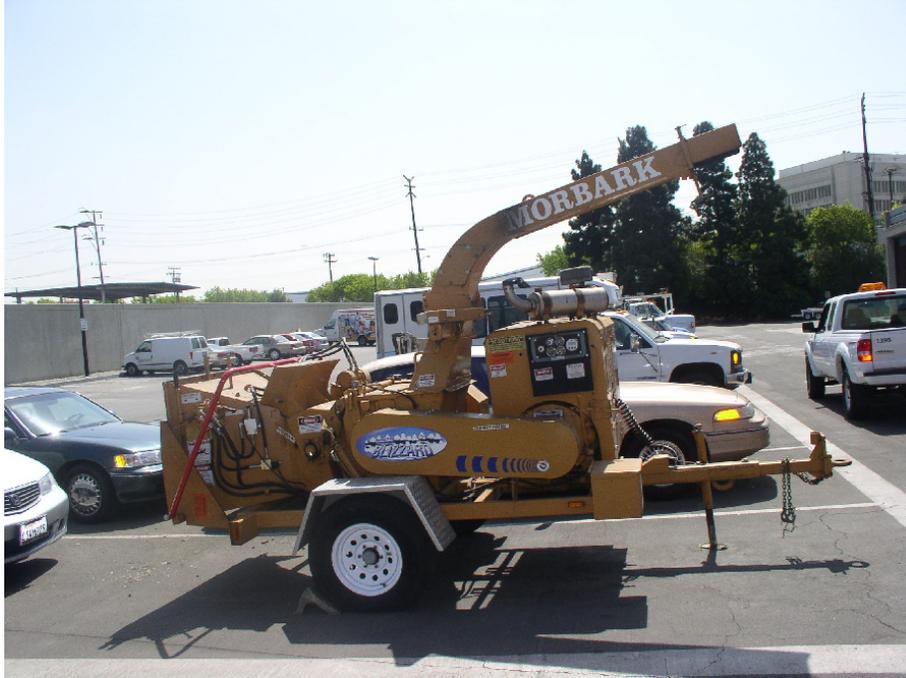
**Exhibit 6. A fully assembled brush chipper similar to the one involved in the incident.**
