SUBJECT: A House Painter Dies When He Falls Through a Roof Opening

SUMMARY
California FACE Report #11CA005

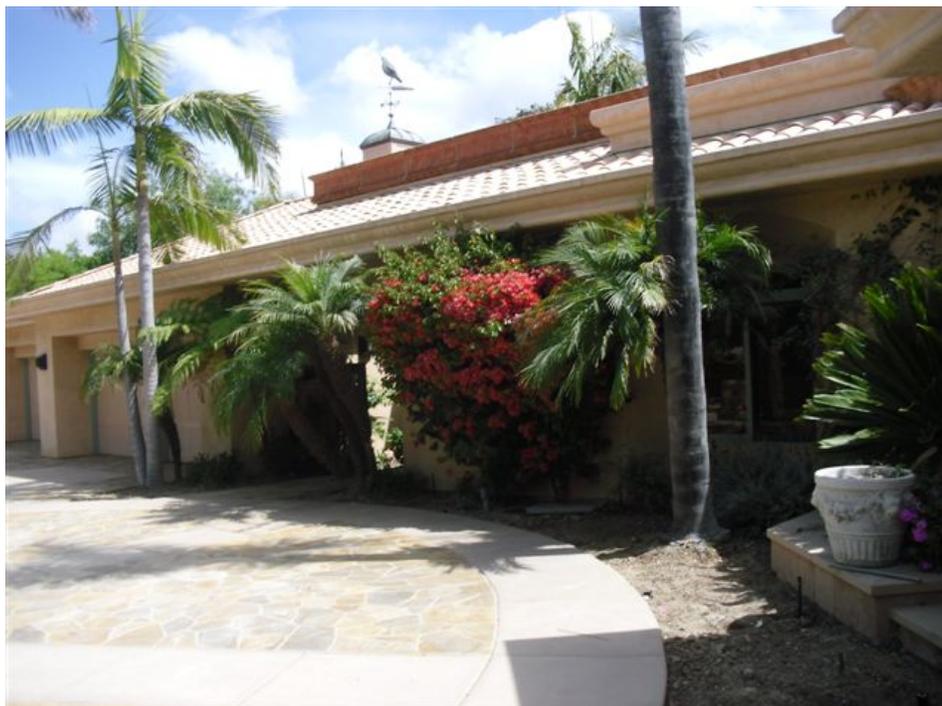
On the morning of the incident, the crew planned to paint the weather vane which was located on the roof of the garage, immediately adjacent to an opening (see Exhibits 1 & 2). In order to match the paint sample, the victim climbed a ladder and walked across the roof to the weather vane. As he neared the roof opening, he tripped and fell forward through the opening 15 feet to the floor below. The owner of the painting company and his son saw the victim fall through the opening and ran to his assistance. Workers from one of the other contractors onsite heard the fall and called 911. The fire department and paramedics were contacted and arrived within minutes of the call. The victim was air lifted to a local hospital where he died from his injuries the following day.

Exhibit 1 - The custom built home involved in the incident.

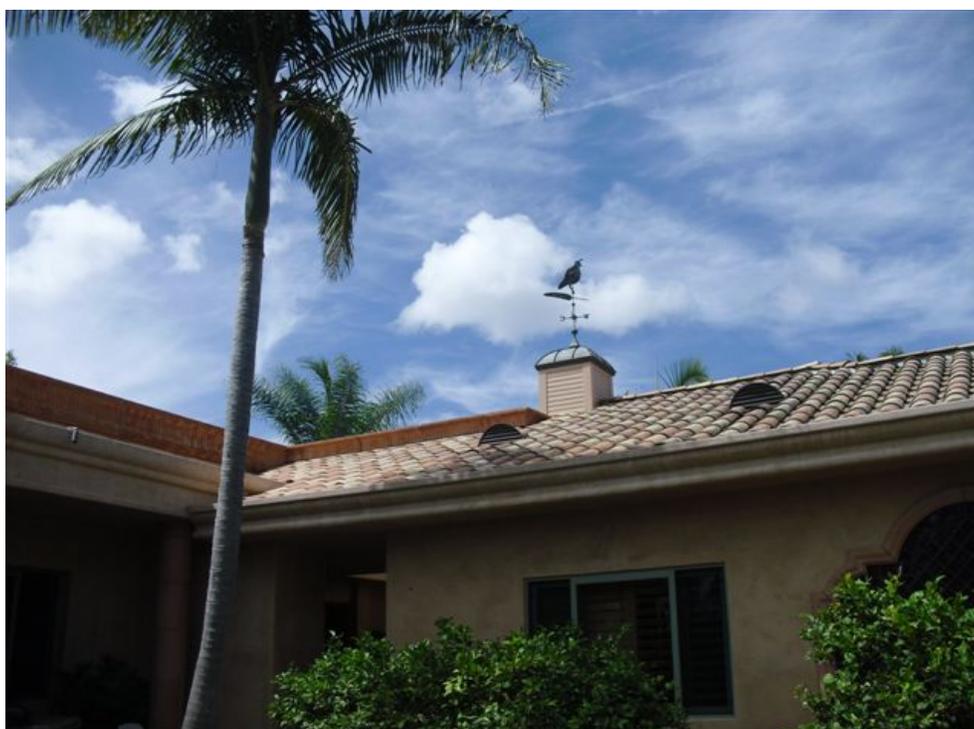
Exhibit 2. The weather vane on top of the garage.

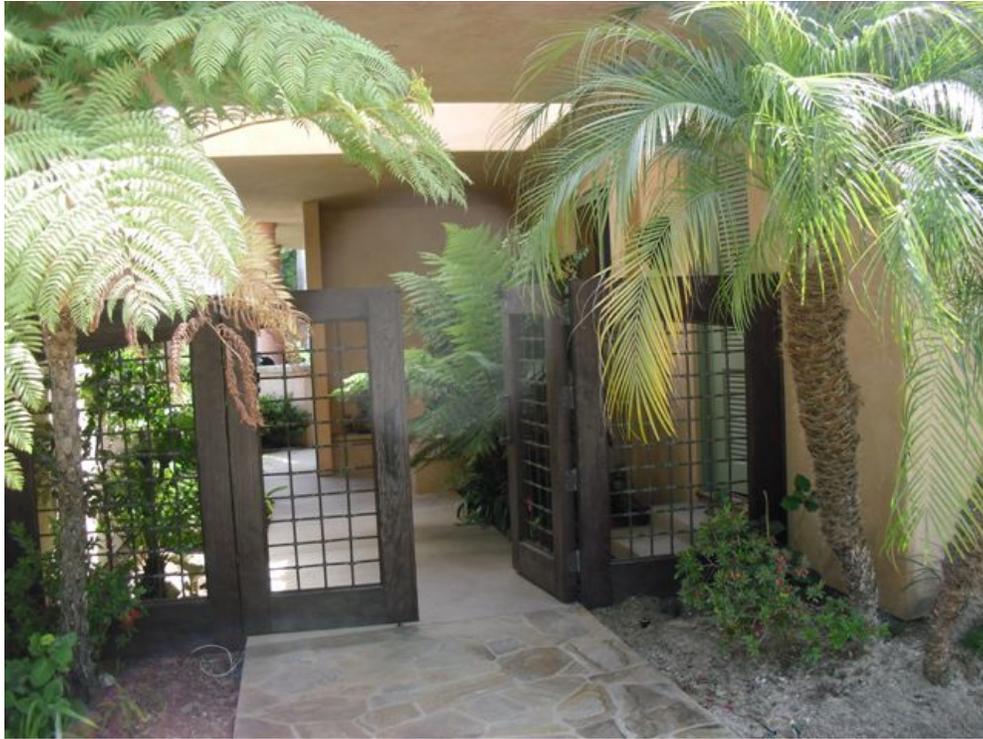
The location of the incident was a custom-built single-story private residence that was undergoing renovations to the exterior. A breezeway connected the house to the garage. There was a permanent 3 x 5 foot opening in the roof of the breezeway that served only as an architectural element. Additional work was being done on the home by other contractors.

fatality. The CA/FACE investigator identified the unguarded roof opening, lack of a job hazard analysis prior to the start of the job to determine potential risk factors, and the lack of training as contributing factors in this incident that ultimately led to the fatality.

Exhibit 3. The breezeway entry where the victim fell through the opening in the roof.

A fall protection plan in this incident should have included the use of personal fall protection equipment, guardrails around the roof opening, or if these were not feasible,

a safety monitoring system. The use of a "traditional" safety belt/lanyard combination is sometimes not practical during construction operations, particularly where worker mobility is required. Use of a retracting lifeline equipped with a locking device, and attached to a support line, can provide sufficient mobility in some cases. In this case, the work was being done 15 feet above a floor. A retracting lifeline connected to a safety line probably would have prevented this fatality. Alternative forms of worker protection, such as safety nets or a catch platform, should be considered. Safety nets can effectively prevent injury or death when a worker falls. The use of alternative fall protection systems must be carefully considered, regardless of what height is involved. If these safeguards had been in place, the victim would not have been able to fall through the roof opening to the ground below.

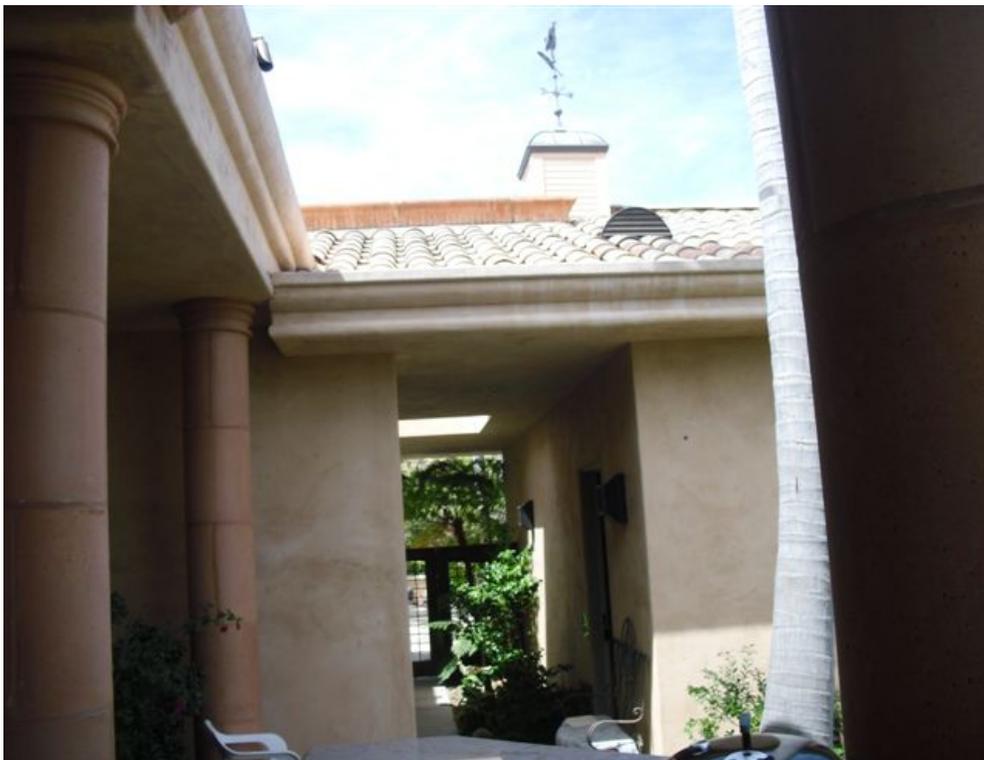
Exhibit 4 - The breezeway from the rear of the house.

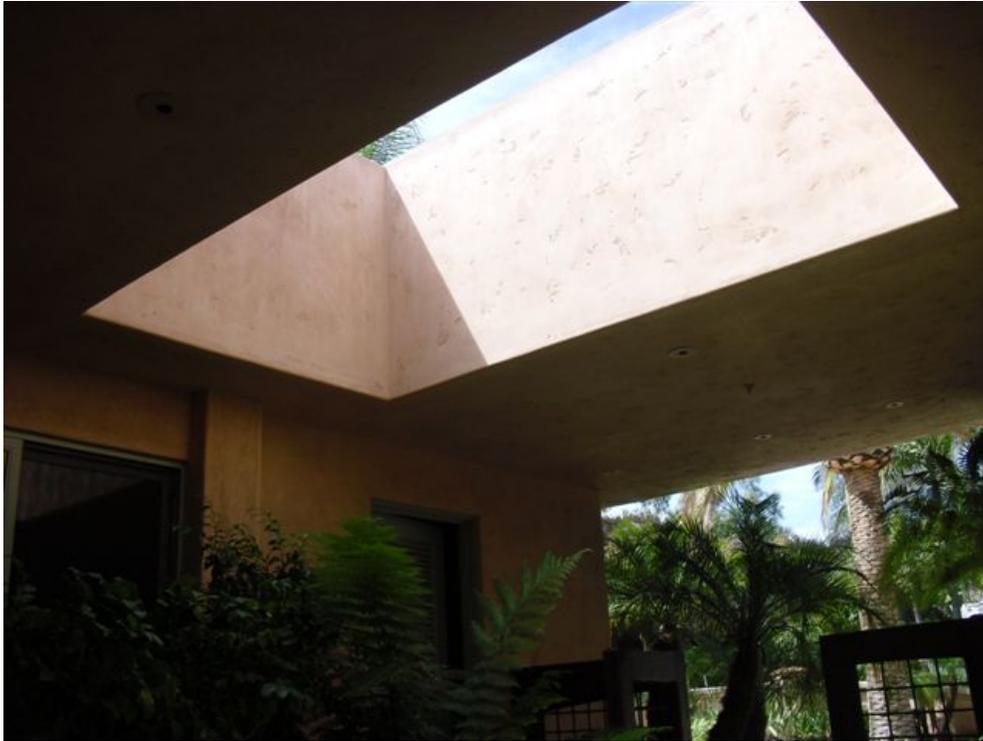
Exhibit 5 - The roof opening as seen from below.

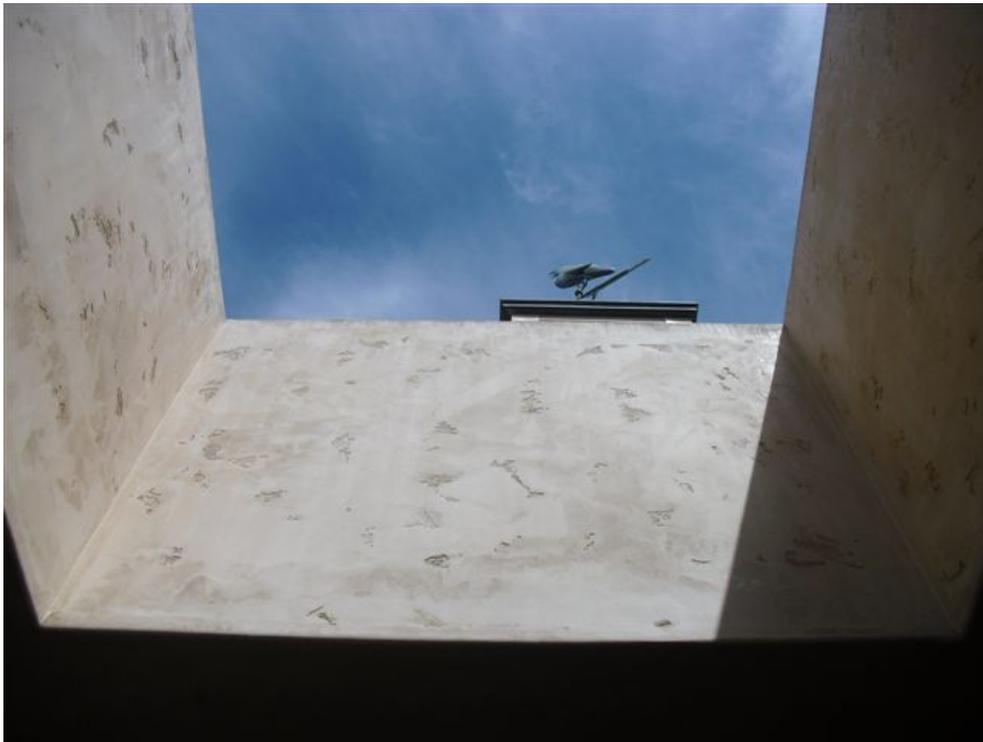
Exhibit 6. The roof opening and the weather vane mounted on the residence garage.
