FROM: California Fatality Assessment and Control Evaluation (CA/FACE) Program

SUBJECT: A Supervisor Dies When He is Decapitated by a Rope That Was Pulled Into a Wood Chipper

SUMMARY
California FACE Report #12CA001

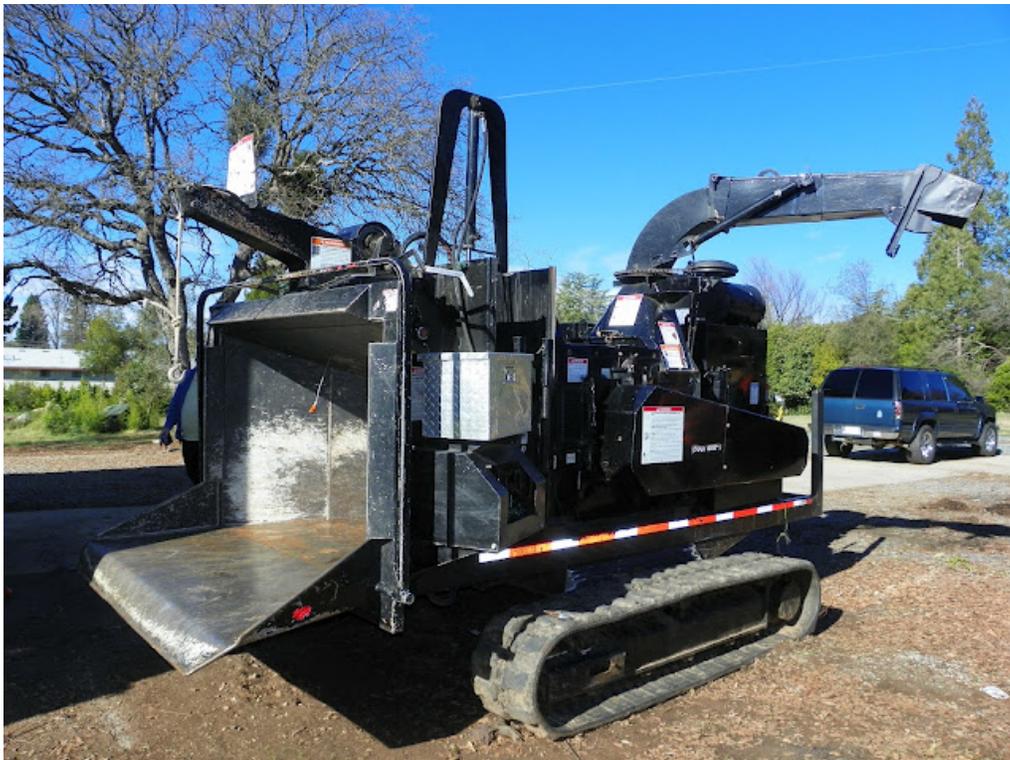
The wood chipper involved in the incident was a Bandit Model 1890 that was purchased new in 2004 (see exhibits 1-4). This was a self-propelled track-mounted chipper with reversing auto feed rollers, hydraulic swivel discharge, and a remote control for portable operation. The wood chipper also included a hydraulically controlled rope winch mounted above the feed table (see exhibit 4).

Exhibit 1. The right side of the wood chipper involved in this incident.

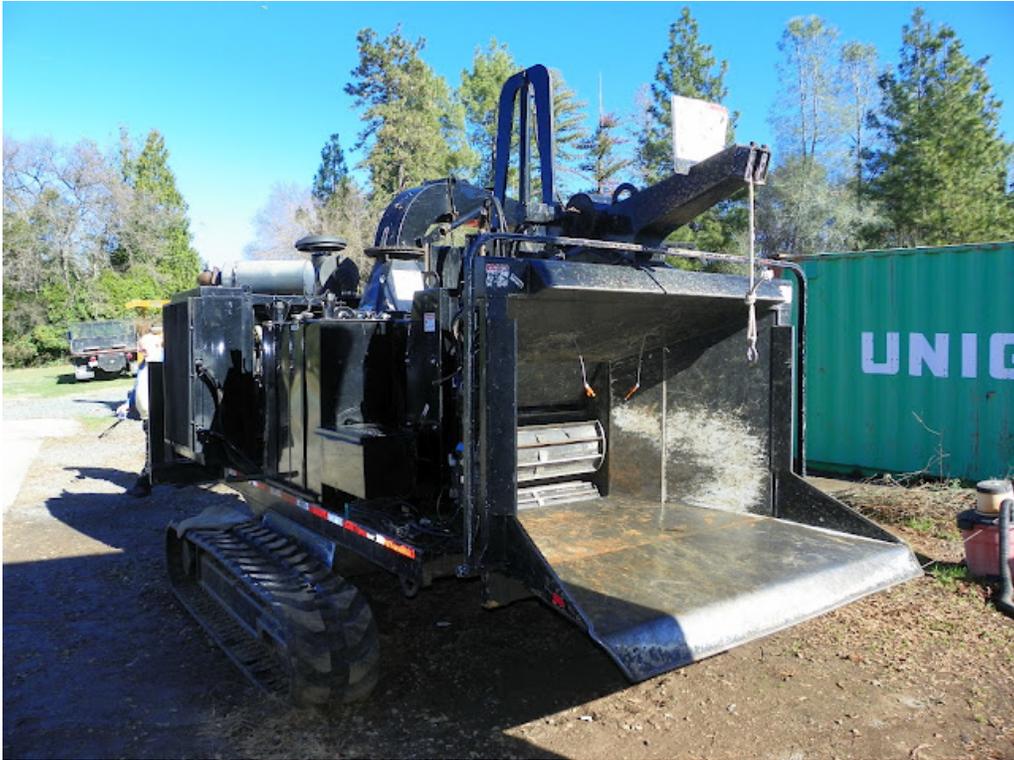
Exhibit 2. The left side of the wood chipper involved in the incident.

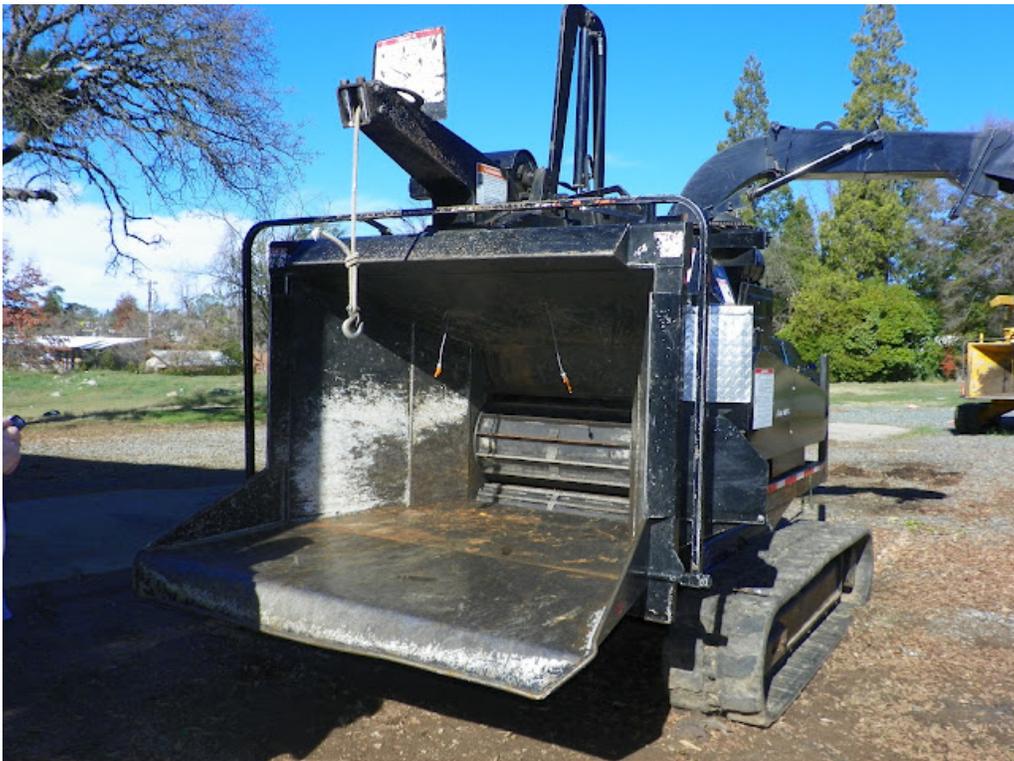
Exhibit 3. The wood chipper feed table and feed rollers.

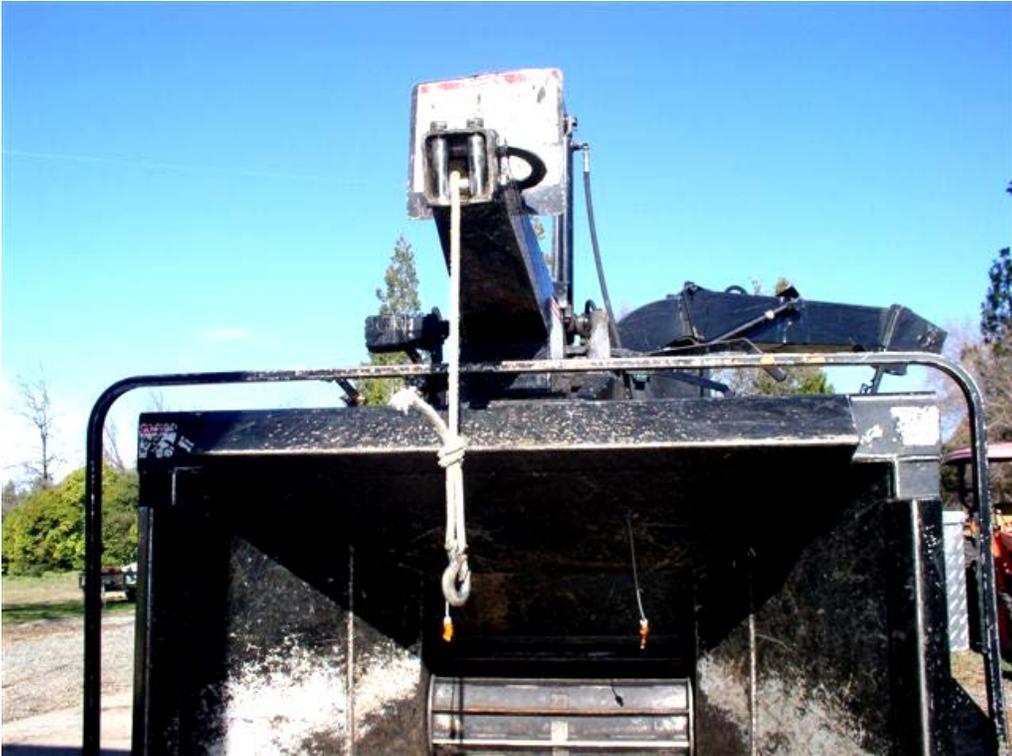
The work process involved cutting trees and brush, cinching cut limbs and brush into bundles with a rope, and dragging them up the steep incline by a second rope from the wood chipper-mounted winch. The wood chipper was controlled and operated by a remote control that the victim wore around his waist. After the bundles of cut limbs and brush were dragged to the wood chipper, the rope was supposed to be removed from the bundle before the branches were fed into the chipper.

Exhibit 4. The rope winch on the wood chipper used to pull tied bundles of brush and cut branches up to the feed table.

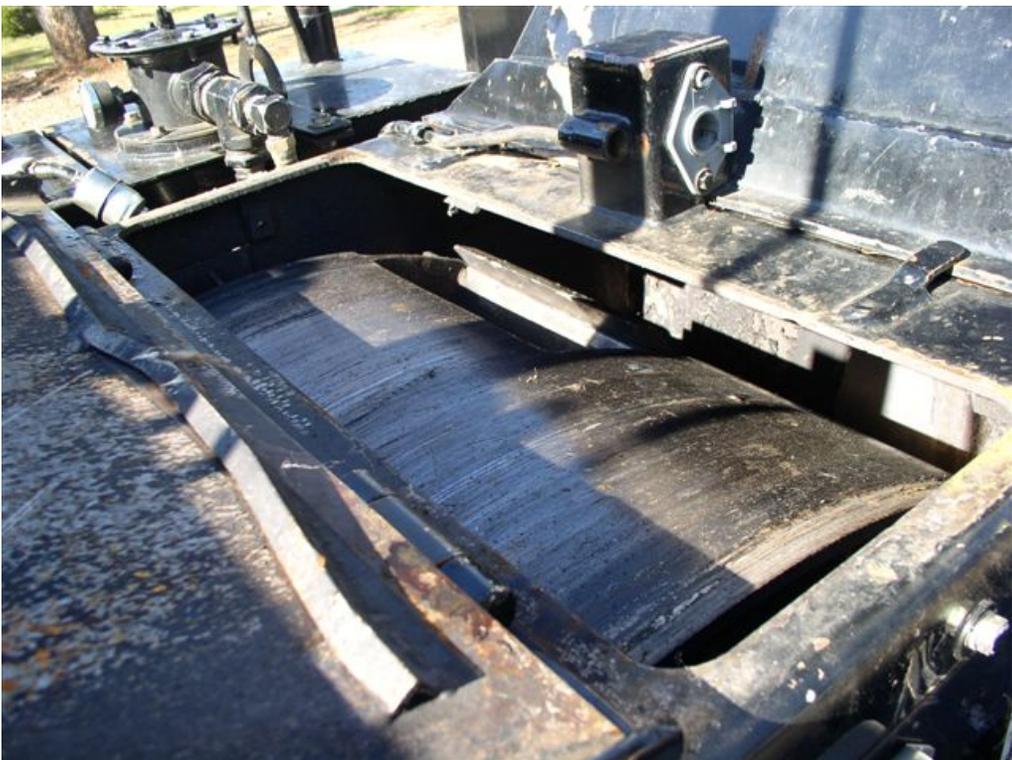
Discussion: In this incident, a co-worker cinched a bundle of brush with a rope and used the winch to drag it up the hillside to the chipper. While feeding the brush into the chipper, one end of the rope entered the chipper and wrapped around the chipper's drum, pulling the rope taut, entangling the victim, and decapitating him. Although ropes serve a useful purpose in the tree trimming and brush clearing business, they should always be removed from the point of operation of chippers before chipping begins and never used to feed material into the wood chippers. To prevent such incidents, all cut branches and brush should be placed in piles and inspected prior to being fed into wood chippers to ensure that they are free of any unwanted object(s) that might cause personal injury. Had the material been placed in piles and inspected prior to being fed into the chipper, the rope may have been removed from the bundle thereby preventing this incident.

Exhibit 5. The wood chipper's drum that the rope was wrapped around.

Recommendation #1: Ensure that cut tree branches are placed in piles and checked for unwanted objects before being fed into wood chippers.

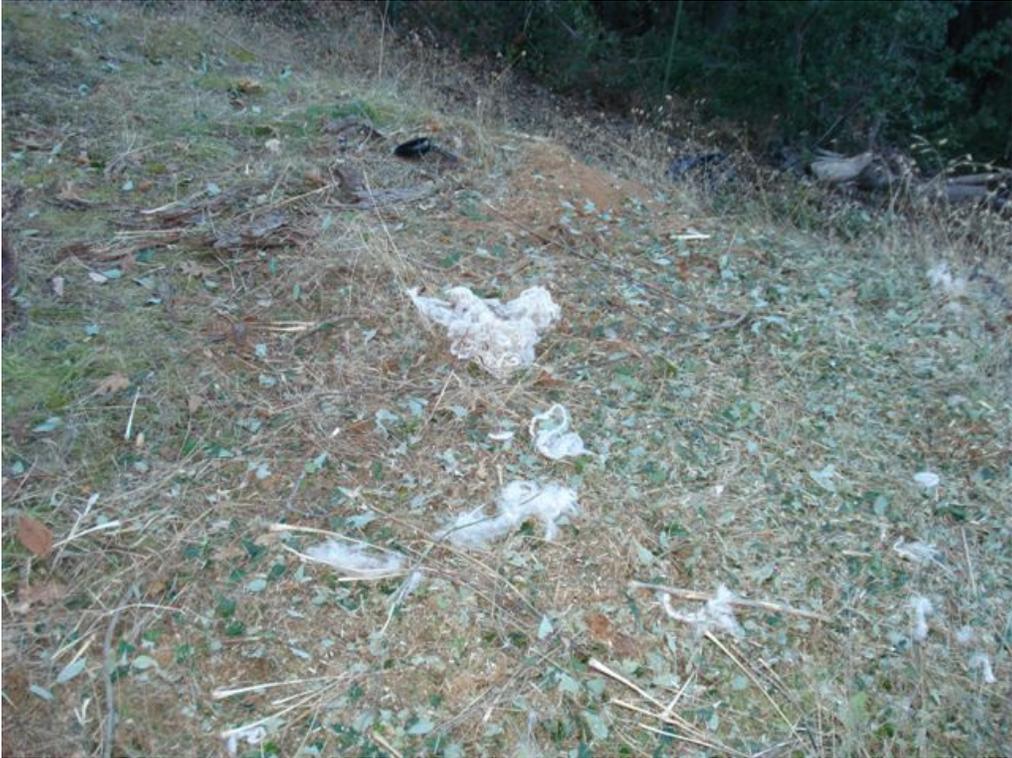
- Feeding branches or brush which contained a foreign object into the wood chipper.
- Ropes that presented an entanglement hazard at the point of operation of the chipper.

Exhibit 6. Portions of the frayed rope after it went through the wood chipper.

Recommendation #2: Assign a co-worker as a safety watch whenever cut tree branches are being fed into a wood chipper.

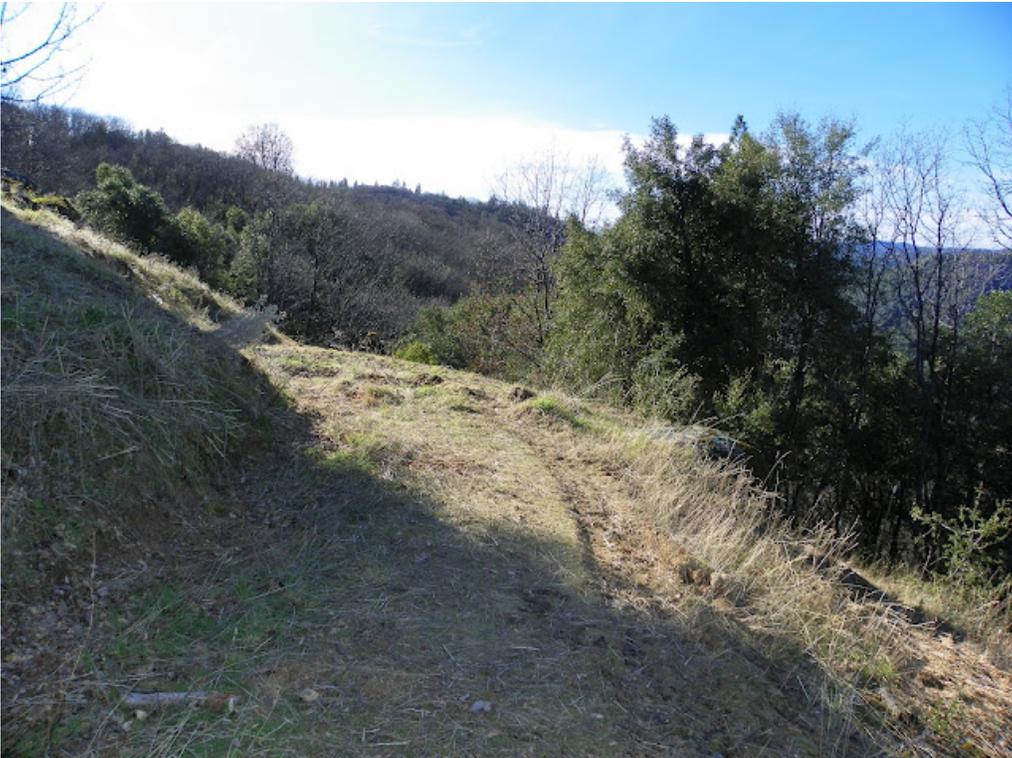
Exhibit 7. The location in the back of the house where the wood chipper was parked.

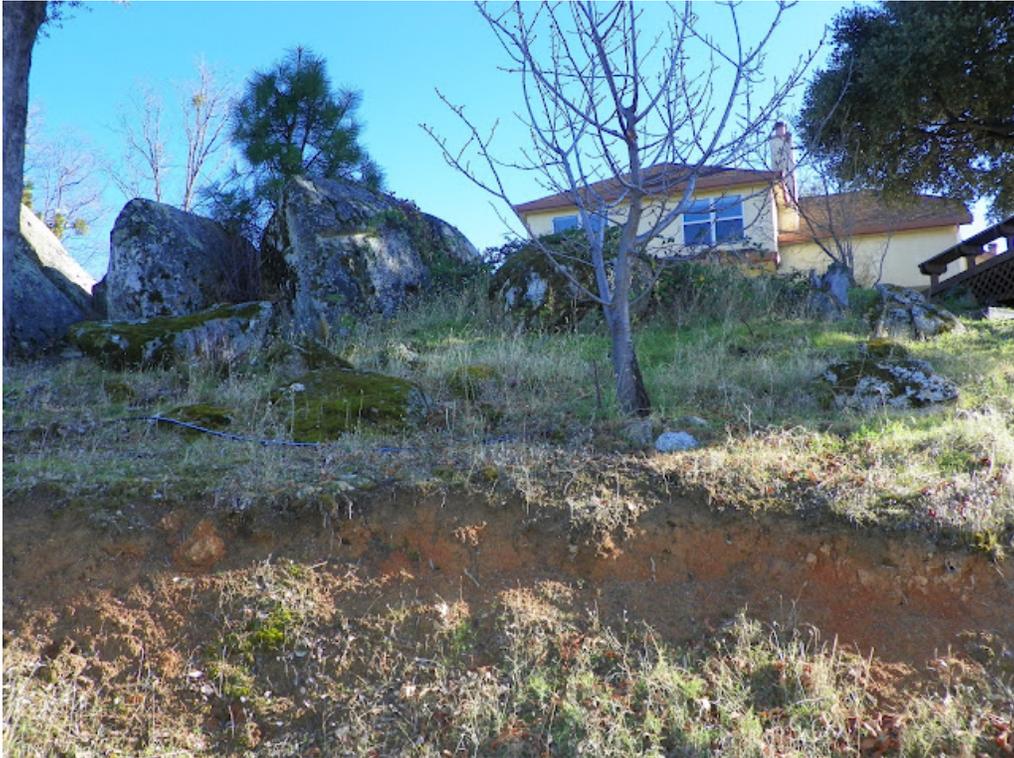
Exhibit 8. The back of the residence where the wood chipper was located.

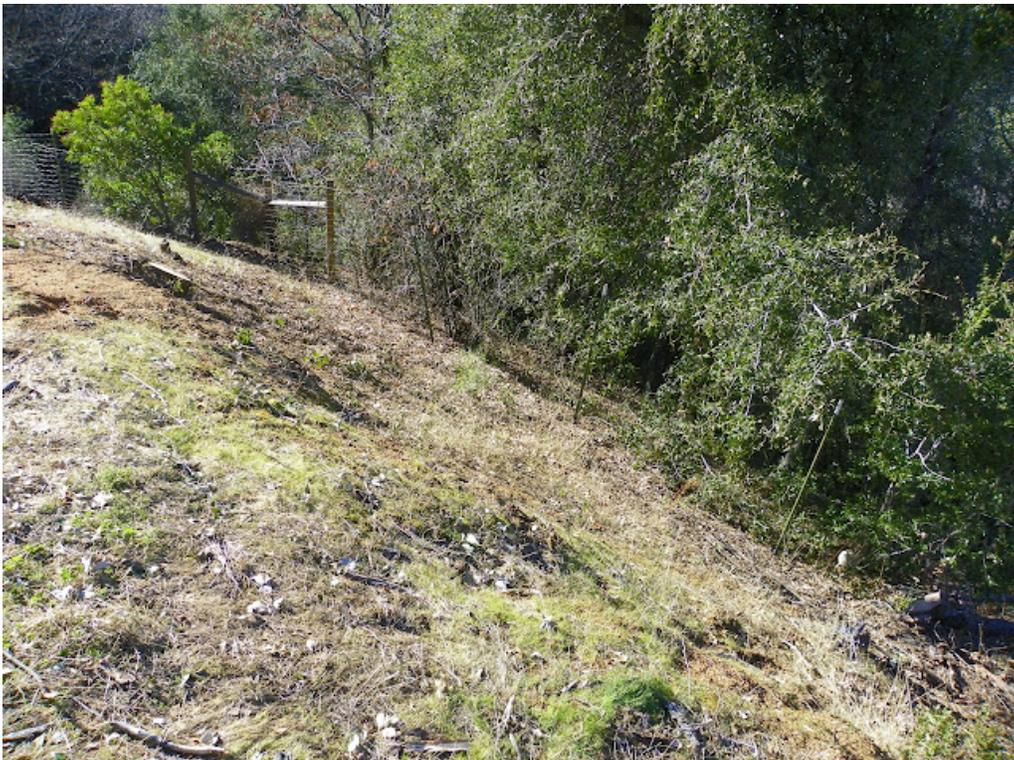
The incident scene was the backyard of a private residence. The new homeowner hired the land clearing company to trim and remove trees and overgrown brush around the perimeter of the property. The area the crew was clearing was a steep backyard hillside. This job was to last two days.

Exhibit 9. The steep hillside where the employees were working.

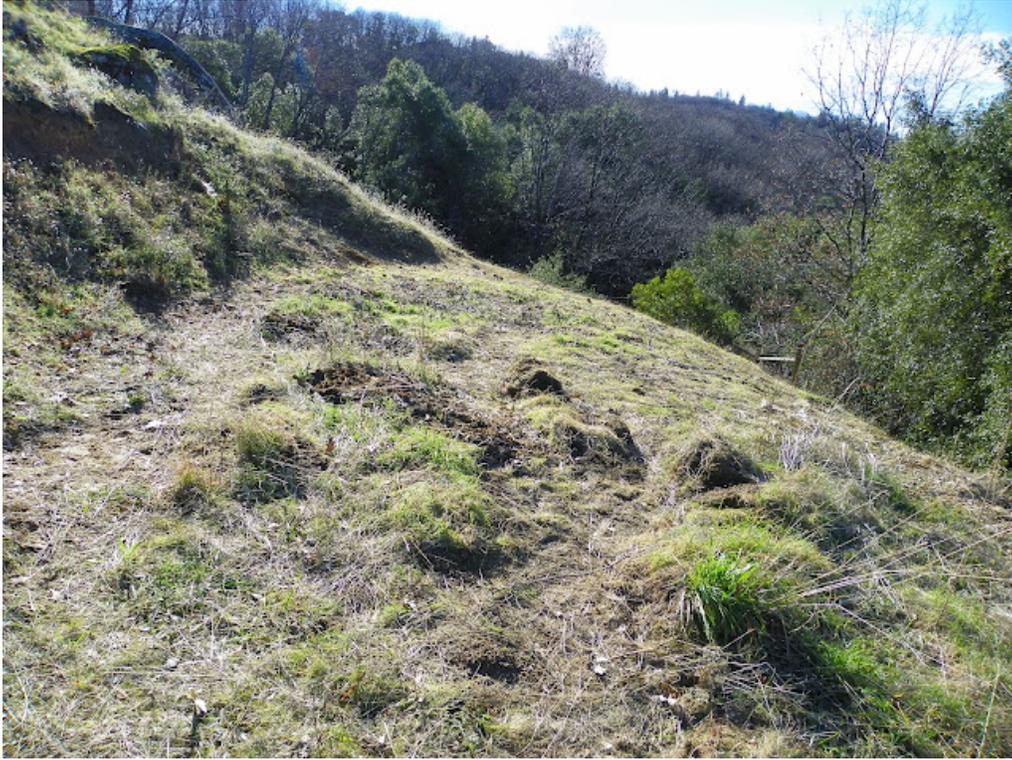
Exhibit 10. The incident scene showing the topography of the land.
