SUBJECT: A service writer for a car dealership died when he was struck in the head by an alignment rack that rolled off a handcart.

California FACE Report #02CA005

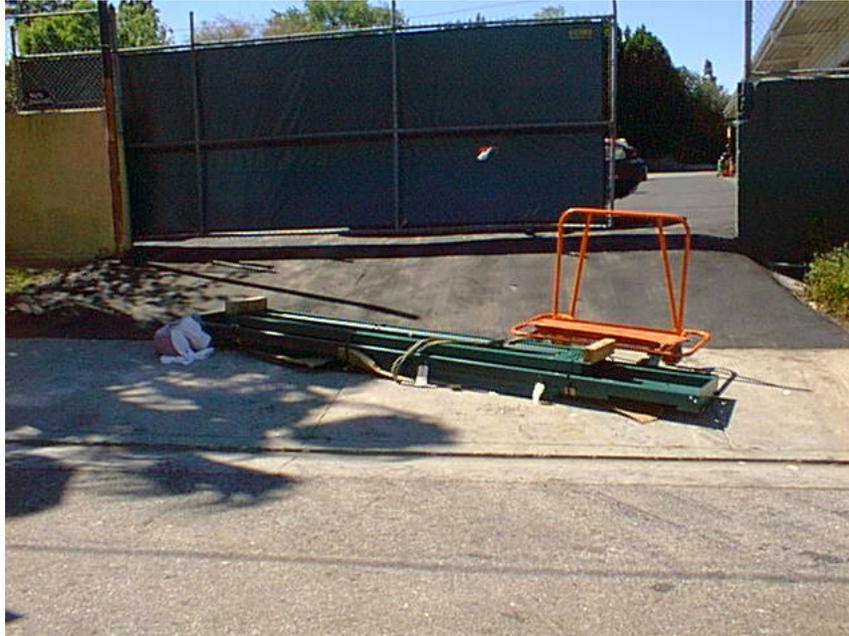
02CA005
Exhibit #1

With the aid of the hydraulic lift gate on the delivery truck, the alignment rack was removed from the truck bed and onto a handcart. The alignment rack was approximately 15 feet long, 4 feet wide, and weighed over 1,000 pounds. The rack was too long and too wide to be placed flat on the cart, so it was placed lengthwise and on edge on the handcart with the two ends hanging over. The rack was tilted so its base was at an angle to the back of the handcart. The victim and supervisor then attempted to push the handcart sideways up the driveway incline and into the shop. Approximately half way up the ramp, with their hands at the base of the handcart and their bodies fully extended, the weight was too much to move and the alignment rack starting slipping off the handcart. The supervisor was able to roll out of the way, however, the victim's footing slipped and he fell on his stomach just as the alignment rack came off the cart. The alignment rack landed on the victim's head. The supervisor immediately called 911 and the paramedics responded. They transported the victim to a local hospital where he was pronounced dead.

View of the incident scene showing the alignment rack, handcart, and the driveway incline.

Discussion: The use of a handcart to move the alignment rack was not sufficient in size or weight to handle such a load. Material handling equipment should have its capacity marked or stamped on it to indicate its limitations. Had the proper equipment been used to move this alignment rack, this incident might have been prevented.

Discussion: Unstable material being moved, regardless of its weight, should always be secured to avoid any sudden movement. Had this load been properly secured, this incident might have been prevented.

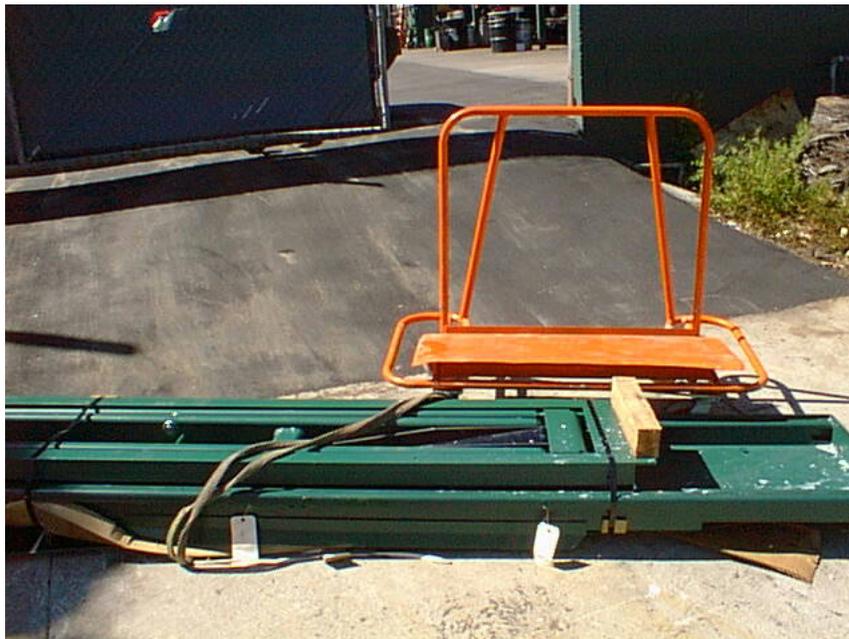
02CA005
Exhibit #2

A closer view of the alignment rack, handcart, and driveway incline.

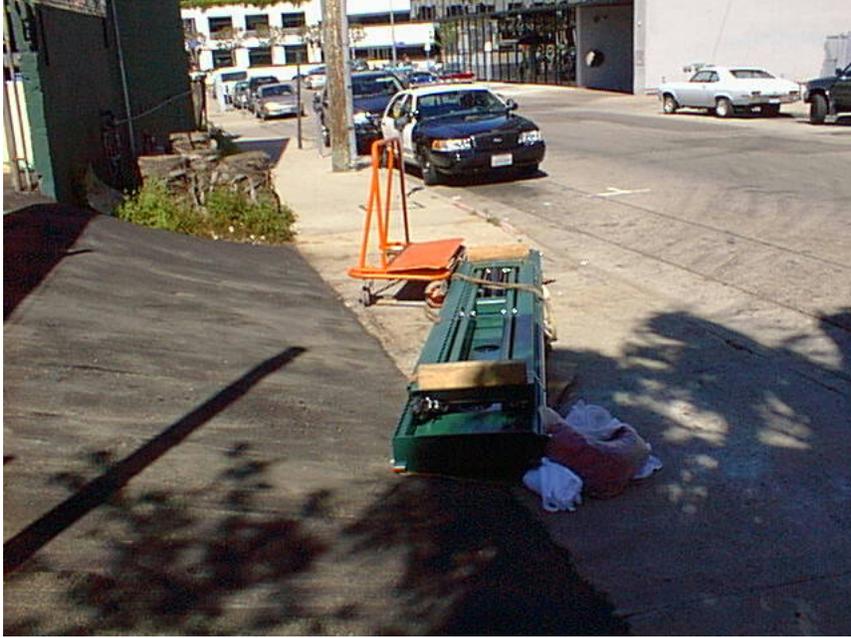
Exhibit #3

View of the incident scene looking south and depicting the pitch of the driveway ramp.

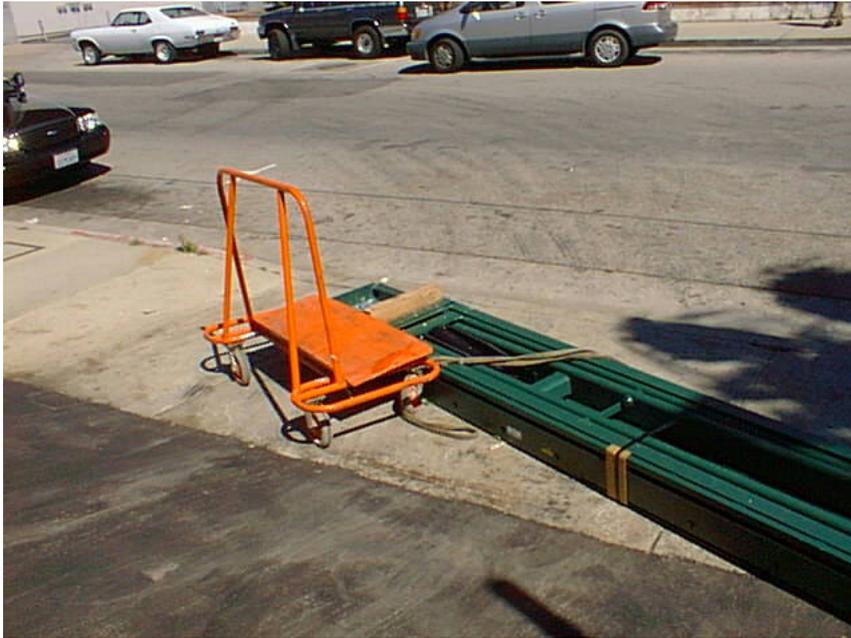
Exhibit #4

View of the incident scene looking down from the driveway entrance of the shop.
