SUBJECT: A truck driver died when he fell off of and was run over by the backhoe he was riding on.

SUMMARY
California FACE Report #02CA006

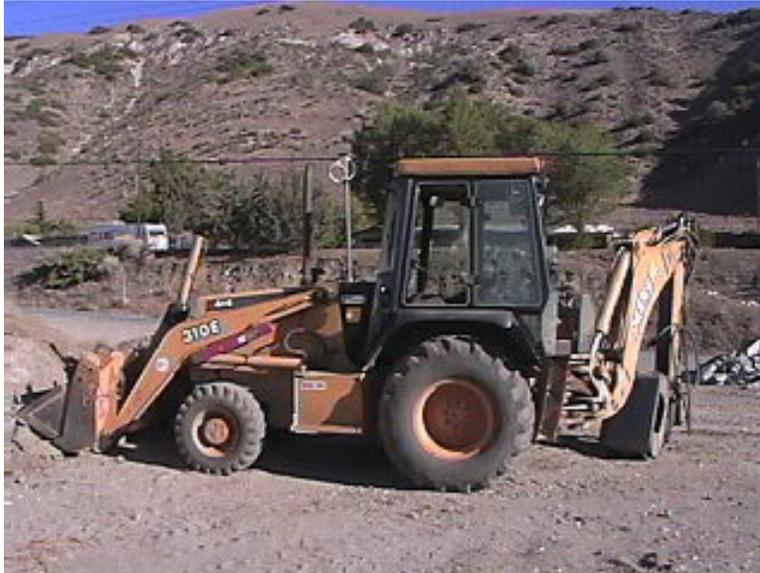
Exhibit #1

View of the backhoe involved in the incident

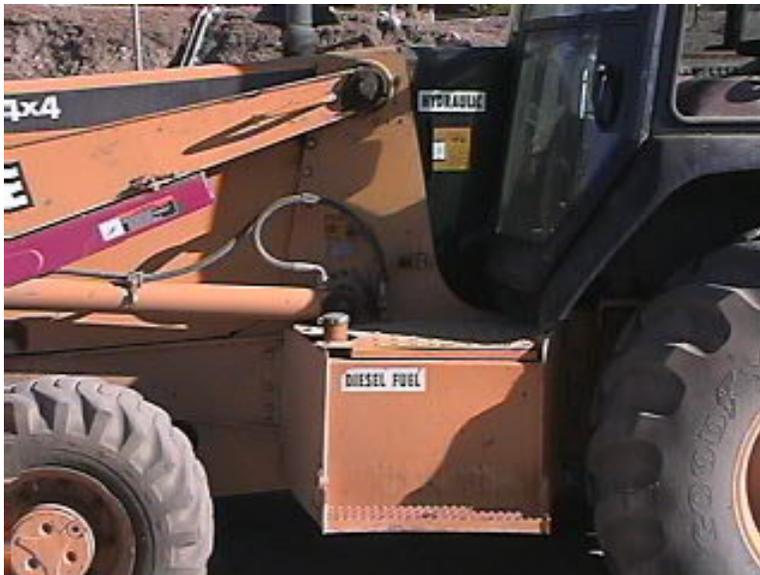
Exhibit #2

Discussion: Backhoes are designed for one operator with one set of controls and do not have passenger seats. The step and handrail that the victim used to hitch a ride on the backhoe was designed for the operator to enter and exit the tractor and not intended for riders. Operators of backhoes need to not only demonstrate their ability to operate the controls and movement of the tractor, they also need to demonstrate their knowledge of the safety precautions needed to be taken when operating. One vital point of backhoe operation is not allowing an unsafe practice to occur because “everybody else does it”. Employers can ensure safe work practices by establishing work procedures through programs of training, supervision, safe work recognition, and progressive disciplinary measures.

Close-up view of the step and handrail used by the victim.

Recommendation #1: Develop, implement and enforce a policy that clearly states no riders are allowed on backhoes.

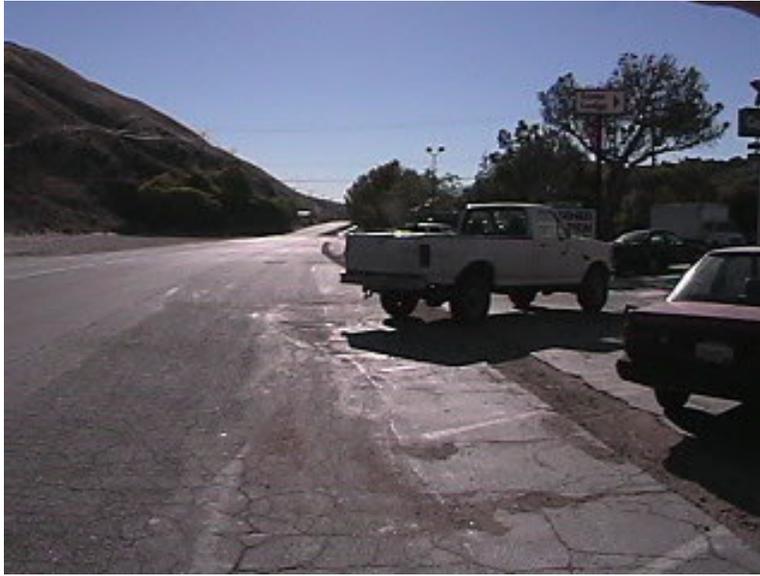
02CA006
Exhibit #3

View of the incident scene looking south.

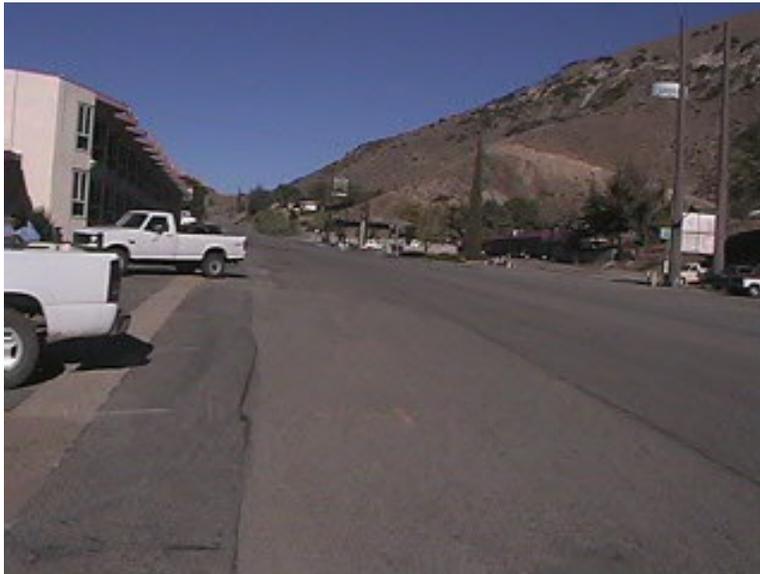
02CA006
Exhibit #4

View of the incident scene looking north.
