FROM: California Fatality Assessment and Control Evaluation (FACE) Program

SUBJECT: A construction laborer was killed when a rubber tire bulldozer backed over him as he was doing a grade check.

SUMMARY
California FACE Report #02CA002

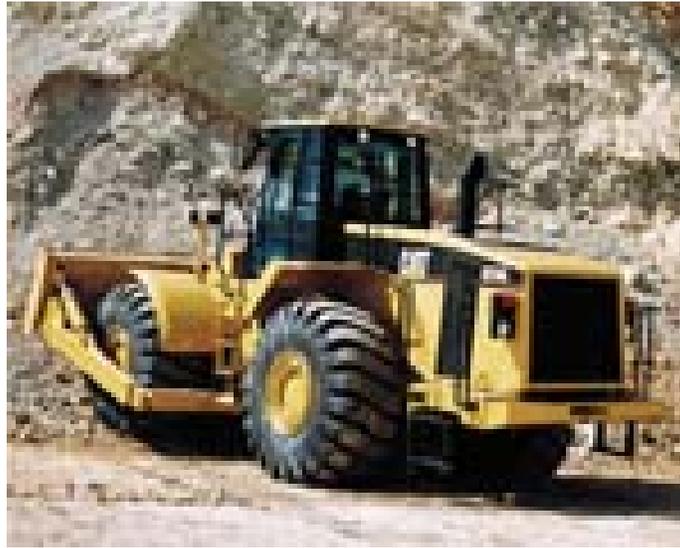
Exhibit #1

View of a rubber tire bulldozer similar to the one involved in the incident
