TO: Director, National Institute for Occupational Safety and Health
FROM: California Fatality Assessment and Control Evaluation (CA/FACE) Program
SUBJECT: A laborer died when crushed between the forks and the cab of a trash truck.

SUMMARY
California FACE Report #03CA002

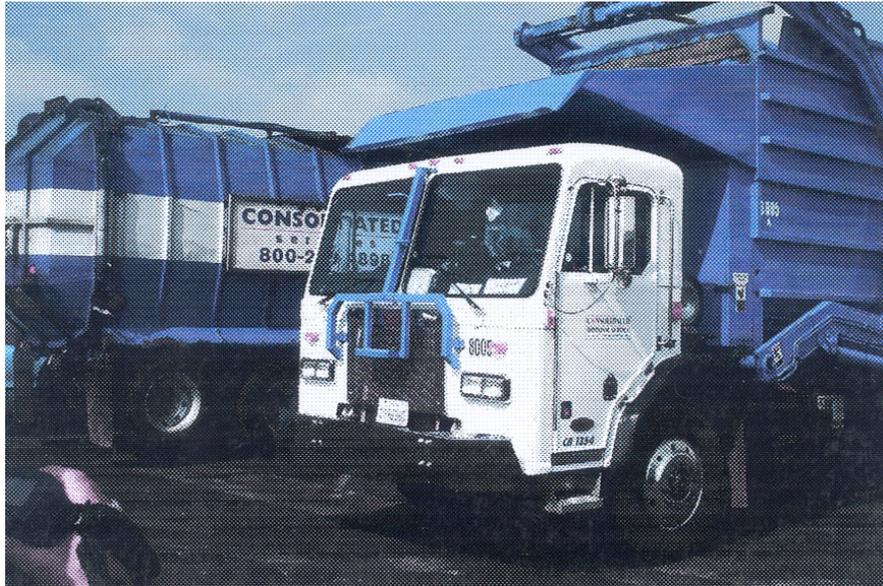
Exhibit #1

Picture of the trash truck involved in the incident.

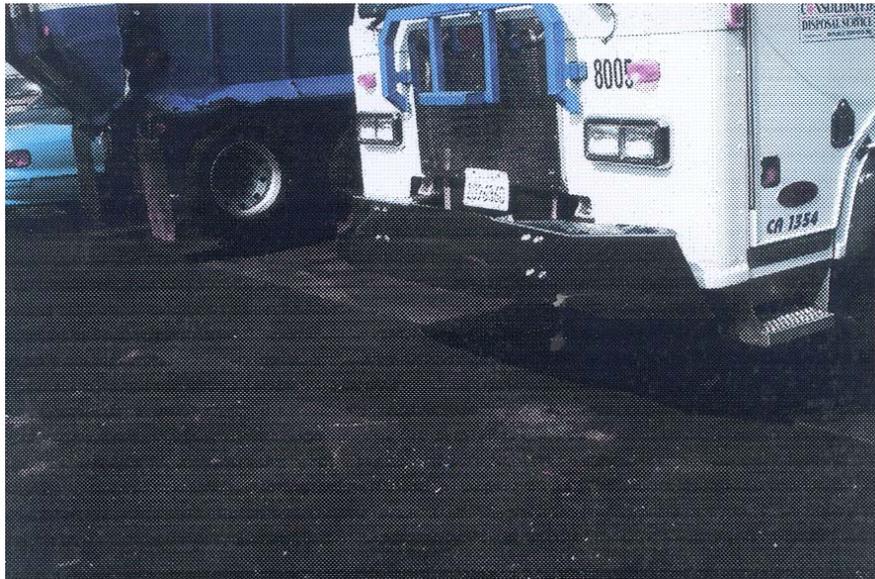
Exhibit #2

Picture of the front of the trash truck where the victim was crushed.

Discussion: When operating the controls on the driver's side of the equipment, the operator does not have a clear and unobstructed view of the front of the trash truck. A convex mirror mounted on the cab or bumper could provide the necessary view for the operator. These mirrors could supplement, not replace, visual inspection of the front of the trash truck, and possibly could help eliminate any future incidents of this type.

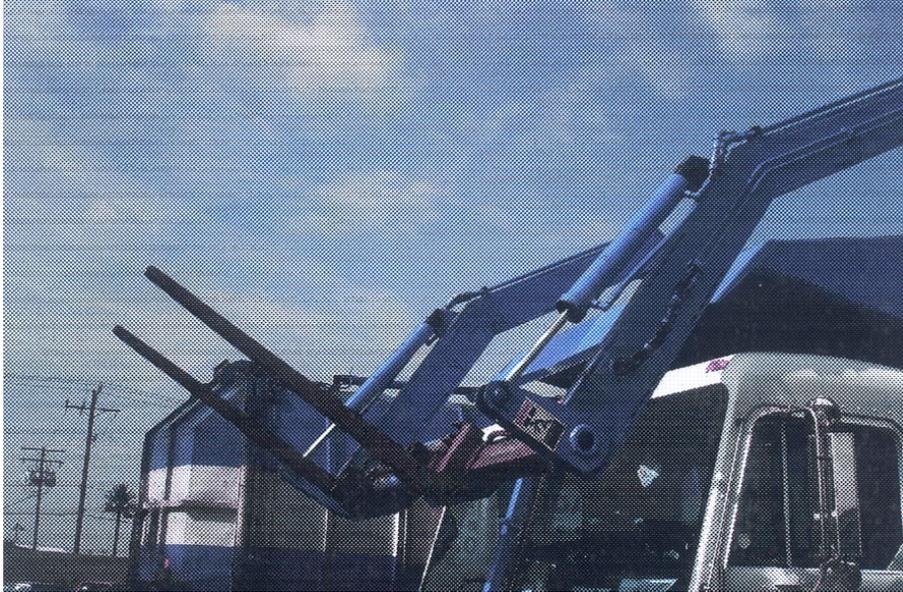
Exhibit #3

Picture of the hydraulic forks being lowered in front of the cab.

Discussion: An operator of this particular type of trash truck has a clear view of the front forks while seated in the driver's seat, but the view is obstructed when using the side controls. The operator must physically check the area in front of the trash truck, to ensure it is clear immediately before using the side controls. In this case, the operator was momentarily distracted when he took time to clear out some loose trash that had fallen on the truck exhaust system. During that time period the conditions changed when the victim entered the area in front of the trash truck below the raised forks.

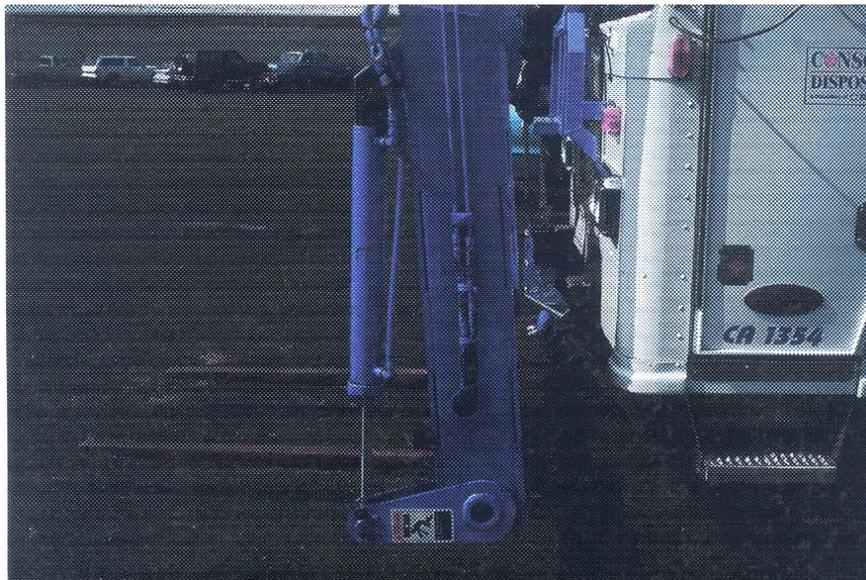
Exhibit #4

Picture of the forks lowered in front of the cab showing the space where the victim was crushed.

Discussion: Employers should make sure that all employees who work with or near trash trucks are aware of the hazards that are associated with trash trucks even if they are not the operator. The company supplied written rules and regulations for all employees to follow. These rules stated that workers should never stand under the area of the fork travel and should always let the driver know where they are. Safe work practices can be assured through programs of training, supervision, rewards, and progressive disciplinary measures.
