SUBJECT: A machine operator died when caught in the threads being wound onto the take-up spool of a warping machine

SUMMARY
California FACE Report # 06CA006

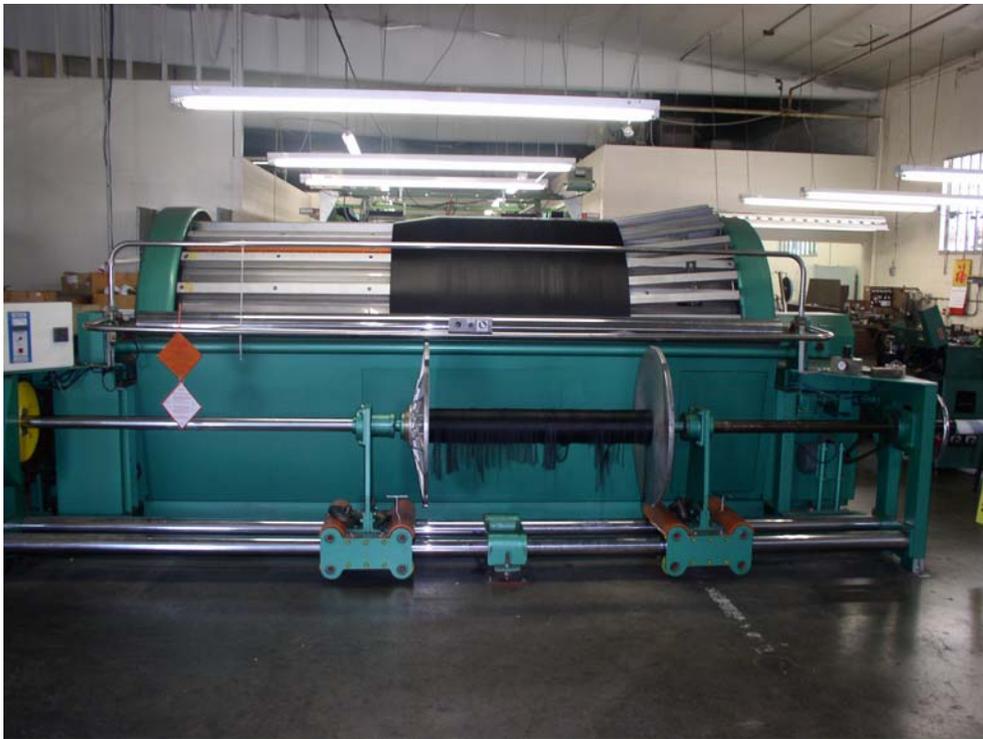
Exhibit 1. A picture of the machine involved in the incident.

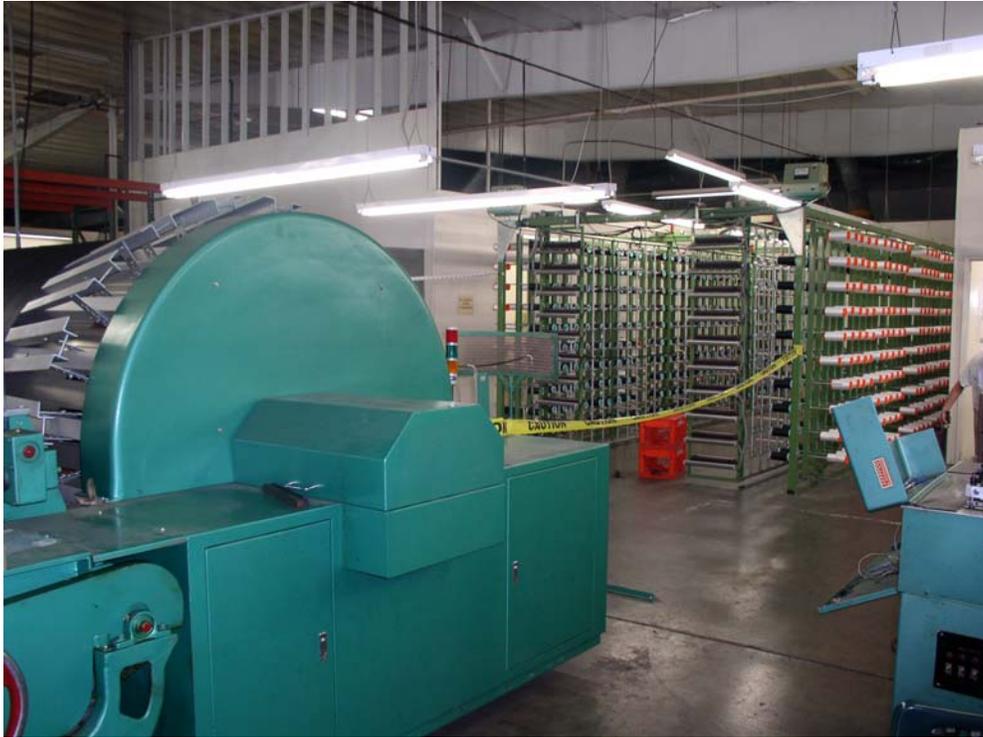
Exhibit 2. A picture of the left side of the machine showing individual spools of thread on racks being fed into it.

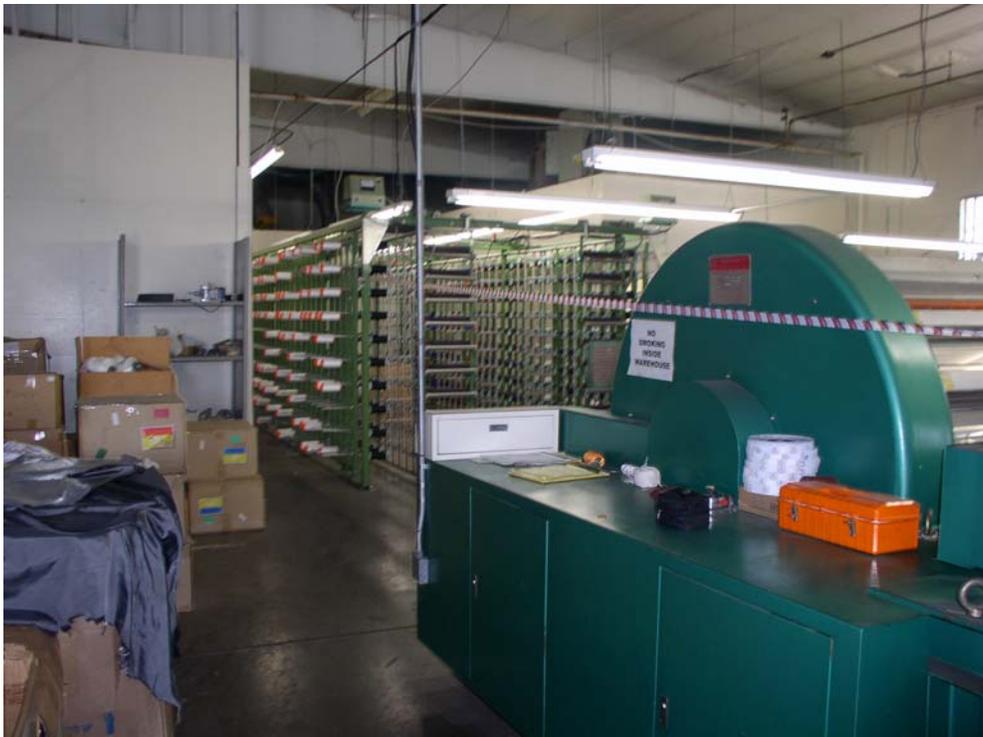
Exhibit 3. A picture of the right side of the machine showing the individual spools of thread on racks that are being fed into it.

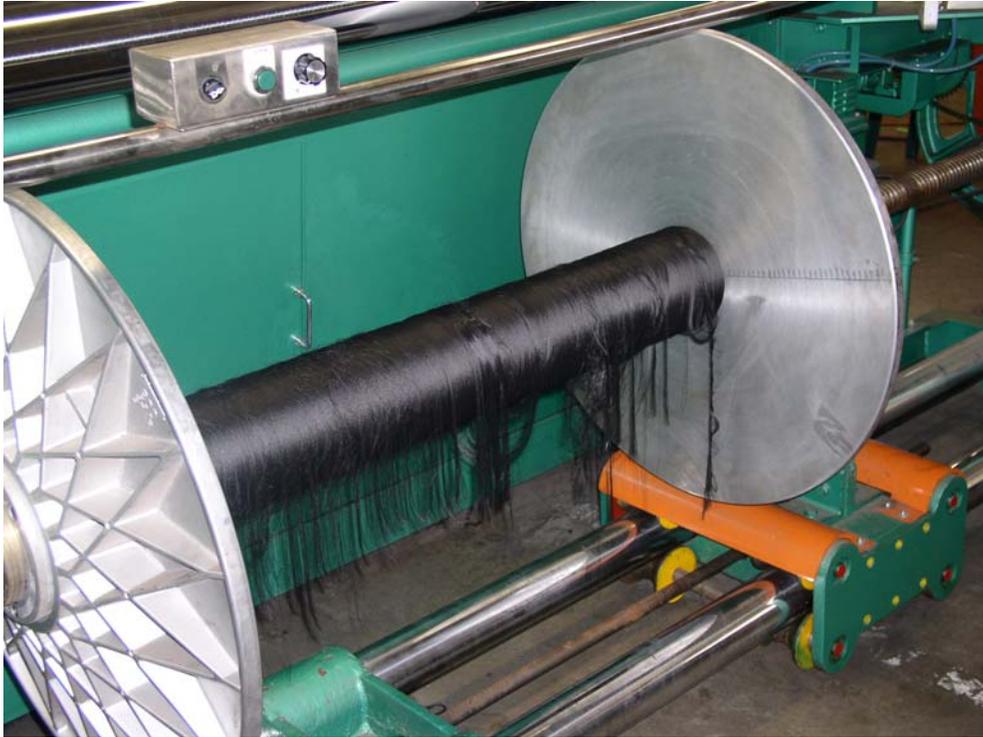
On the day of the incident, the victim was operating the warper machine, and a video surveillance camera in the shop showed that the victim placed his hands in the proximity of the spool while it was spinning. The victim hit the safety bar in front of the machine as he was being pulled into the spool. That action shut the machine down but not before the victim was wound tightly around the spool by the threads. The incident was not witnessed, and the time lapse before the victim was discovered was seven minutes. The company president discovered the victim and tried to rescue him by cutting the threads. The paramedics subsequently arrived and checked the victim for vital signs. They found no pulse or respiration and pronounced him dead.

Exhibit 4. A picture of the spool of thread the victim was caught in.

Recommendation #1: Ensure employee safety by installing guards around the moving parts and pinch points of the machine to protect employees from accidental contact.

Discussion: In this particular case, the victim was seen reaching into the machine while the spool of thread was spinning at a high rate of speed. Because of the ever-present danger of entanglement when working near moving machinery parts, employers should continually strive to protect employees by providing machine guarding in the areas where work is actually performed upon the material being processed. Swivel double-bar gates would be one method of providing this protection. Employers should contact machine manufacturers and, if applicable, retrofit the machine with guards which will prevent any part of the body from contacting the machines moving parts. Electronic sensors can also be used to protect employees from moving parts and pinch points, as they shut down the machine whenever the sensor beam is broken.

Discussion: In this particular case, when the victim was being pulled into the spool of thread, he hit the safety bar to shut the machine down. However, by the time the machine stopped rotating, the victim was wound tightly in the threads causing his death. A braking system activated by the use of the safety bar would have stopped all motion of the machine instantly, and might prevent future incidents such as this one from occurring.

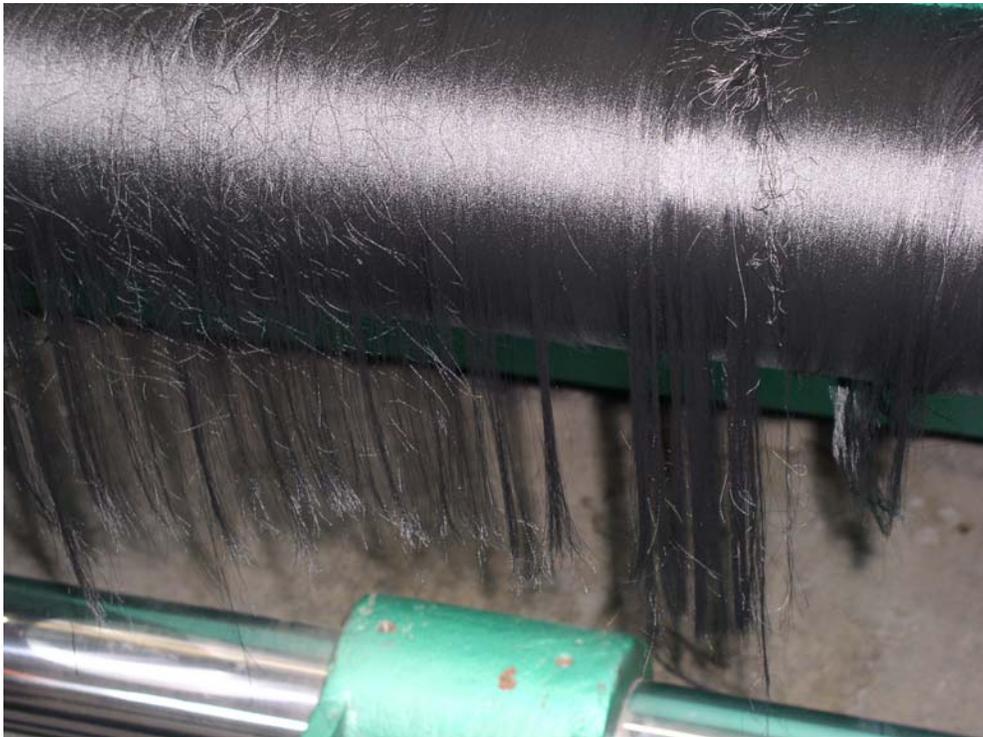
Exhibit 5. A picture of the threads that were being wound on the spool the victim was caught in.

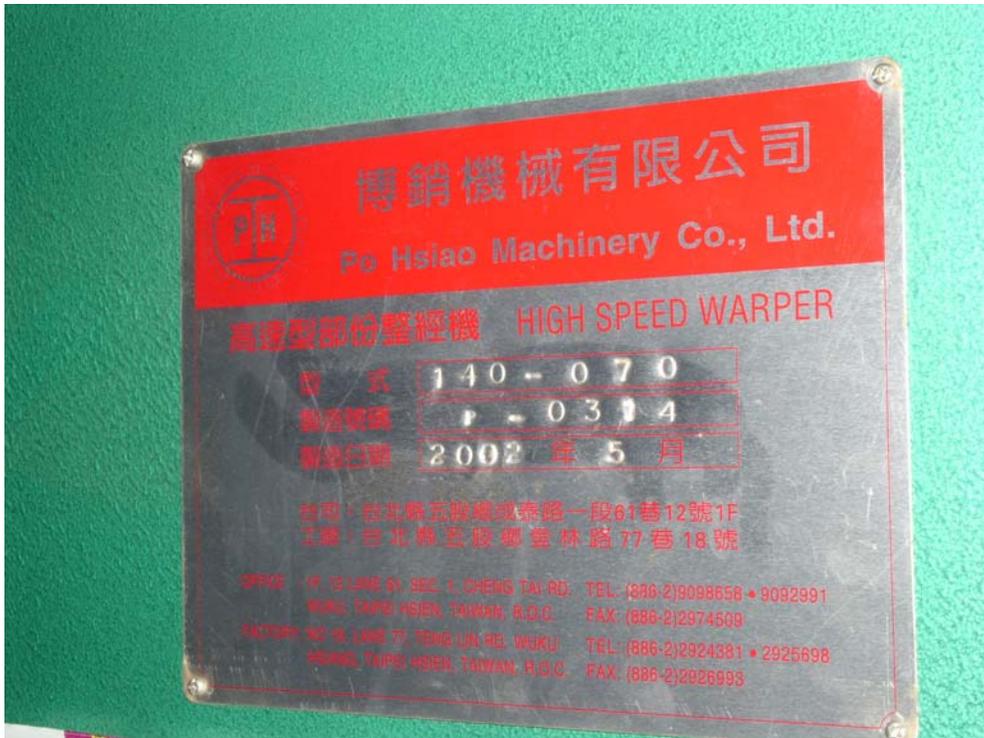
Exhibit 6. A picture of the name plate on the machine involved in the incident.
