SUBJECT: Machine Operator in a Plastic Recycling Facility Dies After Being Caught in a Bale Breaker Machine.

SUMMARY
California FACE Report #08CA007

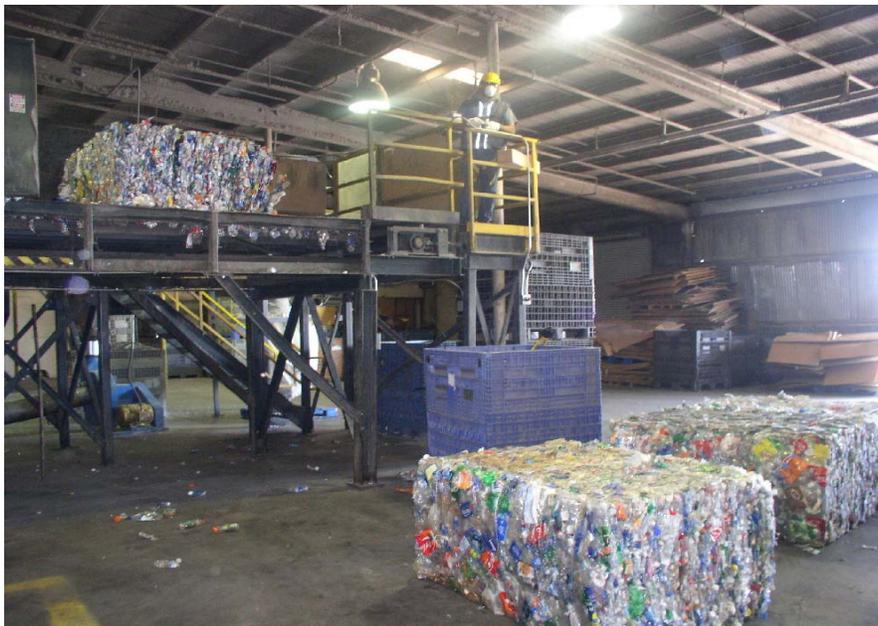
Exhibit 1. The plastic bottle bale breaker machine with bales of plastic bottles.

The site of the incident was a bale breaker machine within a plastic bottle recycling facility (**Exhibit 1**). Plastic bottles were received at the company warehouse in bales from various vendors, and the bale breaker was used to separate the bottles from each other so that they could be further processed. The bale breaker was approximately 9 ft. high by 5 ft. wide by 30 ft. long. There was a twenty foot long conveyor belt that carried the bales to rapidly spinning blades that tore apart each bale and sent the individual bottles onto the next portion of the recycling process. The breaker had been manufactured by the Bulk Handling Systems (BHS). The bale breaker machine had stairs that led to a catwalk along one side of the conveyor belt. The conveyor belt on the bale breaker was enclosed with a hinged gate at the beginning of the conveyor belt to gain access to that area. The opening on the outside portion of the conveyor belt allowed a forklift to raise the bales of plastic bottles onto it. A forklift placed the bales on the conveyer belt, and the bales fed into rotating blades that broke apart the compressed bottles. During the bale breaking process, some bottles would break loose from the bale, begin to bounce off the blades, and fail to pass through the breaker into the next portion of the process. If bottles from the bales failed to properly feed into the blades, the company's standard procedure was to stop the blades and reverse the direction of the conveyor belt until the misfed bottles moved away from the blades then restart the blades and conveyor and again try to feed the bottles into the breaker blades. This entire procedure was performed using controls safely away from the conveyor and blades.

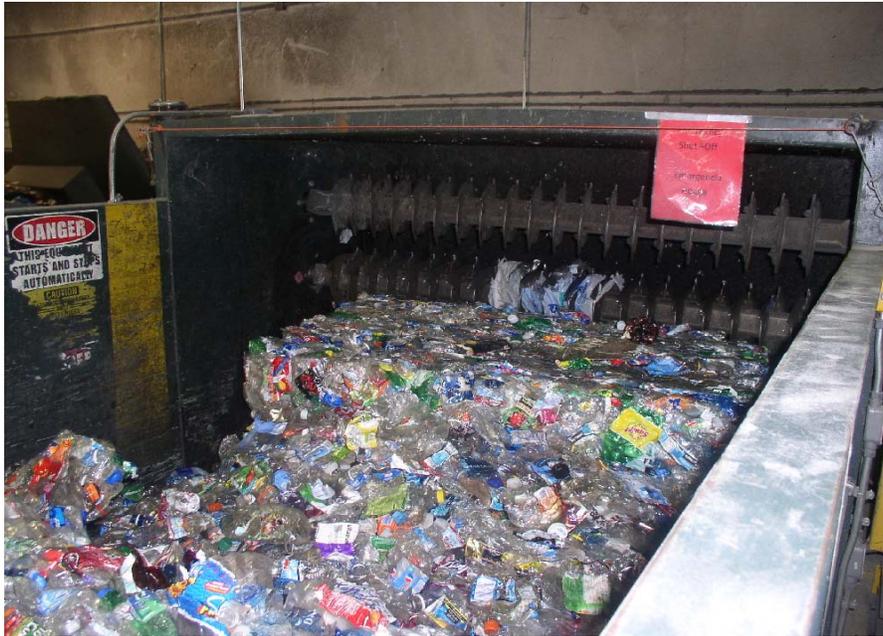
Exhibit 2. The bales of plastic bottles being fed into the rotating blades of the bale breaking machine.

Discussion: In this incident, the victim was able to gain access to moving portions of the bale breaker. The design of the conveyor and bale breaker had physical barriers but they did not prevent access to moving parts. There were also no safety interlocks which could have shut down the machine in case a worker entered an unsafe area. By working and collaborating with machine manufacturers, additional safety devices could be added to the machine that would assure employees safety when working with machines that require an employee to be in close proximity to moving parts.

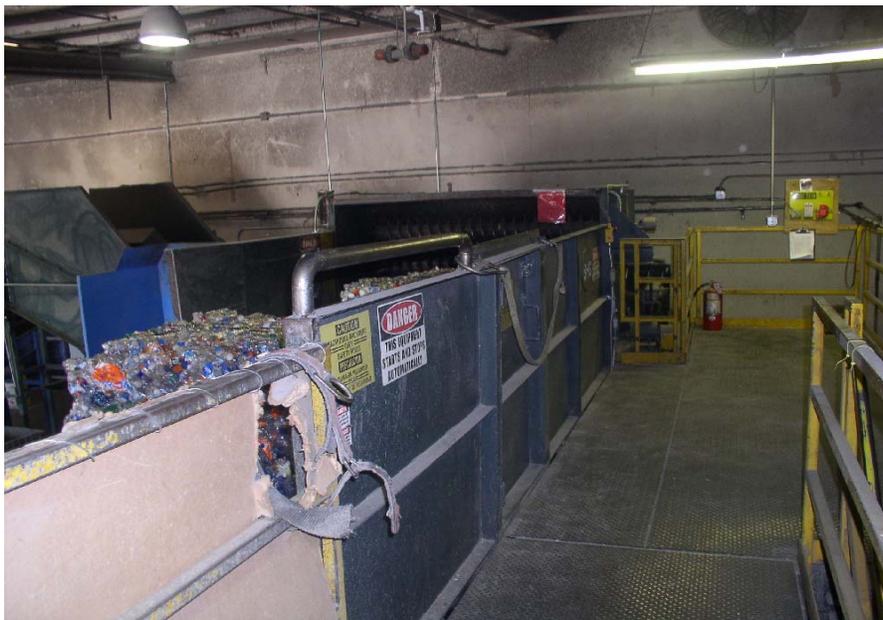
Exhibit 3. The catwalk used to gain access to the bale breaker machine.

On the day of the incident, the victim and his co-worker were standing on the bale breaker catwalk (**Exhibit 3**) and saw a small portion of a bale not properly feeding into the blades. The co-worker left the victim to address the problem and started down the catwalk stairs. According to the victim's co-worker, the victim entered the conveyor belt area while the machine was still running, and used his foot to kick the stuck bale into the blades. The victim's foot was caught by the rotating blades and pulled his body into the machine. The co-worker heard the victim cry for assistance and shut the machine off at the machine control panel located at the top of the stairs. The victim could not be removed from the blades by the coworker. Emergency services were summoned by office personnel after the co-worker ran to the office for help and then returned to stay with the victim until help arrived. Once the victim was removed from the bale breaker machine he became unresponsive, and subsequently died after being transported to a local emergency room.
