SUBJECT: A Laborer Dies When He is Struck By an Exploding Forklift Multi-Piece Rim

SUMMARY
California FACE Report #10CA001

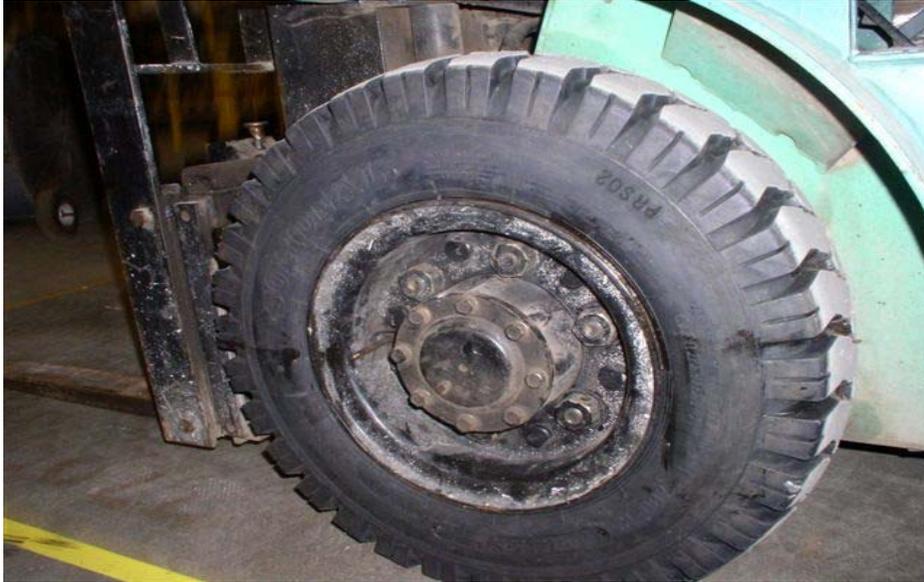
Exhibit 1. A forklift multi-piece rim and tire assembly similar to the one involved in the incident.

Recommendation #1: Laborers are not assigned skilled tasks such as changing tires on multi-piece rims.

Discussion: In this incident, the tile manufacturer used laborers from a local employment agency to perform tasks such as yard duties, janitorial work, and lifting heavy objects. Flat tires on forklifts were changed onsite. The victim in this case had changed tires in the past but had never received proper training in multi-piece rims. The victim attempted to disassemble the wheel before deflating the tire. This will always result in an explosion in a fully inflated tire. The first principle in tire assembly is to fully deflate the tire before performing any work. Because of the extreme danger and severe consequences of improper handling of tires with multi-piece rims, employees assigned to change this type of wheel should receive specific training on each multi-piece rim produced by a different manufacturer. This training should be verified through testing and noted in the worker's personnel or training file. These workers did not have the technical skills necessary to perform the job safely, which led to the victim's death. The task of changing the flat tires on a forklift with multi-piece rims required skills beyond the

scope of a general laborer. Had the victim not been assigned this task, this incident would have been avoided.

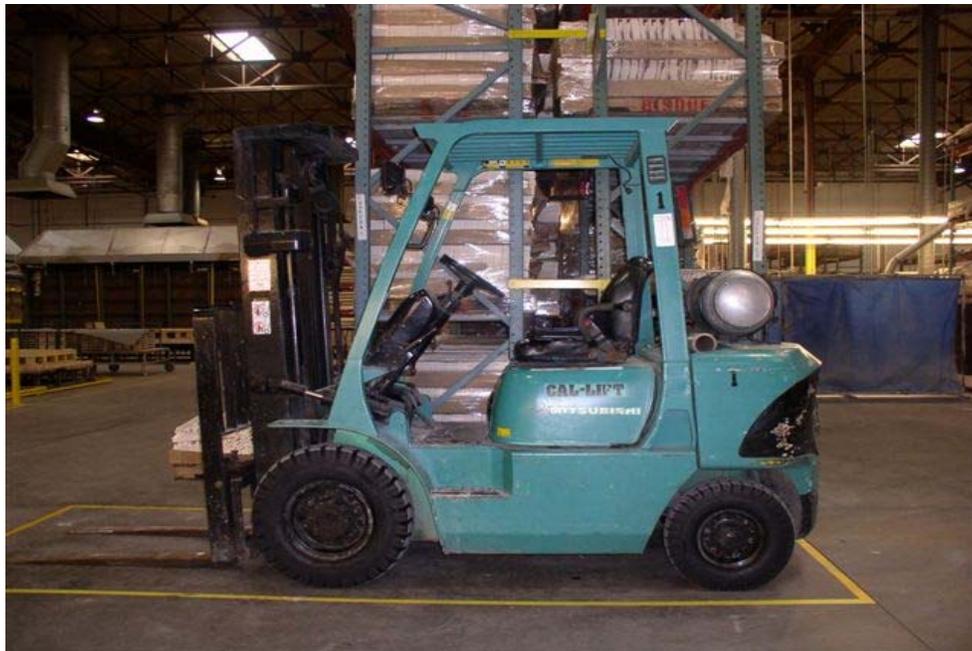
Exhibit 2. The forklift involved in the incident.
