SUBJECT: A Solar Panel Installer Dies When He Falls Off a Roof

SUMMARY
California FACE Report #10CA003

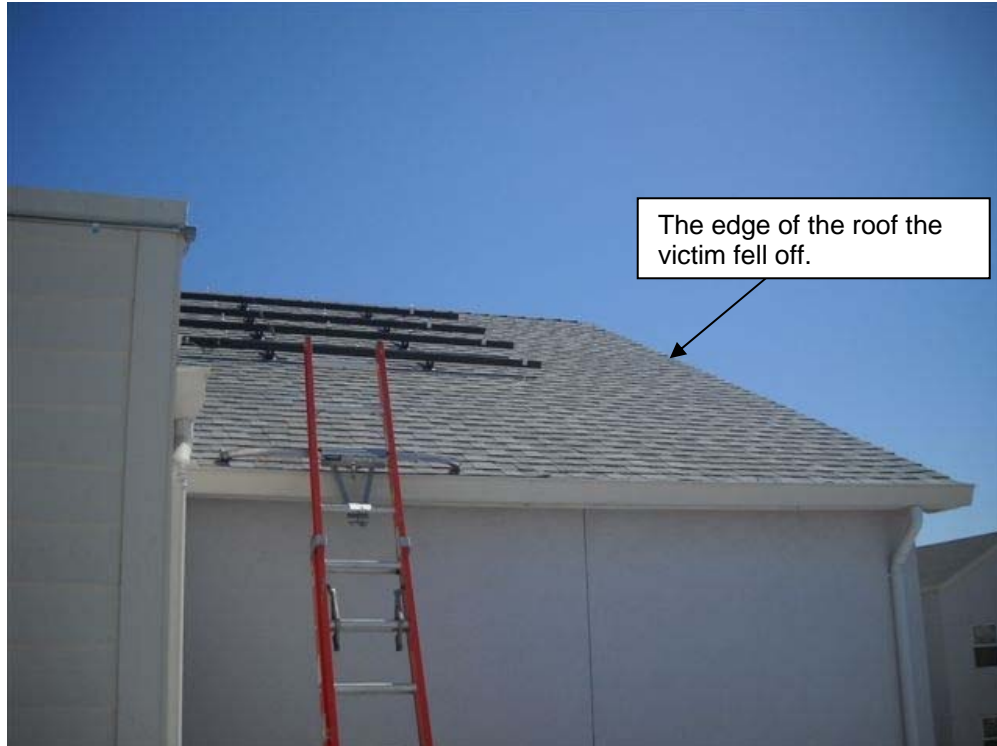
Exhibit 1. The roof edge the victim fell from.

Recommendation #1: Employees wear fall protection when working on sloped roofs with identified fall hazards.

Fall protection should be worn by employees on sloped roofs greater than 30 degrees, or whose work exposes them to a risk of a fall in excess of 7 ½ feet. The two types of fall protection systems commonly used on roofs are a personal fall restraint (PFR) system and a personal fall arrest (PFA) system. A PFR system is used to prevent an employee from falling. It consists of anchorages, connectors, lanyards, and body harness. A PFA system is used to stop an employee during a fall from a working level. This system consists of an anchorage, connectors, a deceleration device, and a body harness. Had the victim been wearing the required fall protection, his death would have been prevented.

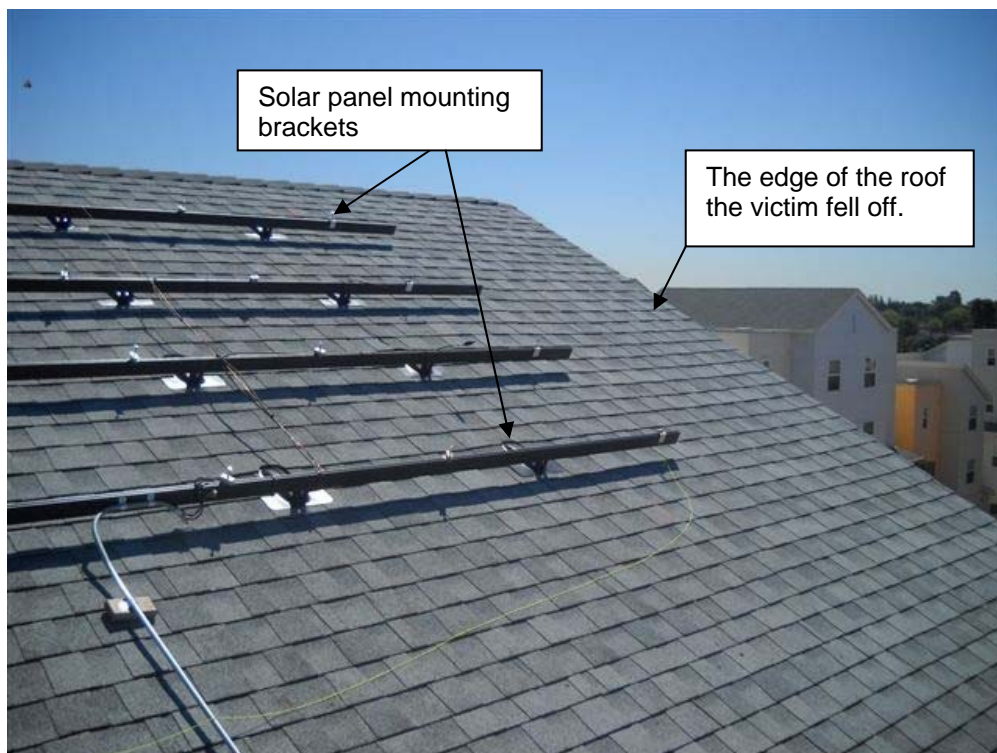
Exhibit 2. The mounting brackets for the solar panels and the roof's edge where the victim fell.

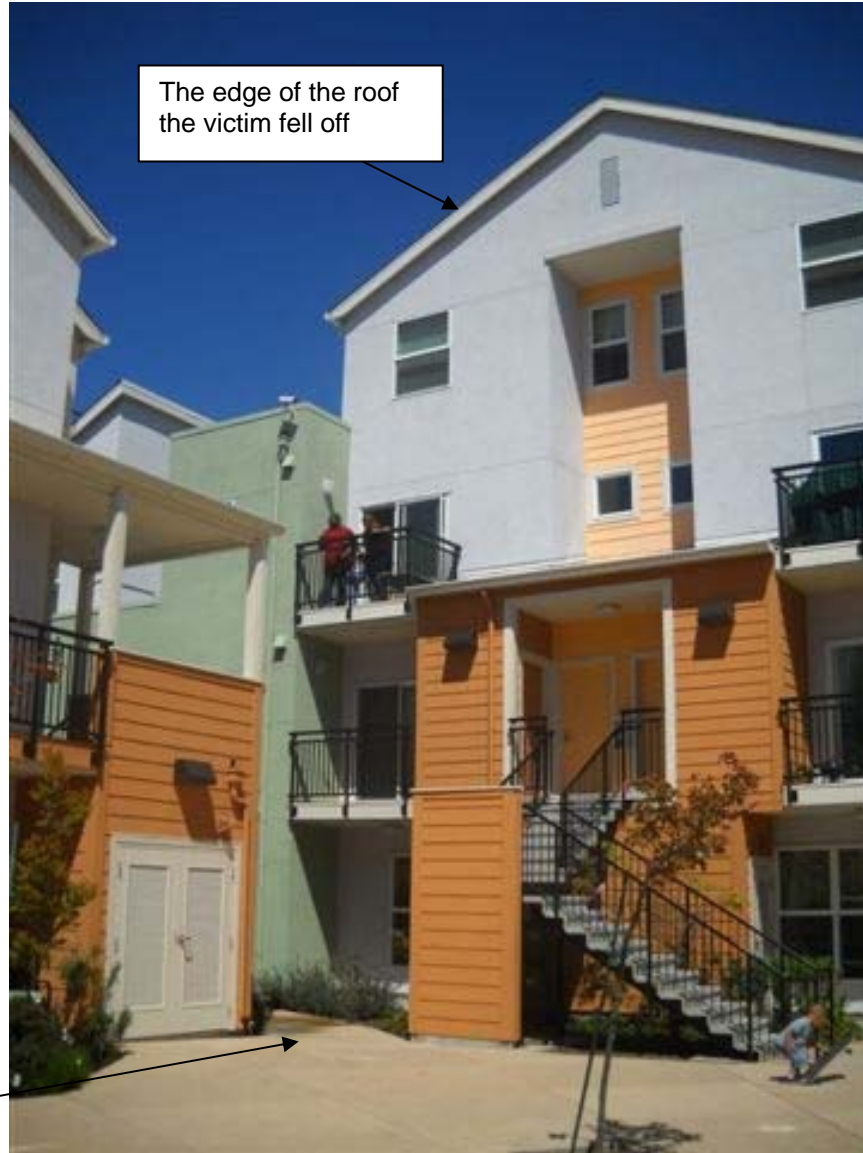
The edge of the roof
the victim fell off

The concrete
sidewalk where the
victim landed after
falling off the roof

Exhibit 3. The three-story apartment building involved in the incident.

The location of the incident was a housing unit with multiple three-story apartment buildings. Solar panels were being installed on the sloped roofs of the apartment buildings. On the unit where the incident occurred, access to the roof was gained by a stairwell up to a third floor landing and then a straight ladder from the landing to the bottom of the sloped roof. The distance from the bottom of the sloped roof to the landing was approximately eight feet. The distance from the sides of the sloped roof to the ground below was approximately 45 feet. The slope of the roof was approximately 9:12 or 37 degrees.
