SUBJECT: A Horticulture Nursery Owner Dies When He Slips and Falls off a Tractor

SUMMARY
California FACE Report #10CA007

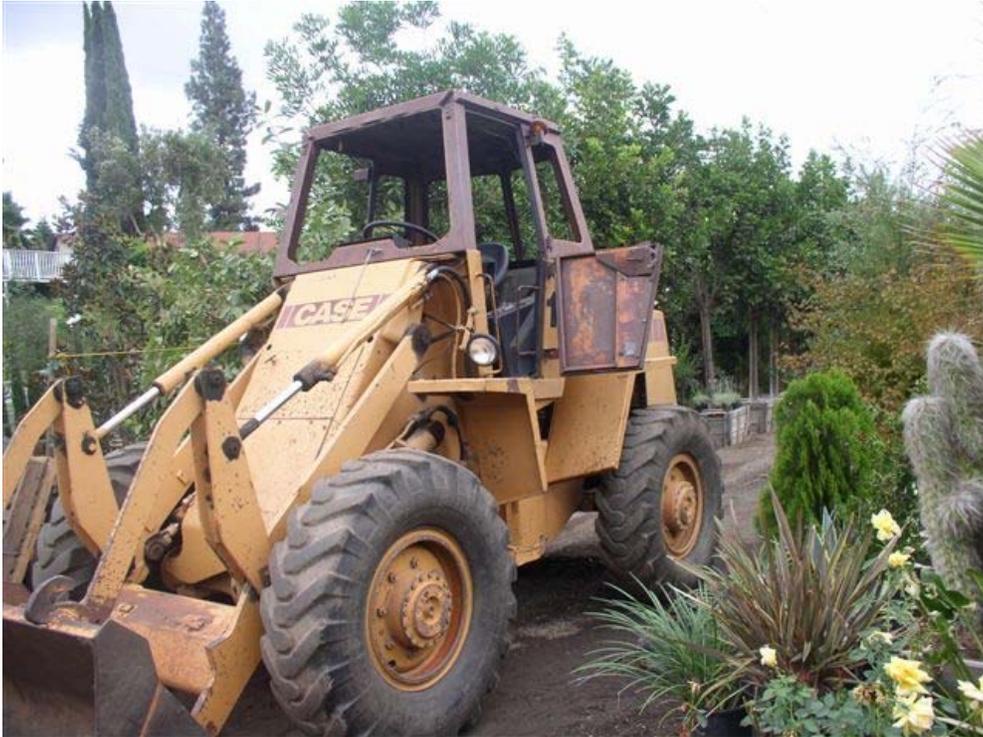
Exhibit 1. The articulating front end loader tractor involved in the incident.

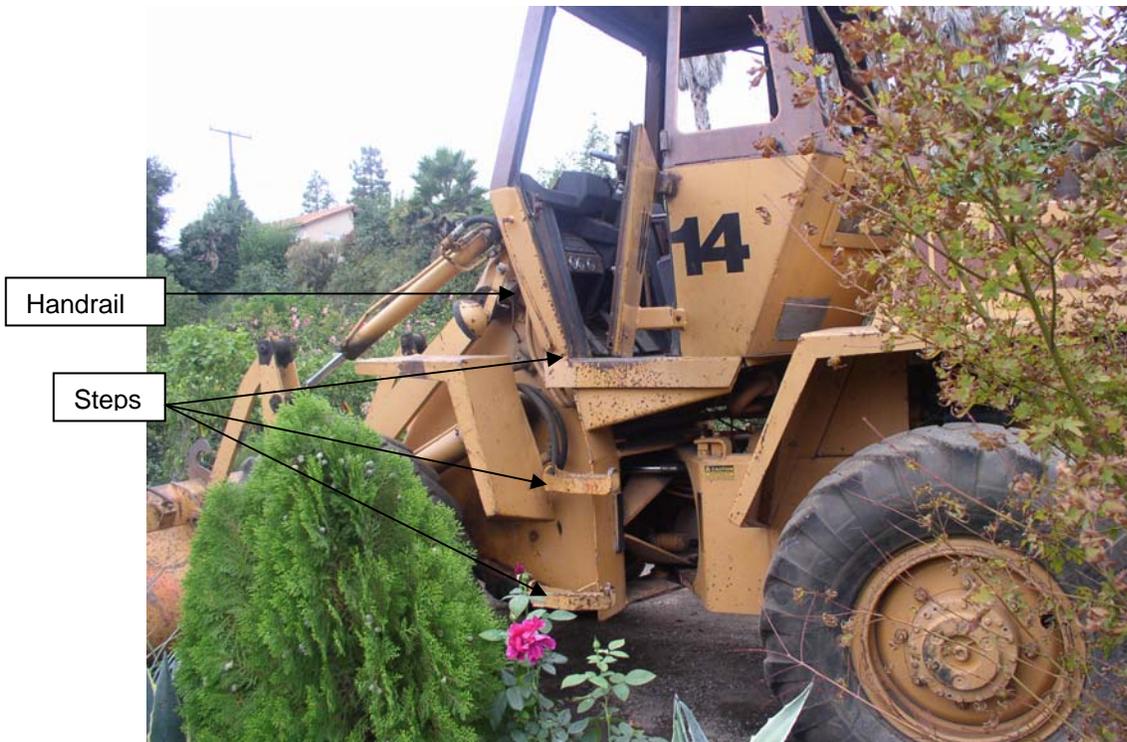
Discussion: In this incident, the victim climbed down from the elevated tractor, which required him to place his foot on the steel steps attached to the tractor cab. This maneuver posed a risk of slipping, especially as it may be difficult to visually see these surfaces when climbing backwards. When the victim was exiting the tractor, the evidence suggests that his cowboy boots slipped off the steel steps and he fell to the ground below. When climbing off or onto a tractor, non-skid or non-slip resistant footwear should be worn to reduce the risk of slip and falls. A work shoe or boot should be selected based on the surface material, the tread design, and the contact area. Had the victim been wearing slip or skid resistant footwear, he may have had secure contact with the steel steps, thereby preventing his fall to the ground below.

Exhibit 2. The stairs and handrail used to gain access to the cab.

Recommendation #1: Wear proper skid or slip resistant footwear when climbing onto or off of tractors.

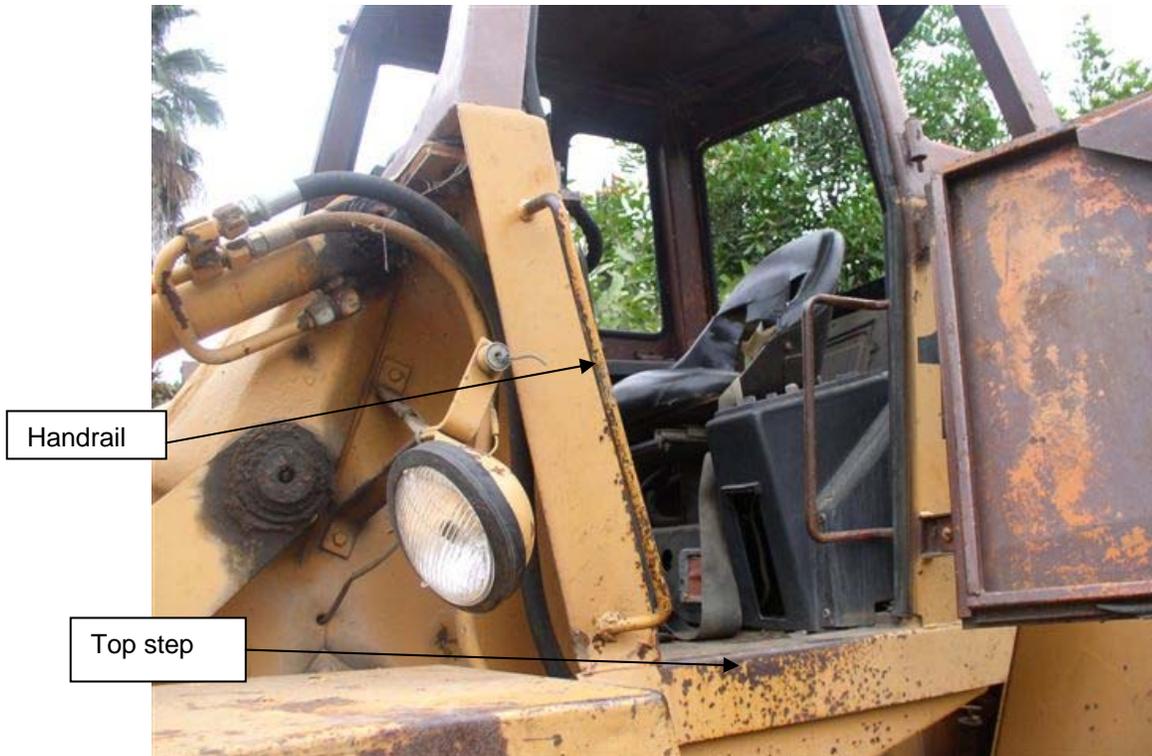
At approximately 2 p.m. on the day of the incident, the victim and his brother were retrieving an articulating front end loader tractor that was stored at another nursery. The weather was clear without rain. The victim climbed into the cab of the tractor and drove it to the rear of the nursery where a truck and trailer were parked. The victim drove the tractor onto the trailer, guided by his brother's signals. After positioning the tractor on the trailer, the brother of the victim went to get chains to tie the tractor to the trailer. Evidence suggests that the victim shut off the engine of the tractor, got out of the seat, turned backwards to descend the stairs on the outside of the tractor's cab, and during his descent slipped and fell backwards onto the asphalt ground approximately 8 feet below.

Exhibit 3. The entrance to the cab of the tractor showing the top step and handrail.
