**SUBJECT:** A Groundsman Working on a Tree Trimming Crew Dies When He is Dragged or Propelled onto a Wood Chipper Feed Table

**SUMMARY**  
**California FACE Report #10CA010**

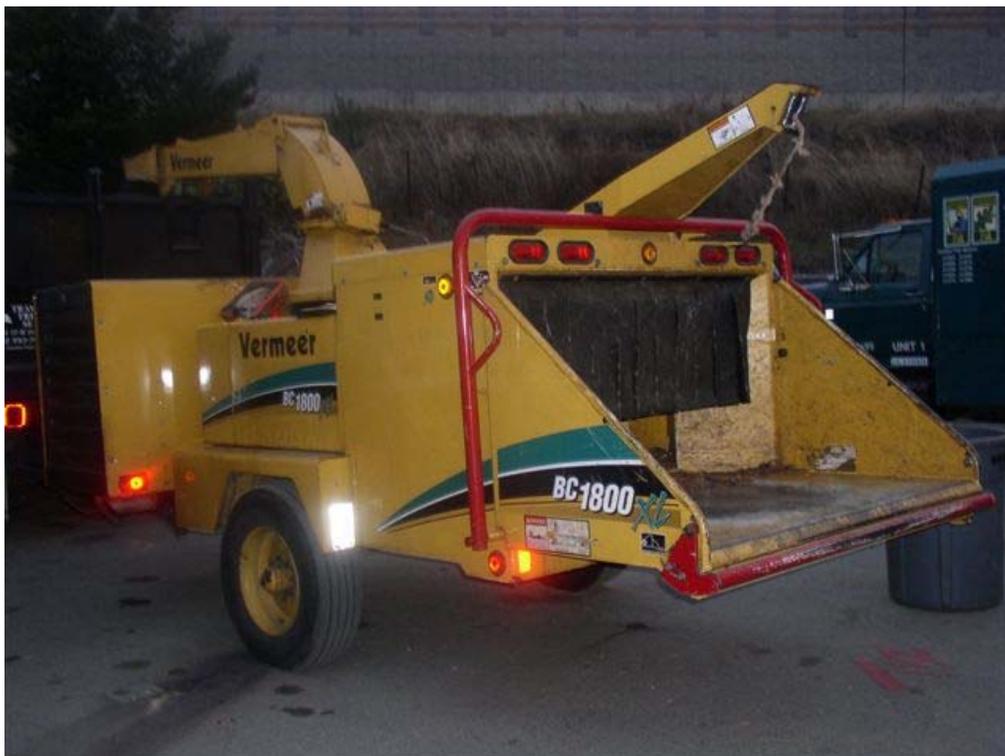
**Exhibit 1. The wood chipper involved in this incident.**

At approximately 1:30 p.m., the victim was dragging a branch from the base of a eucalyptus tree to the wood chipper which was approximately 40 feet away. As he passed another tree, the branch became entangled in the white colored climbing rope of the tree trimmer in that tree. When the victim reached the wood chipper, he fed the branches into the chipper with the climbing rope. Although this incident was not witnessed, evidence suggests that as the rope went through the wood chipper it immediately went taut. The victim was either dragged or thrown onto the chipper, striking his head. As his body landed on the feed table, it most likely struck the safety bar located on the front and shut the machine down.

### **Recommendation #1: Ensure that cut tree branches are staged and free of unwanted objects before being fed into wood chippers.**

Discussion: In this incident, the victim dragged a tree branch that became tangled in a tree trimmer's climbing rope that was coiled at the base of the tree. Because the cut branch was large and full of foliage, it snagged the rope as it was being dragged past the tree. When the victim got to the wood chipper he most likely fed the cut branch into the wood chipper, not realizing there was a rope entangled within it. All cut branches and brush should always be inspected just prior to being fed into wood chippers to ensure that they are free of any unwanted objects that might do harm to the wood chipper or cause personal injury. Staging the brush for inspection prior to starting the chipper would be the most protective procedure. As part of the chipper start-up procedure, the safety interlocks should be re-checked. Had the victim taken the time to inspect the cut branches prior to feeding them into the wood chipper, he might have noticed the entangled rope and prevented this incident from occurring.

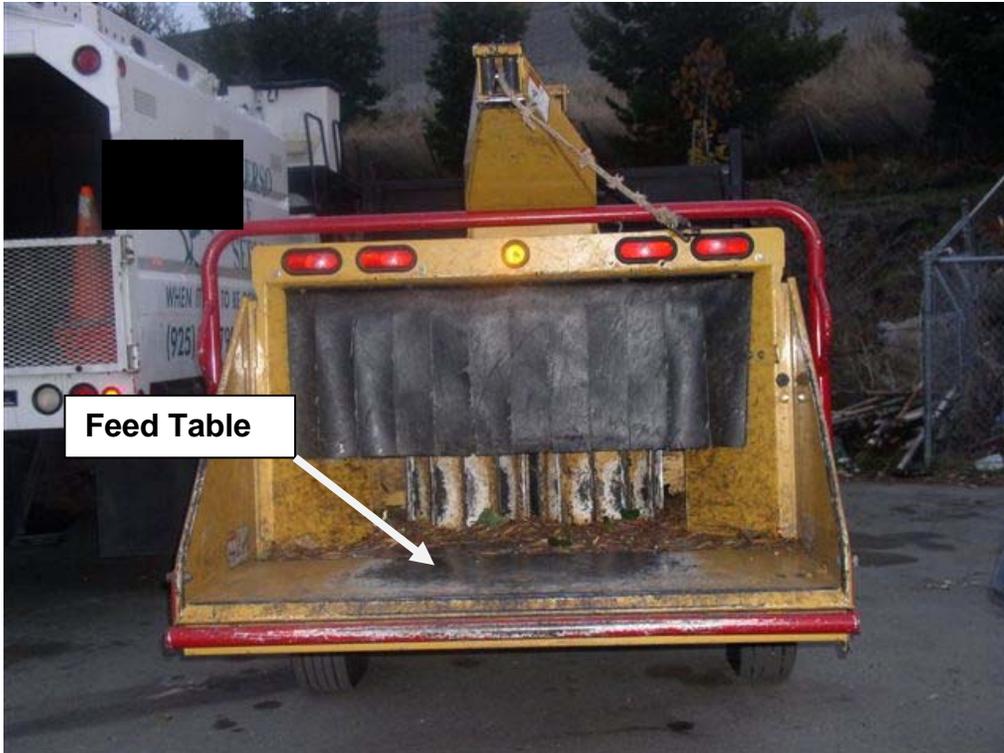
**Exhibit 2. The feed table where the victim landed.**

The tree trimmer, who was approximately 30 feet up in the tree, said he felt a sudden strong and fast pull on his climbing rope but his flip line prevented him from being pulled from the tree. He repositioned himself in the tree and saw the victim lying on the feed table of the wood chipper. The other two tree trimmers who were up in other trees did not witness the incident. The other two employees working on the ground were engaged in other activities at that time and also did not witness the incident. Emergency medical services were immediately called (911) and the local fire department responded. Co-workers began CPR and continued until emergency crews arrived. The victim was pronounced dead at the scene.

### **Recommendation #2: Assign another employee as a safety watch whenever cut tree branches are being fed into wood chippers.**

Discussion: In this incident, the victim was working alone even though there were two other employees working on the ground performing similar functions. When this incident occurred, no one witnessed the event, even though they were all in close proximity. Many hazardous work assignments, such as high voltage electrical work or confined space work, mandate the use of a safety watch to be present when certain activities occur to help prevent injuries. When a wood chipper is in operation, at least one worker in addition to the operator placed in the immediate vicinity of the work area and in close proximity to the operator would be able to observe the actions of the operator as well as the material being fed into the wood chipper. In this incident, a designated safety watch stationed near the chipper may have noticed the rope entangled in the cut branches and prevented the victim from feeding the branches into the wood chipper.
