**Investigation of the Taco John's *Escherichia coli* O157:H7 Outbreak  
Associated with Iceberg Lettuce**

Final Report

February 15, 2008

Prepared by: The California Food Emergency Response Team

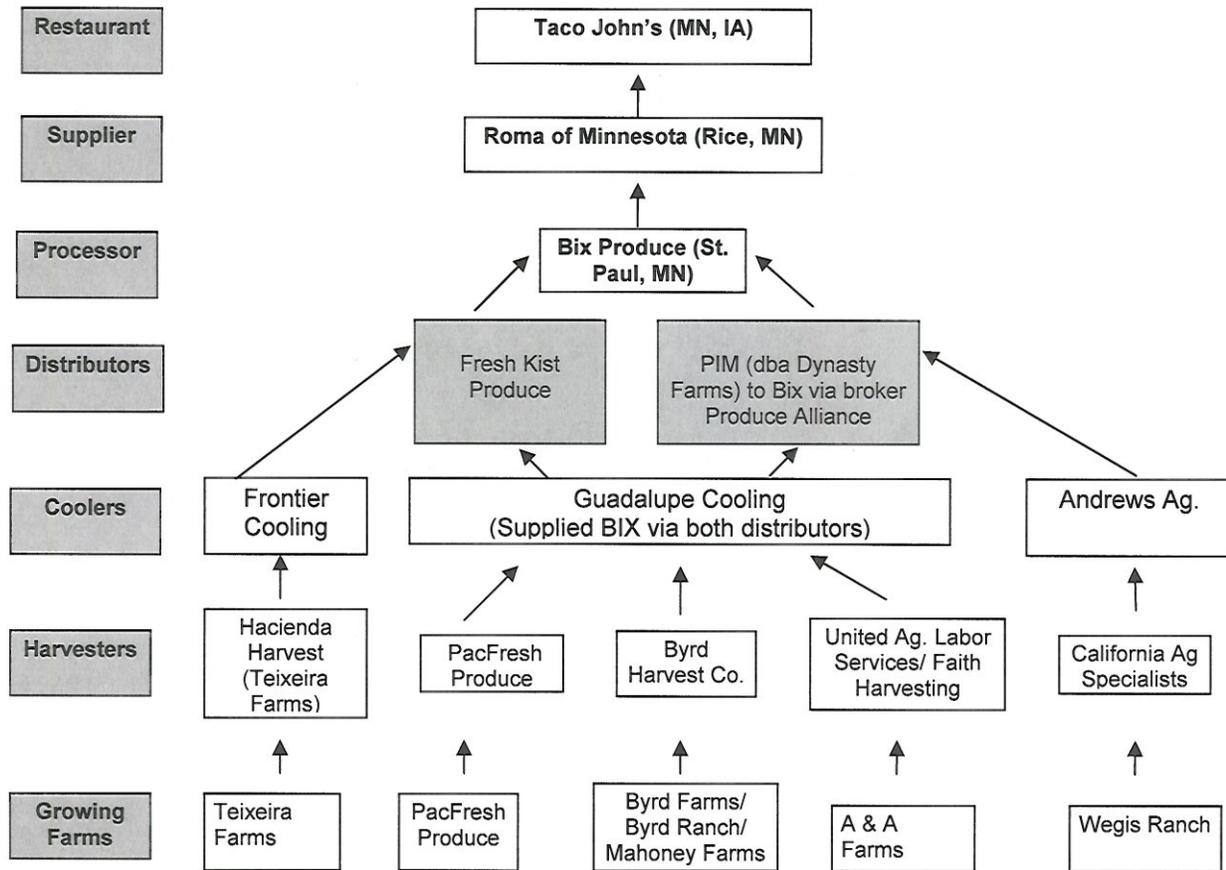
**Figure 1. Product flow chart for implicated iceberg lettuce shipments associated with the Taco John's *E. coli* O157:H7 outbreak.**

An overview of actual product flow is illustrated in Figure 1. Shipping and purchase order (PO) records obtained by the FDA from each of these suppliers led CalFERT to investigate several farms, dairies, harvesters and cooling facilities in California. Specific

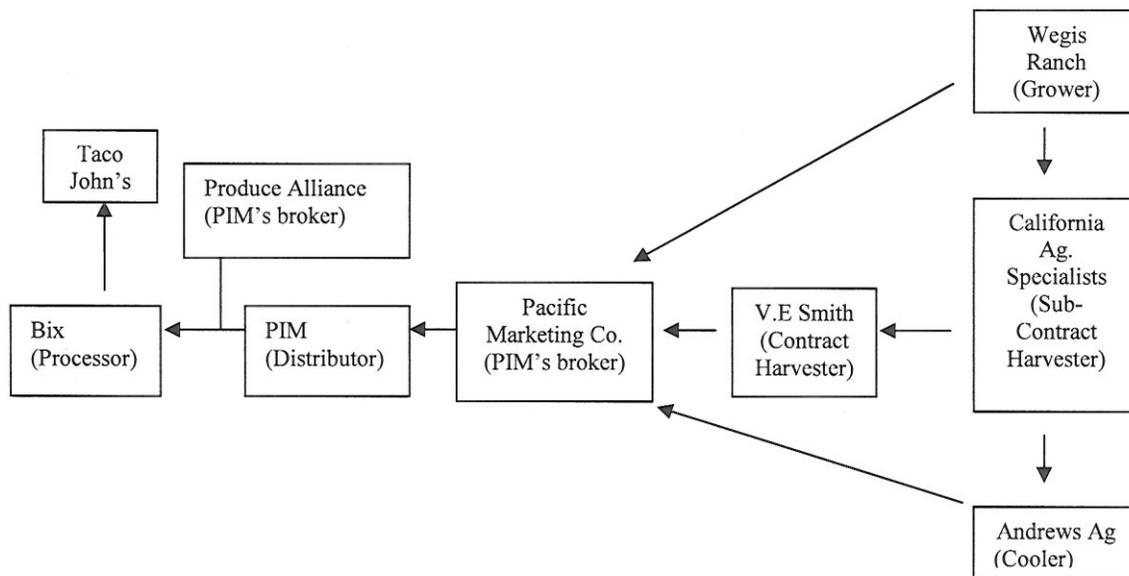
**Figure 2. Business relationships relating to the Buttonwillow lettuce shipments to Bix originating at Wegis Ranch.**

As for the PIM shipments, the Bix POs were #208139 = PIM order #424641, and #208250 = PIM order #424642 (Exhibit 4). PIM order #424641 shipped to Bix on November 16<sup>th</sup>, 2006 implicated Wegis Ranch (19000 Wildwood Rd. Buttonwillow, CA) (Exhibits 2, 4–9). PIM order #424642 shipped to Bix on November 18<sup>th</sup>, 2006 implicated A & A Farms (1615 W. Main St, Santa Maria, CA 93458) (Exhibits 2, 9, 10). On the Buttonwillow PIM traceback leg, a number of business entities were involved in the movement and/or handling of suspect shipments. A summary of the business relationships among the different entities is as follows (Figure 2).

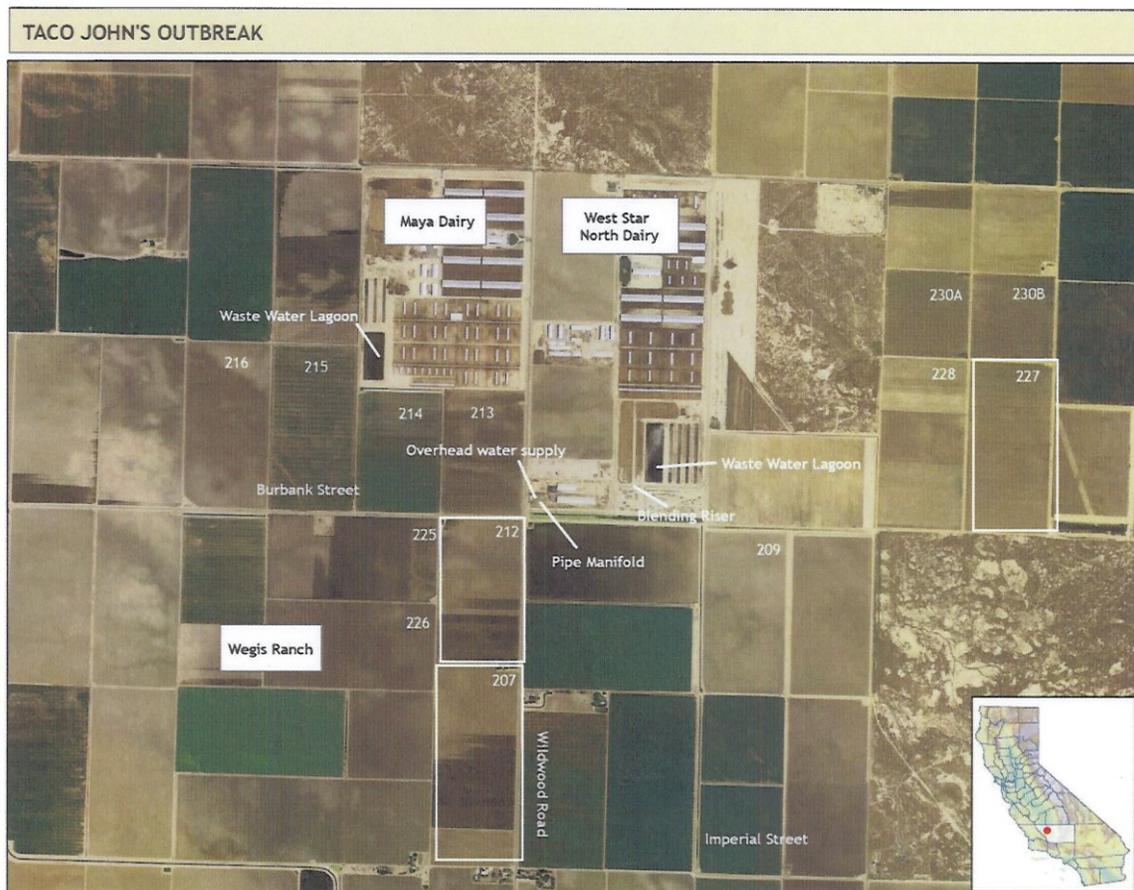
Figure 3. Map of Wegis Ranch and vicinity

Relative to lettuce growing fields, along the west side of Fields 212 and 207 CalFERT found an irrigation system derived from three sources of water – lagoon water from Maya Dairy, district water, and well water (Figures 3–5 and Exhibit 16). Fields 225 and 226 were adjacent (to the west) and at a higher elevation than suspect lettuce growing Fields 212 and 207 (Figure 4). The approximate distance between fields 225/226 to fields of interest (212 and 207) was 30–40 feet, separated by an unpaved road. Wegis management stated that Fields 225 and 226 were used to grow animal feed only, and investigators saw blended water (a mix of lagoon water with district and/or well water) being used on Fields 225 and 226 among others. Between Fields 225 and 226, along the east end, a piping system combining mixtures of lagoon, district and well water was observed. Further south along the southeast corner of Field 226, another irrigation system combining lagoon and district water was seen. Animal fecal material around the irrigated area was observed. Several samples (including swabs, water, water and sediment, soil, and air) were collected from the southeast corners of Field 225 and 226, and a total of six samples (one swab, one water, three water and sediment, and one soil) were found to match the *E. coli* O157:H7 Taco John's outbreak strain (Attachment 5, 9).

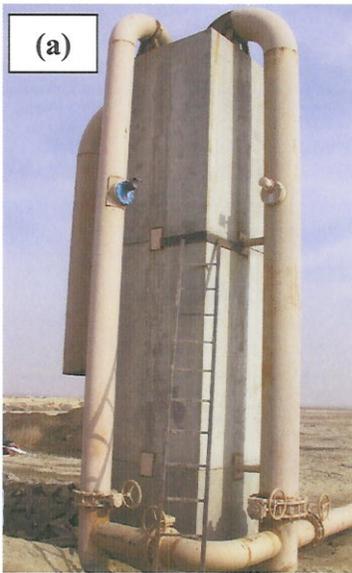
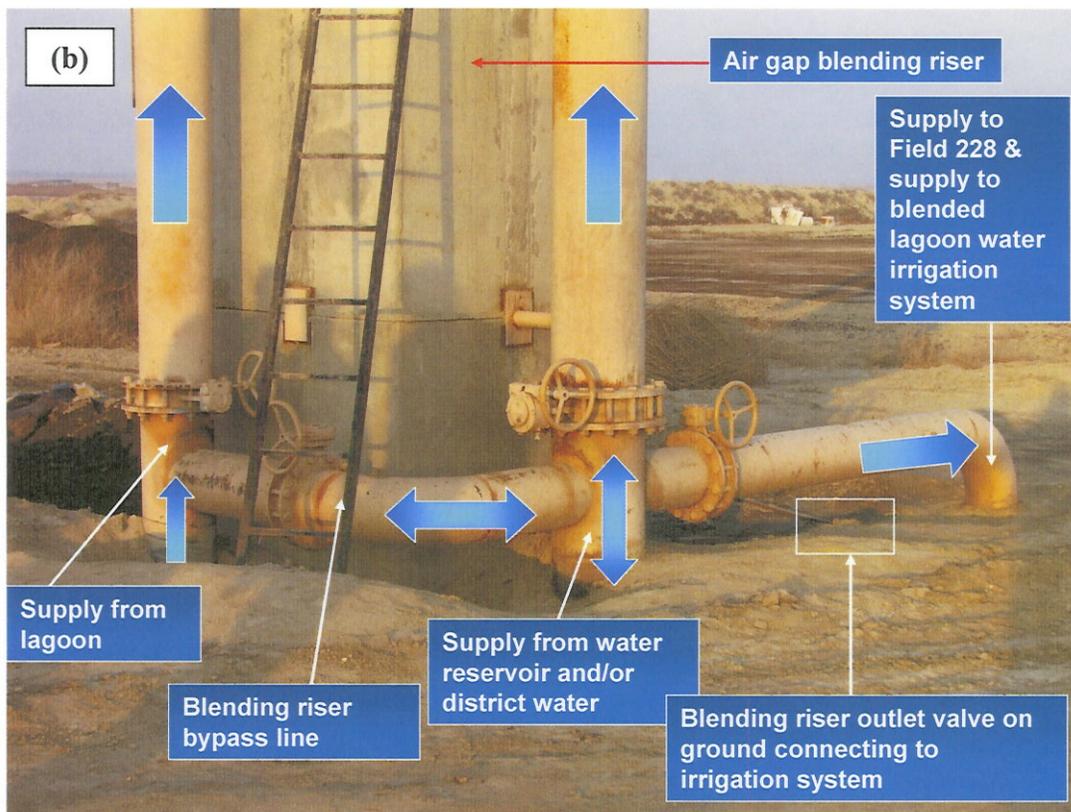
Waste water from the waste lagoon at the West Star North Dairy was commingled with district water and/or well water at an air gap blending riser (Figure 4) in close proximity to the lagoon, and then distributed through the field irrigation system. At the air gap blending riser, a cross connection was observed between the pipe transporting liquid manure from the lagoon and the pipe bringing mixed basin and district water. Gate valves were the only physical separation between the various water sources. No backflow devices were plumbed into the system to prevent cross-contamination of water sources.

Figure 4. West Star North Dairy air gap blending riser: (a) full view of the riser, (b) close up of the cross connections located at the bottom portion of the riser.

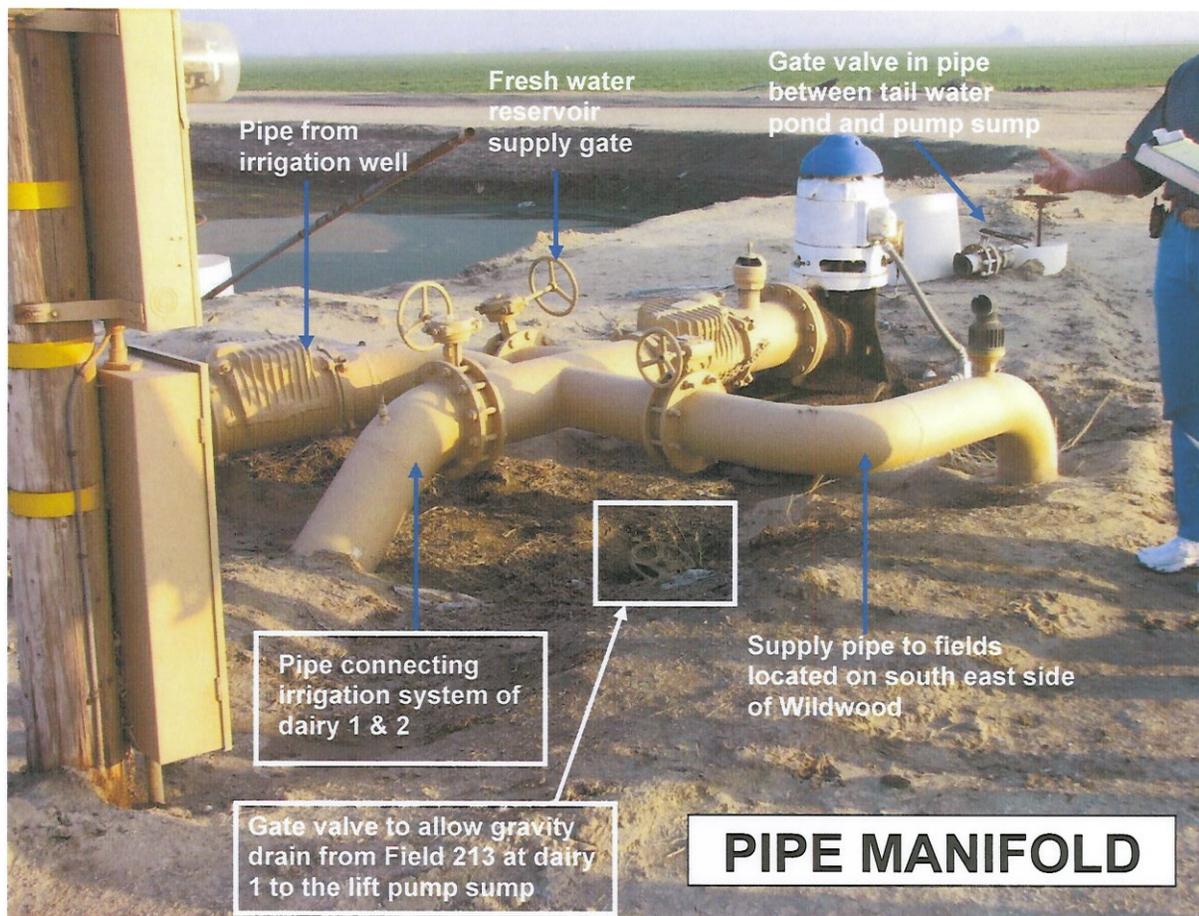
Survey of the Wegis Ranch area and vicinity (included the dairies) revealed that there were several water cross-connections on the grounds. Figure 5 depicts a piping

manifold at West Star Dairy North that interconnects its own irrigation system to the district water pipes, as well as the Wegis Ranch irrigation system located at the intersection of Wildwood Rd. and Burbank St. At that location, a pump on the west end of the water reservoir (Figure 5) was supplied by three sources: a pipe coming from the reservoir, a pipe coming from a nearby tailings pond, and a drain pipe coming from Field 212. Pumped water enters this piping manifold (that also connects pipes from a well pump located on north side) to feed three locations. These locations are (1) fields located on the southeast side of Wildwood Rd, (2) Field 213 which is located on the northwest side of Wildwood Rd., and (3) a return line leading to the fresh water reservoir (Figure 5) at the West Star Dairy North. A well located on the north side of this piping manifold was not operational at the time of this investigation but had the capability to pump well water directly to the fresh water reservoir in addition to the water storage tanks located at the south west corner of the hay cubing yard.

**Figure 5. West Star North Dairy water pipe manifold with labels; Dairy 1 = Maya Dairy, Dairy 2= West Star North Dairy**

Based on information received from both the grower and dairy owners, CalFERT determined that the area’s water pipes were all interconnected. Attachment 11 depicts information on the Wegis Ranch and vicinity water conveyance system. Attachment 11

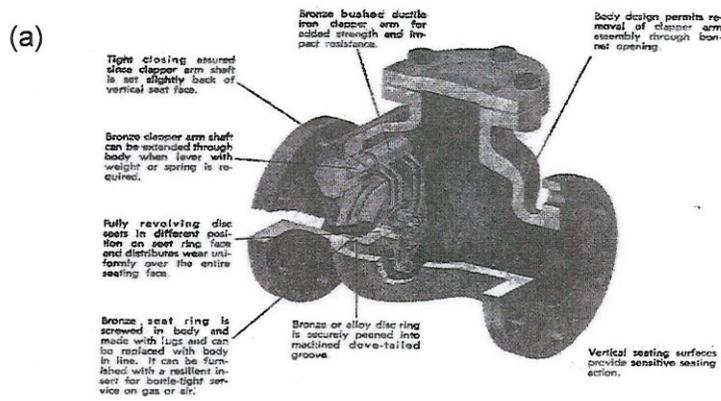
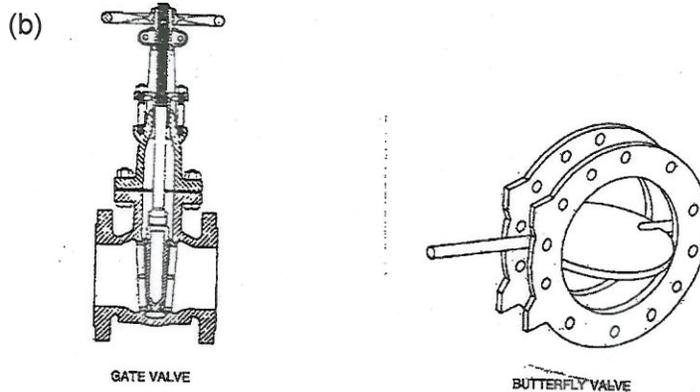
inspection ports, and so cannot be checked for failure or leakage. In general, check valves are not considered approved backflow prevention assemblies to prevent cross-connections between different water sources. To ascertain that water is flowing only in one direction and there is no backflow, an approved backflow prevention assembly that has test ports on it and is capable of being tested by an approved backflow assembly tester should be installed. Gate valves and butterfly valves do not address backflow and/or cross-connection concerns. The California Regional Water Quality Control Board Notice of Violation reports for the two dairies dated February 27<sup>th</sup>, 2007 state, "The wastewater distribution system could allow mixed dairy wastewater and freshwater to enter the Semitropic WSD supply system and agricultural supply wells, causing or threatening to cause a condition of pollution."

Fig. 18-39 Check valve  
(Reprinted from American Ductile Iron, Birmingham, AL)

Fig. 3.41 Valve types  
(Reprinted from WATER DISTRIBUTION OPERATOR TRAINING HANDBOOK by permission, Copyright 1976, The American Water Works Association)

**Figure 6. An illustration of different types of valves<sup>3</sup>**

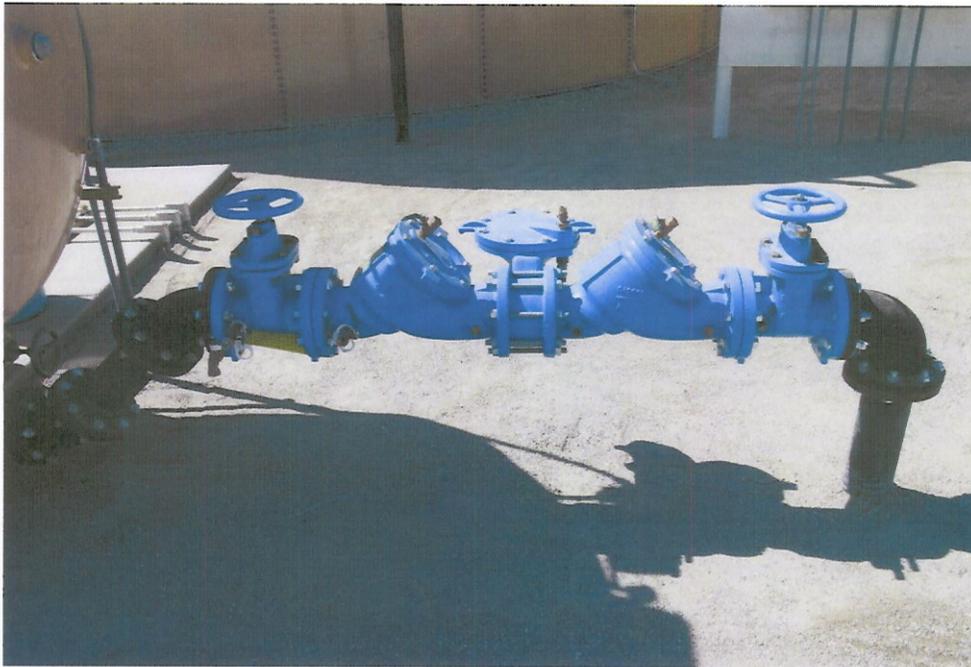
In addition to the use of check valves on some SWSD turnouts, it was commonly assumed that the higher pressures in the SWSD distribution system would prevent any backflow from the Wegis Ranch irrigation water system. However, there was no pressure monitoring on the SWSD system, so this assertion could not be verified. Pressure differentials are not considered adequate protection for backflow concerns. Providing an air gap or installing a Reduced Pressure (RP) Principle Backflow Prevention assembly (Figure 7) is one protection mechanism to address concerns where there is an existing or potential health hazard.

**Figure 7. An illustration of a Reduced Pressure (RP) Principle Backflow Prevention assembly**

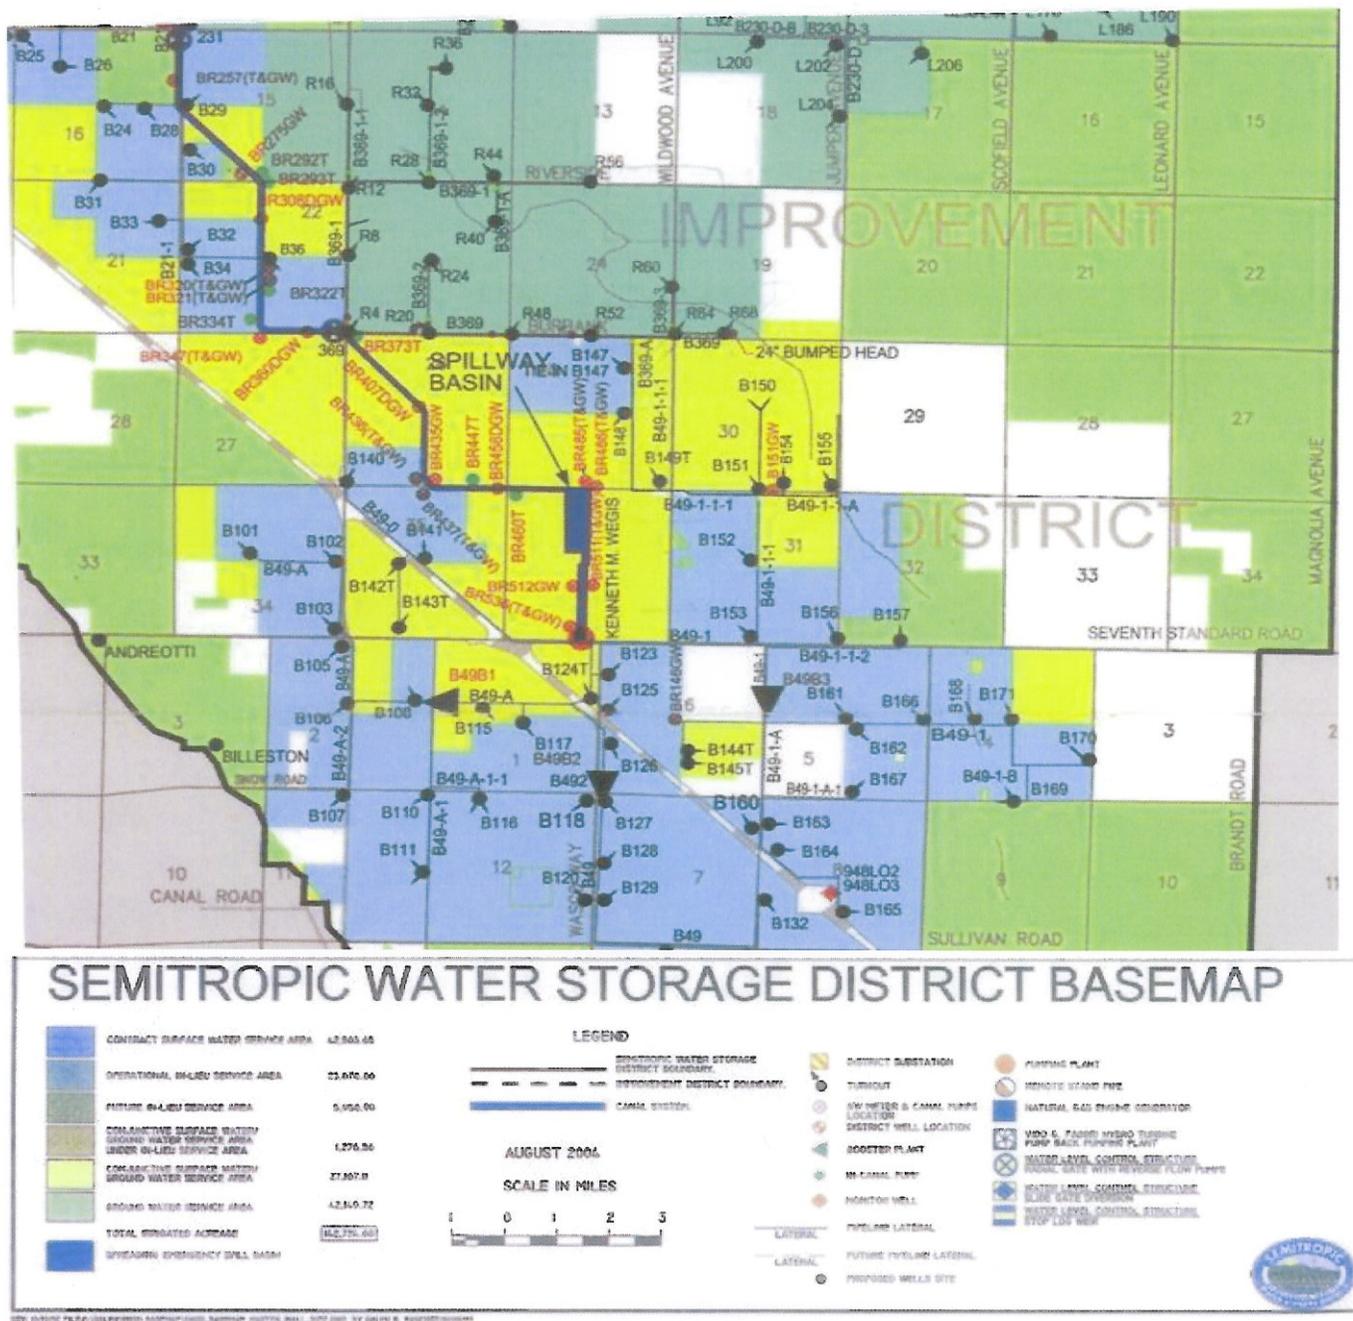
Despite the fact that the farm irrigation system cannot pump water up to Field 227, piping for the farm system is directly connected from the blending riser up to the well in Field 227 (Figure 4). There is no shutoff valve between the pipeline on the north side of Field 227 that carries well water and the pipeline on the east side of Field 228 that carries blended wastewater. Therefore, water being pumped from the Field 227 well could be carried down into the rest of the farm irrigation system. At the time of this visit, this well was being pumped, and a pressure gauge at the well head showed an operating pressure of 28 psi. The elevation difference between this well and Turnout R68 (Figure 8) of the SWSD B369 distribution system is approximately 21 feet, equivalent to 9 psi. A static head of approximately 37 psi could therefore be created at this turnout. According to the SWSD B369 System Design Information, the design operating head at this turnout is 21.61 feet, or 9.4 psi. Therefore, if the blending riser was bypassed at a time when the Field 227 well was pumping, it appears possible that enough head could be created at SWSD turnout R68 to overcome the pressure in the SWSD system and force water from the farm irrigation system into the SWSD system if the gate valve at the turnout was open or not functioning properly (there does not appear to be a check valve at this turnout to prevent backflow). Because portions of the farm pipeline between Turnout R68 and the Field 227 well are used to carry dairy lagoon wastewater, any water potentially forced back into the SWSD system could carry residual wastewater along with it. This is not to say that this was a regular occurrence, but if the blending riser was bypassed and valves at the Field 227 well were open such that water could flow back down into the farm irrigation system adjacent to Field 228, it could occur. This would be especially true if the pressure in the SWSD system were low due to low demand. In the B369 distribution system, there were several days of low or no demand during the time when the lettuce crop of interest was in the field. For example, during 2006, on September 6 and 29, the afternoon of September 30, and October 7 and 12, demand was zero in the B369 subsystem. In addition, there was very low demand in the B369 subsystem on November 7 and 19, 2006. According to SWSD, low demands would correspond with relatively low pressures in the distribution system, as operators would be managing water levels in the storage tanks to correspond to demand, as discussed above.

Figure 8. Close-up of SWSD water sources for the Wegis Ranch area
