SUBJECT: A service writer for a car dealership died when he was struck in the head by an alignment rack that rolled off a handcart.

SUMMARY
California FACE Report #02CA005

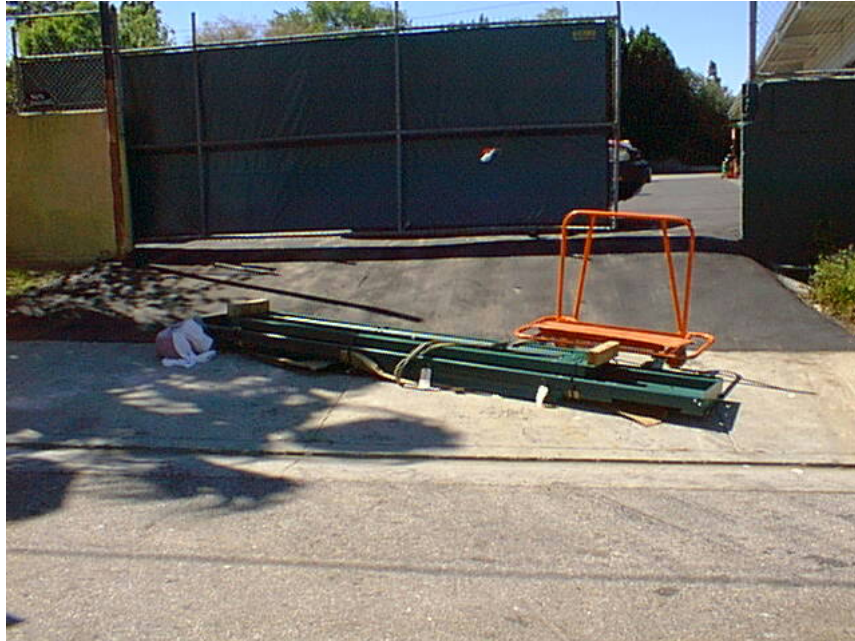
Exhibit #1

View of the incident scene showing the alignment rack, handcart, and the driveway incline.

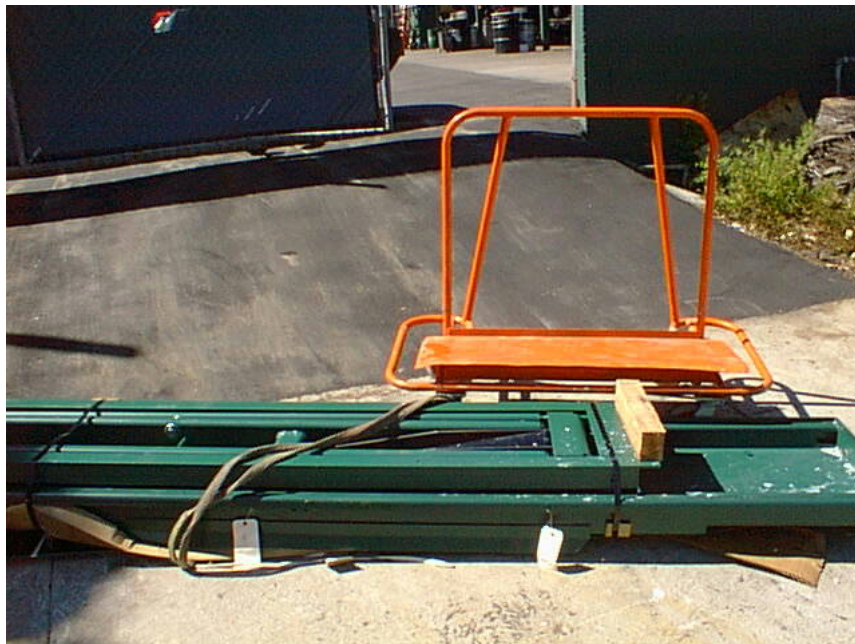
Exhibit #2

A closer view of the alignment rack, handcart, and driveway incline.

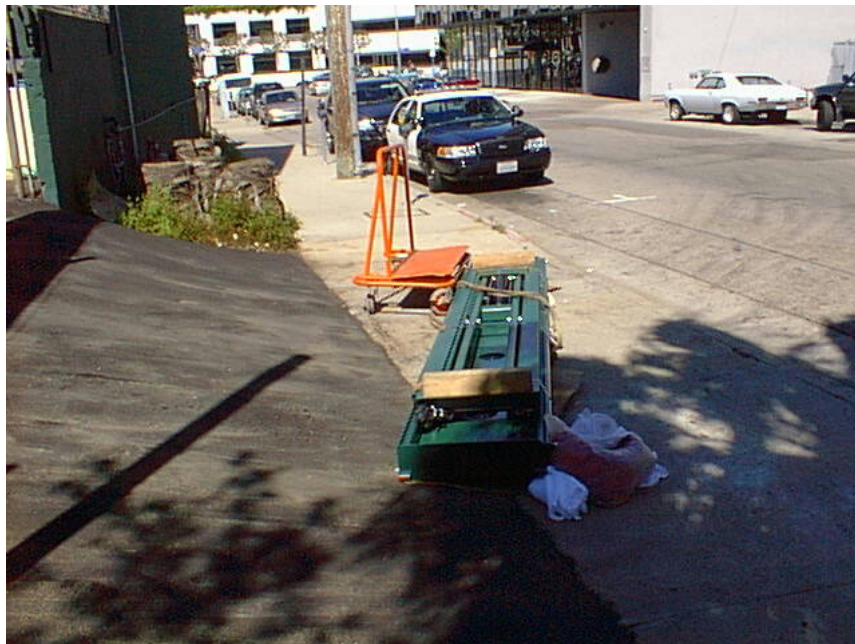
Exhibit #3

View of the incident scene looking south and depicting the pitch of the driveway ramp.

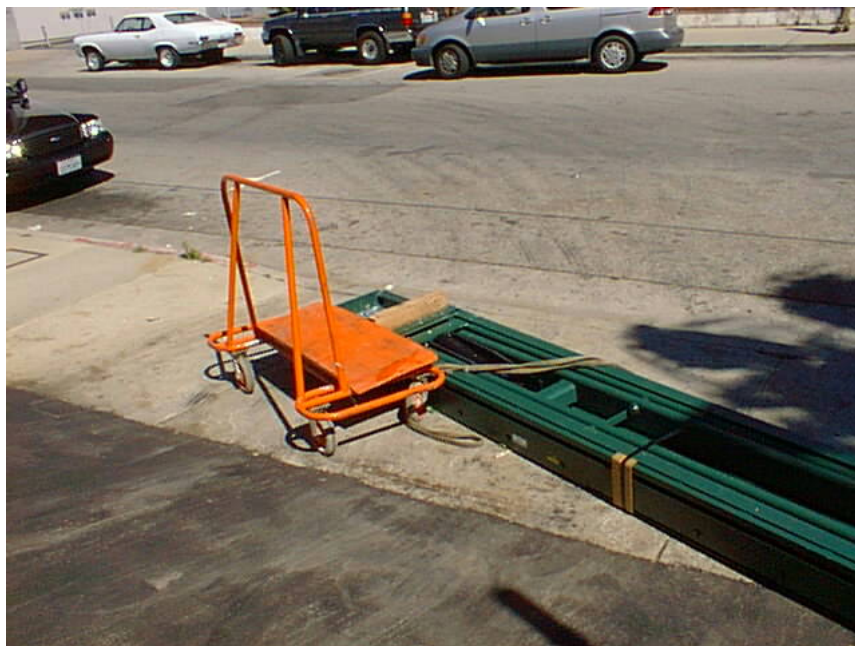
Exhibit #4

View of the incident scene looking down from the driveway entrance of the shop.
