SUBJECT: A truck driver died when he fell off of and was run over by the backhoe he was riding on.

SUMMARY
California FACE Report #02CA006

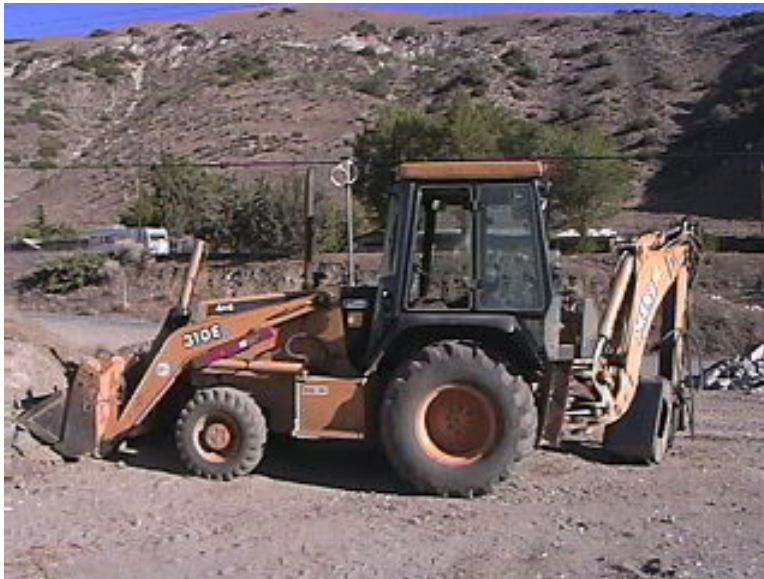
Exhibit #1

View of the backhoe involved in the incident

Recommendation #1: Develop, implement and enforce a policy that clearly states no riders are allowed on backhoes.

Discussion: Backhoes are designed for one operator with one set of controls and do not have passenger seats. The step and handrail that the victim used to hitch a ride on the backhoe was designed for the operator to enter and exit the tractor and not intended for riders. Operators of backhoes need to not only demonstrate their ability to operate the controls and movement of the tractor, they also need to demonstrate their knowledge of the safety precautions needed to be taken when operating. One vital point of backhoe operation is not allowing an unsafe practice to occur because “everybody else does it”. Employers can ensure safe work practices by establishing work procedures through programs of training, supervision, safe work recognition, and progressive disciplinary measures.

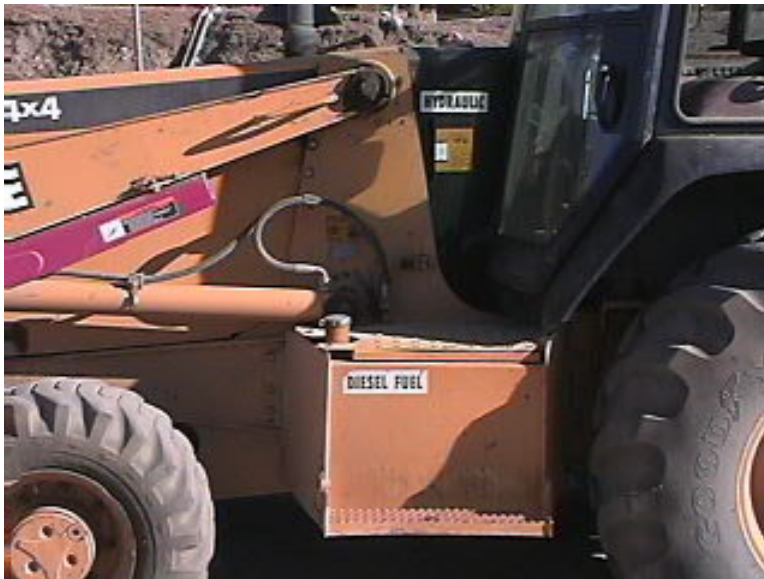
Exhibit #2

The backhoe operator got into the cab of the backhoe and started it up. Just as he was ready to move the tractor backwards, he noticed the victim jump on the step on the left side of the backhoe. He saw the victim grab the handrail and assumed he was on the backhoe. He looked over his right shoulder and started backing up. After traveling about 10 feet, the backhoe operator felt a bump and turned to see what it was. At that time he realized the victim had fallen off the tractor and that he had run over him.

Close-up view of the step and handrail used by the victim.

Recommendation #2: Install safety-warning labels on backhoes that clearly state that riders are prohibited.

Discussion: Sometimes it might be necessary to use visual signs to remind employees of their responsibility when it comes to safety. Posting signs on the backhoes that literally state “NO RIDERS” can alert a possible rider of the imminent danger and might prevent a similar occurrence.

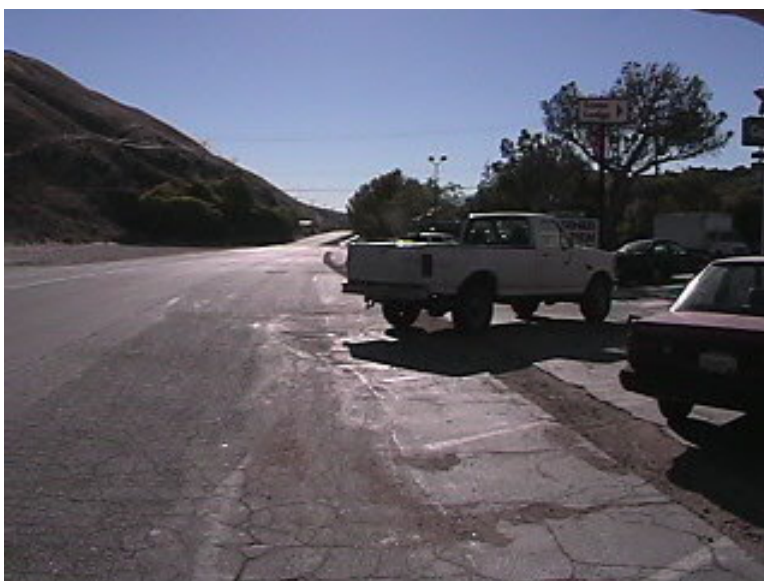
Exhibit #3

View of the incident scene looking south.

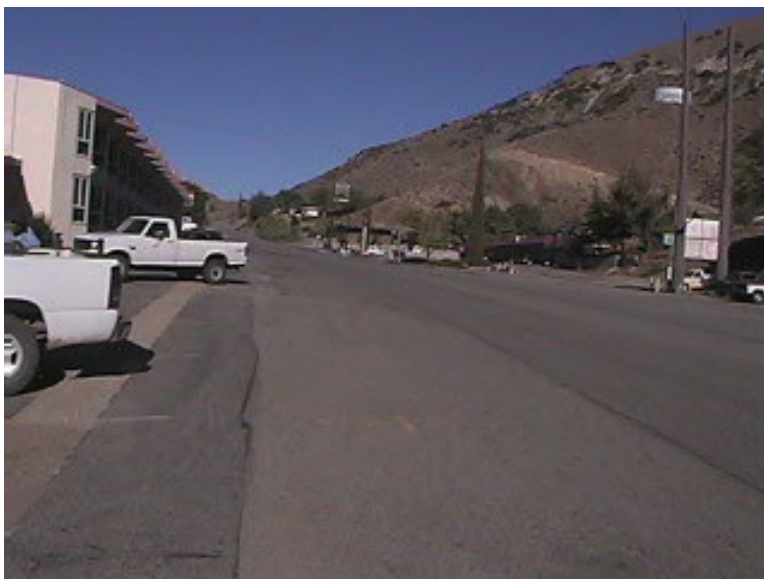
Exhibit #4

View of the incident scene looking north.
