SUBJECT: A security guard is killed when he was run over by a heavy-duty industrial forklift while directing traffic in a cargo container storage yard.

SUMMARY
California FACE Report #02CA007

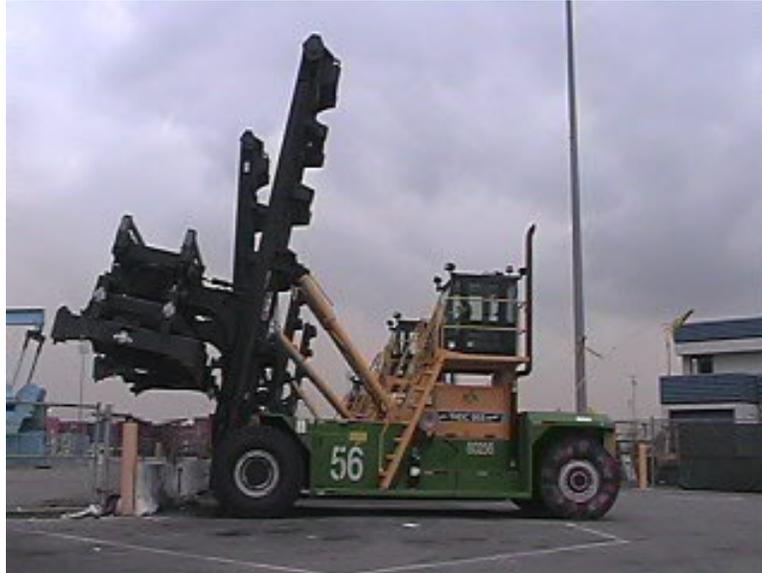
Exhibit #1

A side view of a forklift “top handler” similar to the one involved in the incident.

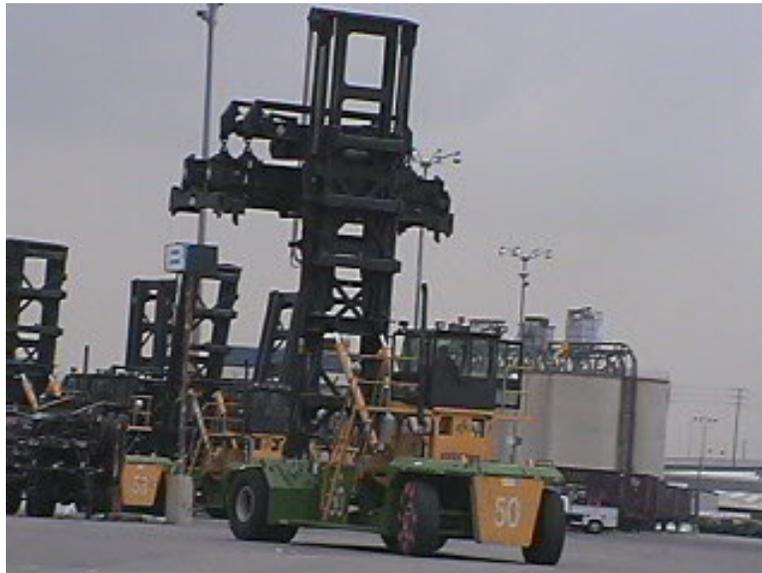
Exhibit #2

A rear view of a forklift “top handler” similar to the one involved in the incident.
