**SUBJECT:** A laborer died when crushed between the forks and the cab of a trash truck.

**SUMMARY**  
**California FACE Report #03CA002**

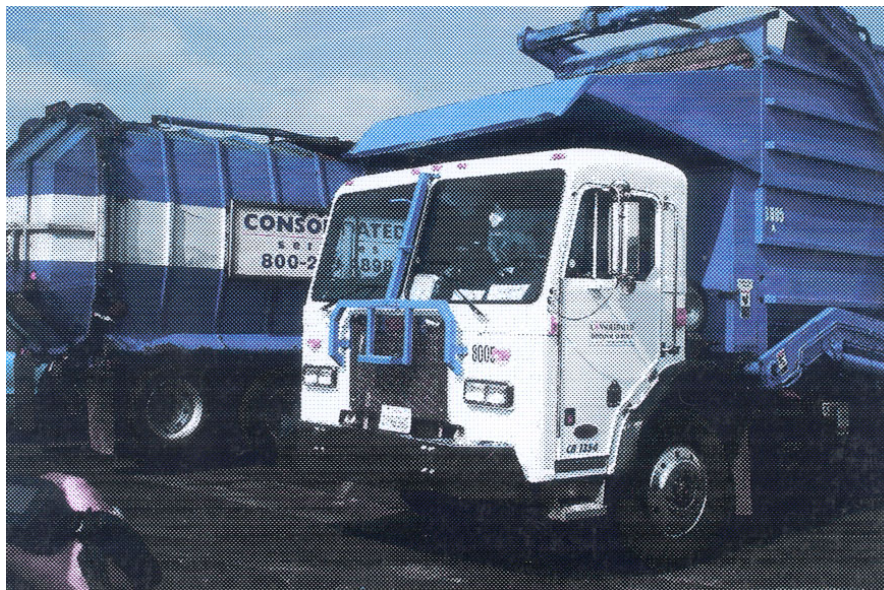
Exhibit #1

Picture of the trash truck involved in the incident.

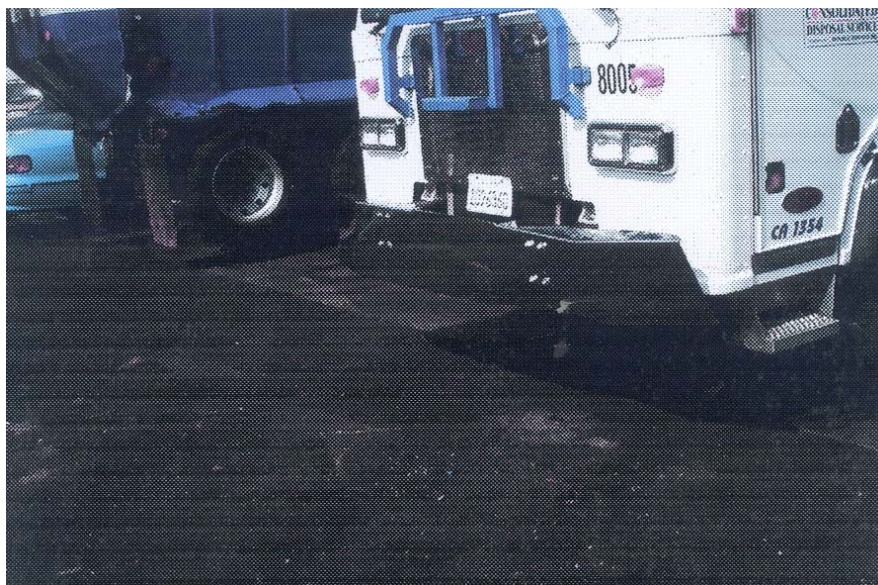
Exhibit #2

Picture of the front of the trash truck where the victim was crushed.

Discussion: When operating the controls on the driver's side of the equipment, the operator does not have a clear and unobstructed view of the front of the trash truck. A convex mirror mounted on the cab or bumper could provide the necessary view for the operator. These mirrors could supplement, not replace, visual inspection of the front of the trash truck, and possibly could help eliminate any future incidents of this type.

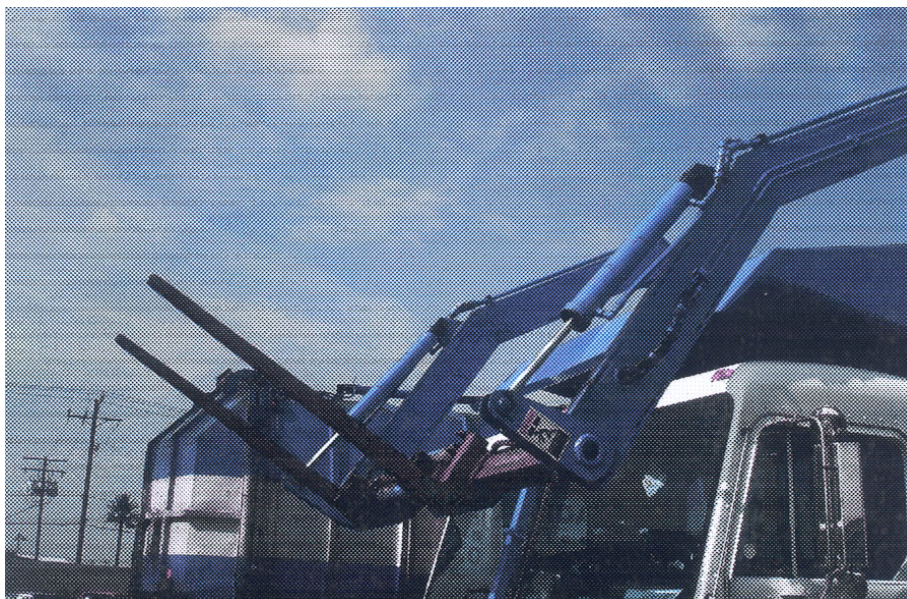
Exhibit #3

Picture of the hydraulic forks being lowered in front of the cab.

Discussion: An operator of this particular type of trash truck has a clear view of the front forks while seated in the driver's seat, but the view is obstructed when using the side controls. The operator must physically check the area in front of the trash truck, to ensure it is clear immediately before using the side controls. In this case, the operator was momentarily distracted when he took time to clear out some loose trash that had fallen on the truck exhaust system. During that time period the conditions changed when the victim entered the area in front of the trash truck below the raised forks.

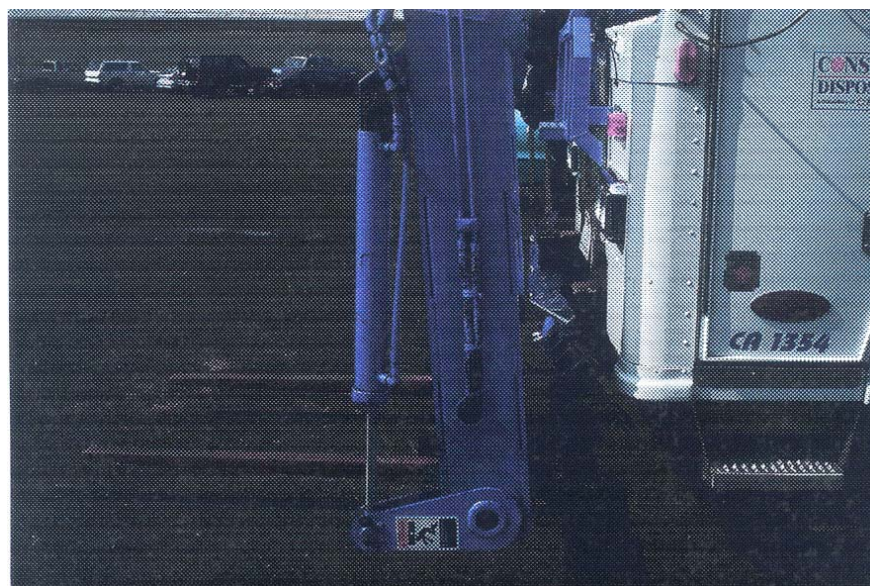
Exhibit #4

Picture of the forks lowered in front of the cab showing the space where the victim was crushed.

Discussion: Employers should make sure that all employees who work with or near trash trucks are aware of the hazards that are associated with trash trucks even if they are not the operator. The company supplied written rules and regulations for all employees to follow. These rules stated that workers should never stand under the area of the fork travel and should always let the driver know where they are. Safe work practices can be assured through programs of training, supervision, rewards, and progressive disciplinary measures.
