**SUBJECT:** A Machine Operator Dies When Crushed Inside a Knitting Machine.

**SUMMARY**  
**California FACE Report #04CA001**

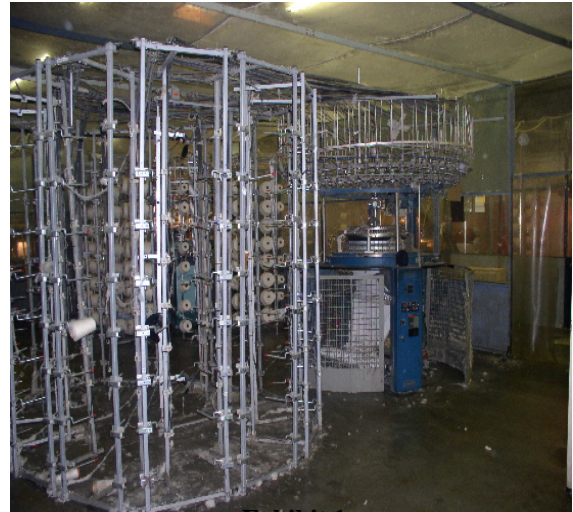
The site of the incident was a large commercial building used to manufacture fabric. The machine involved in the incident was a fully automated circular knitting machine manufactured in Italy (**Exhibit 1**). The machine consisted of a fixed frame base with three support columns. Inside the machine base was a rotating turntable with two upright arms that supported a roller which collected the finished fabric. The turntable rotated at approximately 24 revolutions per minute. On top of the base was the knitting machine with thread guides. A large rack of threaded spools was located next to the machine. In between the three support columns were safety gates which protected employees from contact with the rotating turntable (**Exhibit 2**). Each gate was equipped with a safety interlock switch that shut the machine down when the gate was opened. The controls for the machine consisted of three colored buttons marked green, red, and yellow. The green button turned the machine on, the red button shut it off, and the yellow button jogged the rotating turntable (**Exhibit 3**).

**Exhibit 1:**  
The knitting machine involved in the incident.

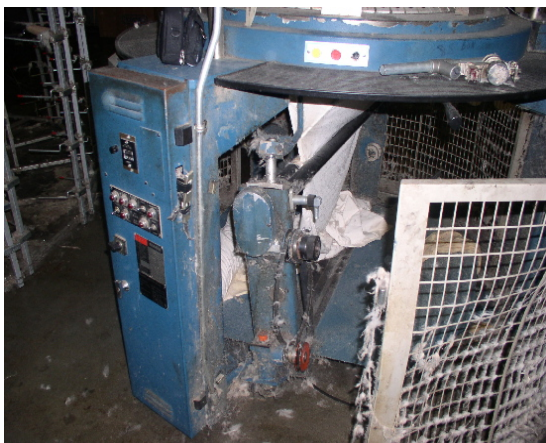
On the day of the incident the victim was working the second shift and operating three machines. At approximately 9:30 p.m., one of his machines was not gathering the fabric correctly, so the victim had to shut off that machine and open the safety gate to gain access to the fabric to untangle it. Two of the victim's co-workers stated they came over to assist him untangle the fabric. The co-workers stated that when they left the victim to return to their work areas, he was still inside the machine. A few moments later the co-workers stated they heard the victim scream. They returned to the victim's work area and found him trapped inside the machine between the base frame and the rotating turntable.

**Exhibit 2:**  
Support columns and safety gate.

Discussion: Every time the rotating turntable passed by a support column of the knitting machine, it created a pinch point. The purpose of the safety gates between the columns was to protect employees from contact with the pinch points. Each gate was equipped with a safety interlock that would shut the machine down when opened. If the machine needed to be operated, then the safety gate should have been reinstalled.

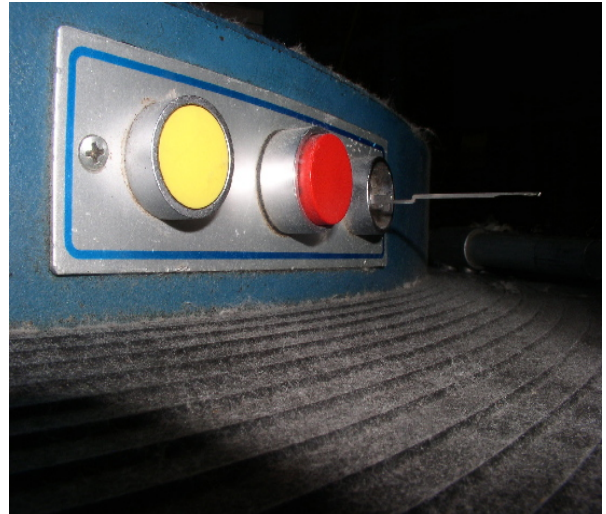
The paramedics were called and pronounced the victim dead after removing him from the machine. One of the co-workers stated that he found a sewing needle wedged in the machine's "on" button (**Exhibit 3**). He said he removed it when he shut down the machine. The purpose of the needle in the "on" button was to allow the machine to continue to operate with the safety gates open.

**Exhibit 3:**  
The control buttons with a needle stuck in the green button.

Discussion: In this incident, the victim knew how to override the safety features of the knitting machine and totally defeat the purpose for which they were intended. The victim's co-workers admitted that this was a common practice in the industry. The company president said he was aware of the unsafe practices taking place, but took no action to stop it. Employees that have developed unsafe work practices will continue to use them as long as there is no corrective action taken.
