SUBJECT: A laborer dies when struck by a packer panel in the hopper of a rear-loading trash truck.

California FACE Report #04CA005

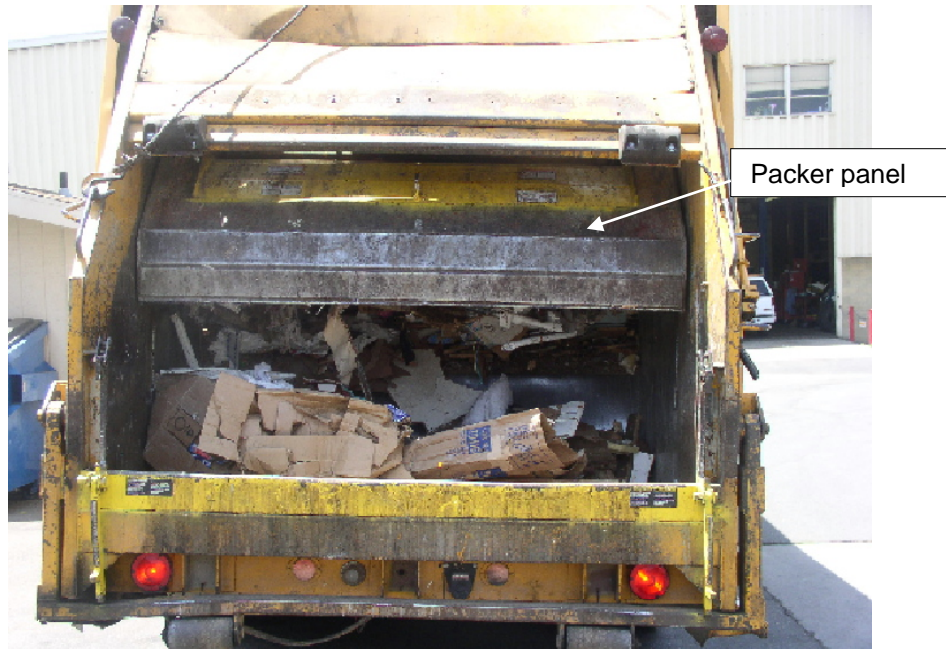
Exhibit #3. A picture of a rear loading trash truck, similar to the one involved in the incident, with the packer panel at the beginning of its cycle.

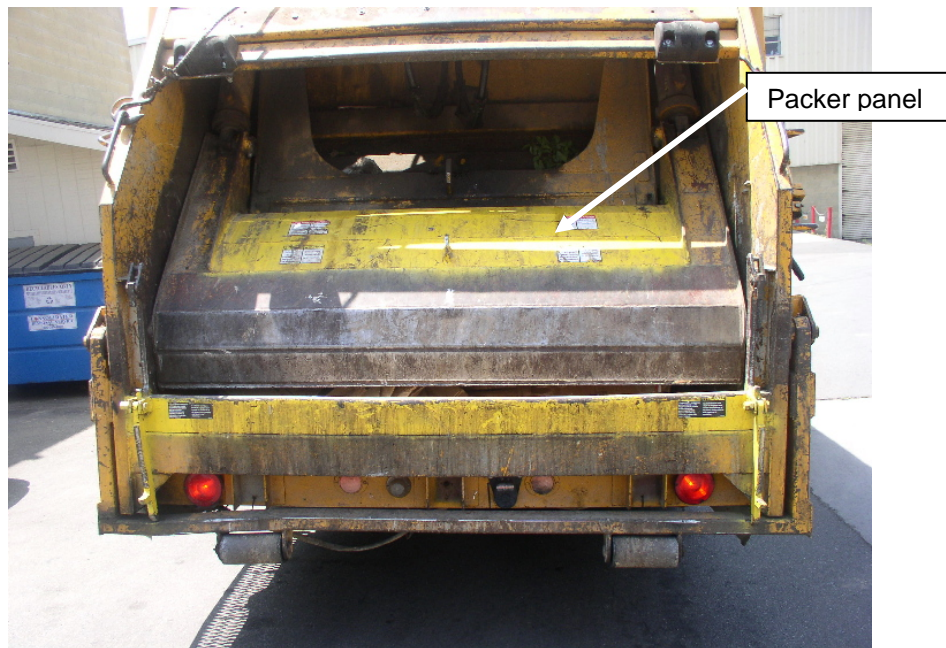
The paramedics were called and pronounced the victim dead at the scene. It is unknown why the victim reached into the hopper, however, according to the co-worker it was common for coins to fall out of large items thrown into the trash hopper. The co-worker stated that both he and the victim often retrieved the coins but never when the packer panel was in motion.

Exhibit #4. A picture of a rear loading trash truck, similar to the one involved in the incident, with the packer panel in the position when it struck the victim who was reaching into the hopper.

Recommendation #1: Ensure employees do not reach into the hopper of trash trucks when they are cycling.

Discussion: Employers are usually protected from hazards through engineering controls or administrative programs after they have been identified. Job safety analysis (JSA) is an administrative process used to review methods or steps for a particular task in order to identify potential safety hazards. The task can be broken down to a sequence of steps or actions, which are used to identify hazards connected to the task or produced by the environment. Once the hazards are known, the proper solutions can be developed to eliminate or control hazards. In this case, a job safety analysis may have identified the hazard of removing objects from the truck while the packer panel was partially raised or while it was being lowered.
