FROM: California Fatality Assessment and Control Evaluation (FACE) Program

SUBJECT: A tractor operator died when his tractor rolled over on him.

SUMMARY
California FACE Report #04CA009

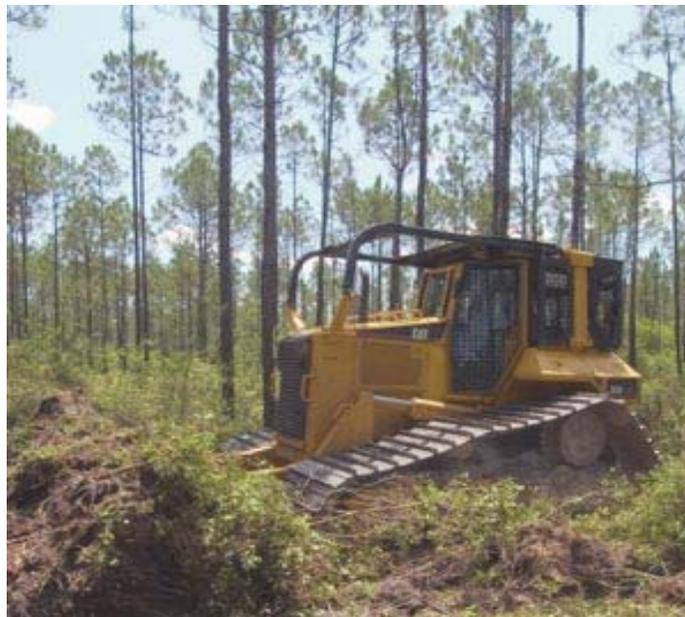
Exhibit #1. A tractor similar to the one involved in the incident.

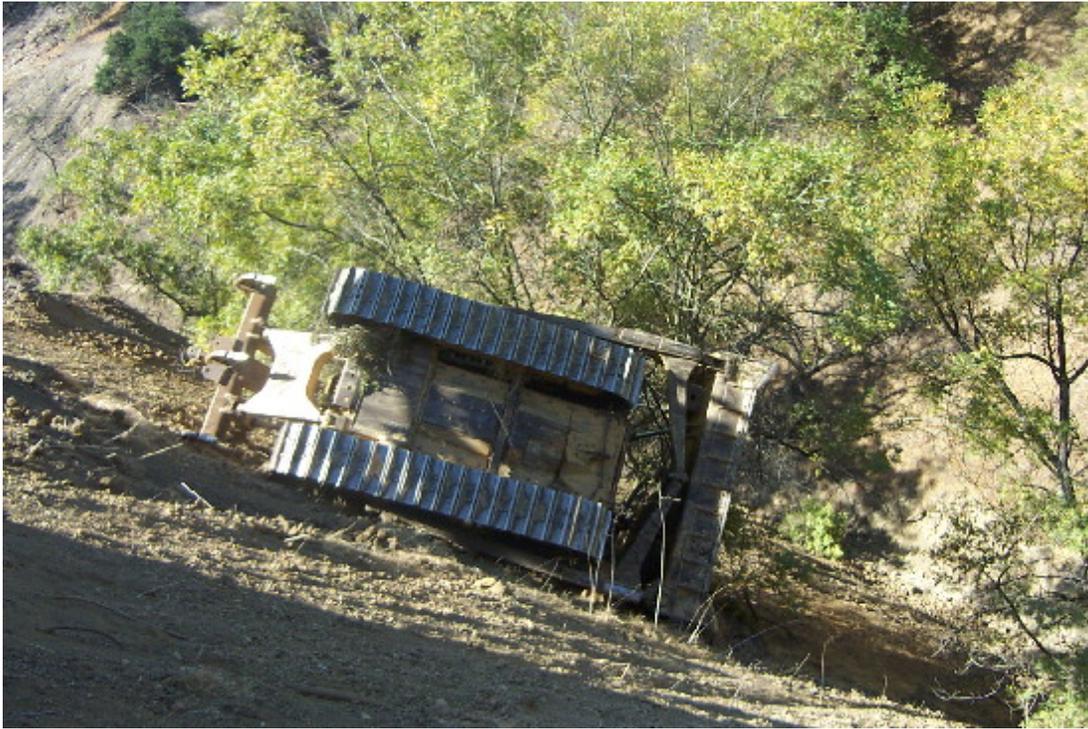
Exhibit #2. The location where the tractor involved in the incident came to rest.

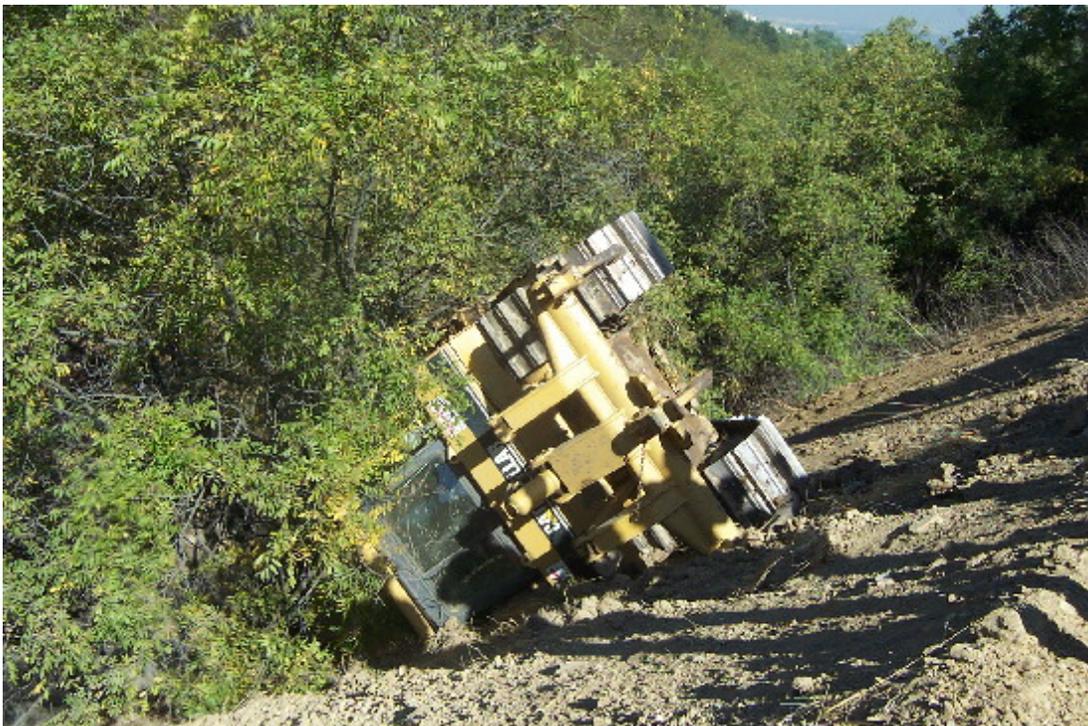
Exhibit #3. A view from the rear of the tractor involved in the incident after it came to rest.

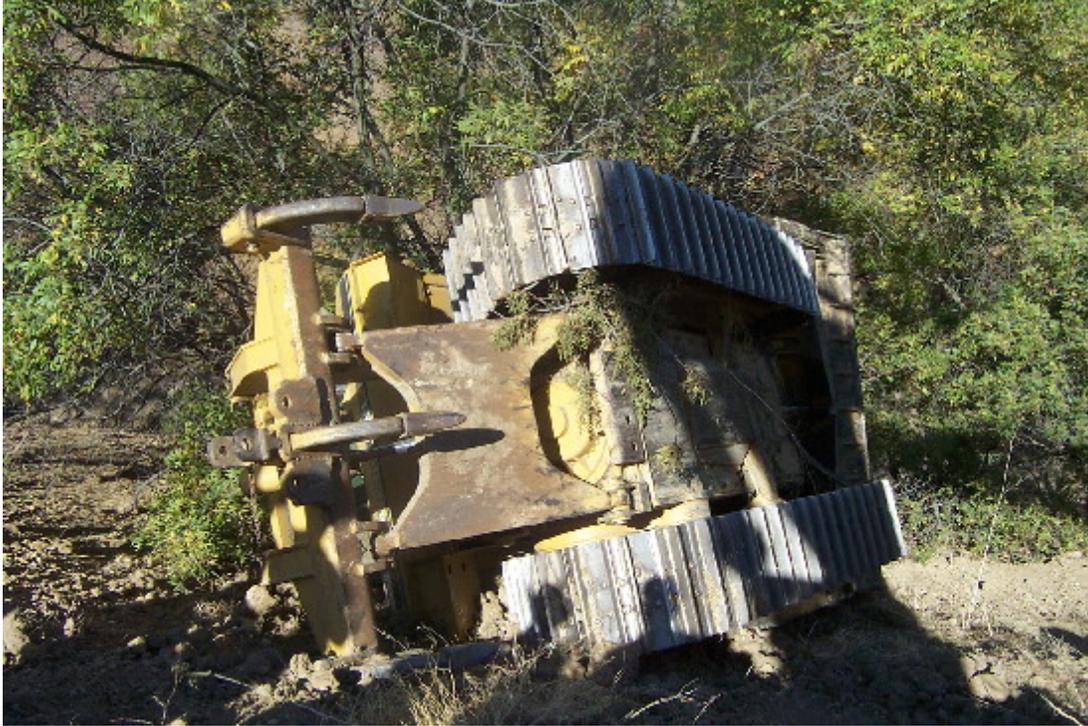
Exhibit #4. A closer view of the tractor involved in the incident after it stopped rolling.
