**SUBJECT:** A forklift operator died when he was crushed in the mast of a forklift.

**SUMMARY**  
**California FACE Report #04CA012**

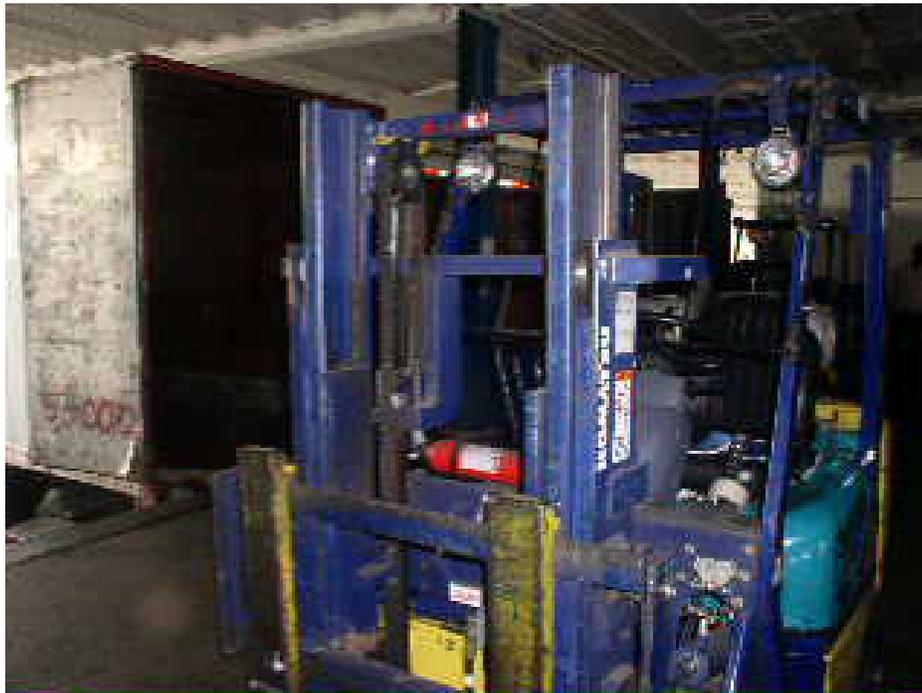
Exhibit #1: A picture of a forklift similar to the one involved in the incident.

The site of the incident was a truck depot for the company where trucks exchange cargo for shipping. The machine involved in the incident was a forklift designed to enter the enclosed beds of trailers. The forklift was equipped with a seat belt. The forklift mast consisted of an outer mast which was stationary and an inner mast which was telescopic.

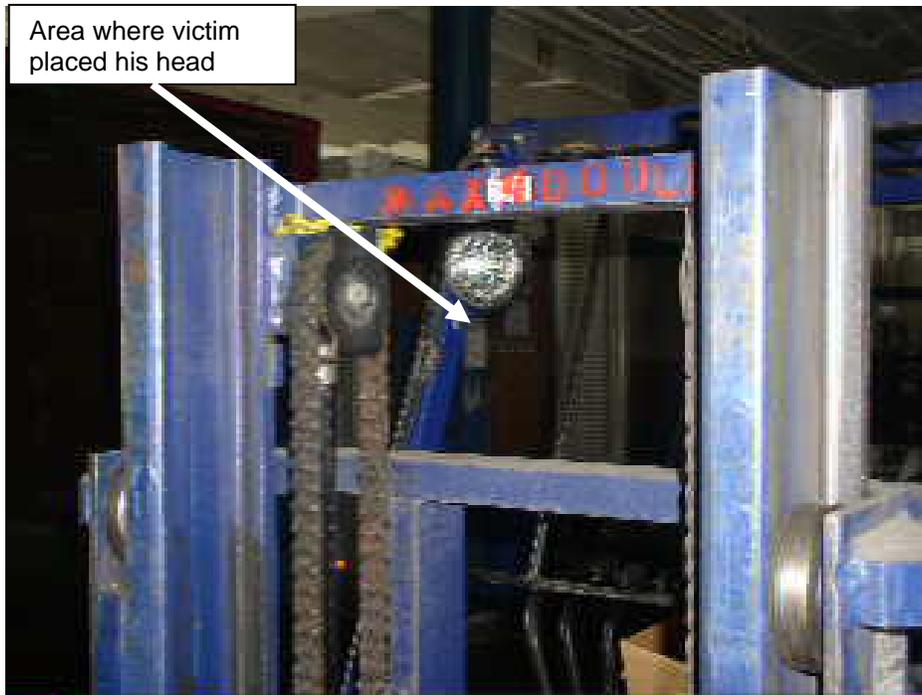
Although the incident was not witnessed, the position of the victim's body suggests that as he leaned forward and stuck his head between the beams of the outer and inner forklift mast, his right leg pushed the control lever forward. This caused the inner mast to come down on the victim's head before he could move out of the way.

Exhibit #2: A picture of the forklift mast showing where the victim placed his head.

Discussion: There are several devices which may have prevented this incident if they had been installed on the forklift. A screen (clear plastic or metal grate) in front of the forklift operator cabin would have prevented the operator from reaching forward between the masts. A safety interlock that requires the operator to engage two controls before moving the forks would have kept the mast from descending on the victim. A pressure interlock under the operator seat would have locked the controls in place when the pressure on the seat was released, or a sensor device could be attached to the seat belt of the forklift that when disconnected would shut off the power to the forklift. These are just some devices that, if installed on the forklift, might have prevented this incident from occurring.
