**SUBJECT:** A supervisor dies when crushed by a machine that manufactures concrete blocks.

**SUMMARY**  
**California FACE Report #05CA006**

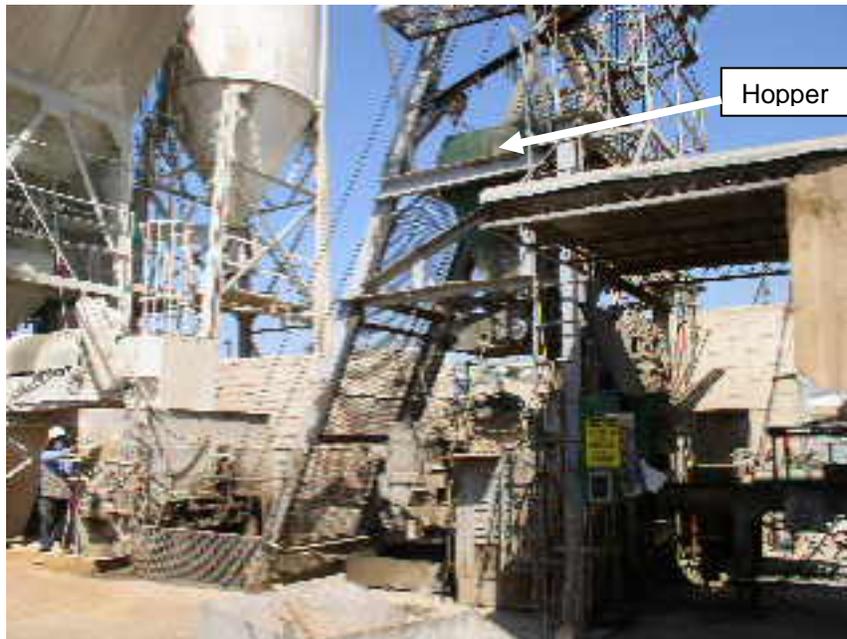
Exhibit 1: The automated machine that made concrete blocks.

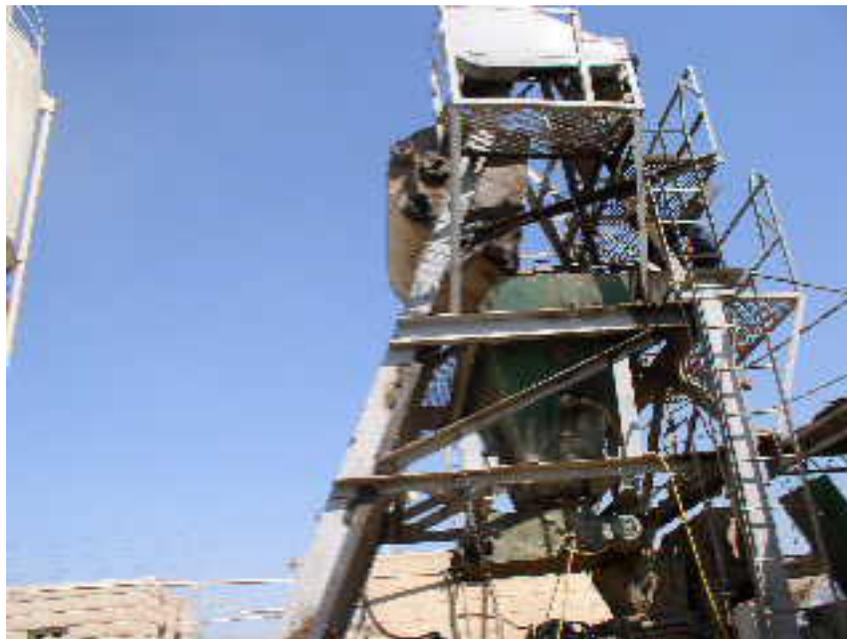
Exhibit 2: The portion of the machine the victim climbed onto.

Discussion: Since the contents of the hopper did not always smoothly feed into the concrete block-making machine, a vibrator was sometimes used to ensure the concrete mixture flowed at a constant rate through the hopper opening. A worker was required to climb up onto the machine to connect an airline to turn on the vibrator every time it was used. If an air hose connection, valve, or service switch had been run down to the control panel, then workers could have turned on the vibrator remotely, eliminating the need to climb onto the machine.

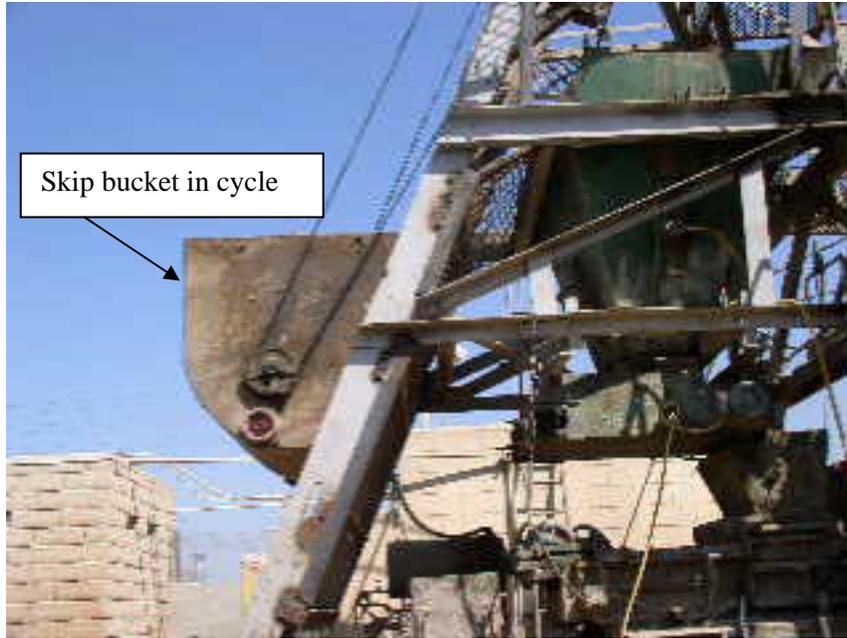
Exhibit 3: The place on the machine where the victim was dragged by the skip bucket.

Discussion: Because of the ever-present danger of entanglement when working near moving machinery components, employers should continually strive to protect employees by providing machine guarding in the areas where work is actually performed. Employers should ensure that hazardous areas are sufficiently guarded against personnel entry by physical barriers or locked gates. Advances in engineering technology may be such that machine guarding may be applicable to this particular machine. Employers should contact machine manufacturers and retrofit the machine, if applicable, with guards and barricades that prevent any part of the body from contacting the machine's moving parts. Another consideration would be to install interlocking mechanisms designed to deactivate the machine when the gate or guard is opened or moved. A gate or guard with a by-pass switch wired to the emergency stop button could stop the machine's movements instantly when the gate is opened. Employers can ensure that employees do not climb on running, unguarded machines through enhanced programs of task-specific training, supervision, safe work recognition, and progressive disciplinary measures.

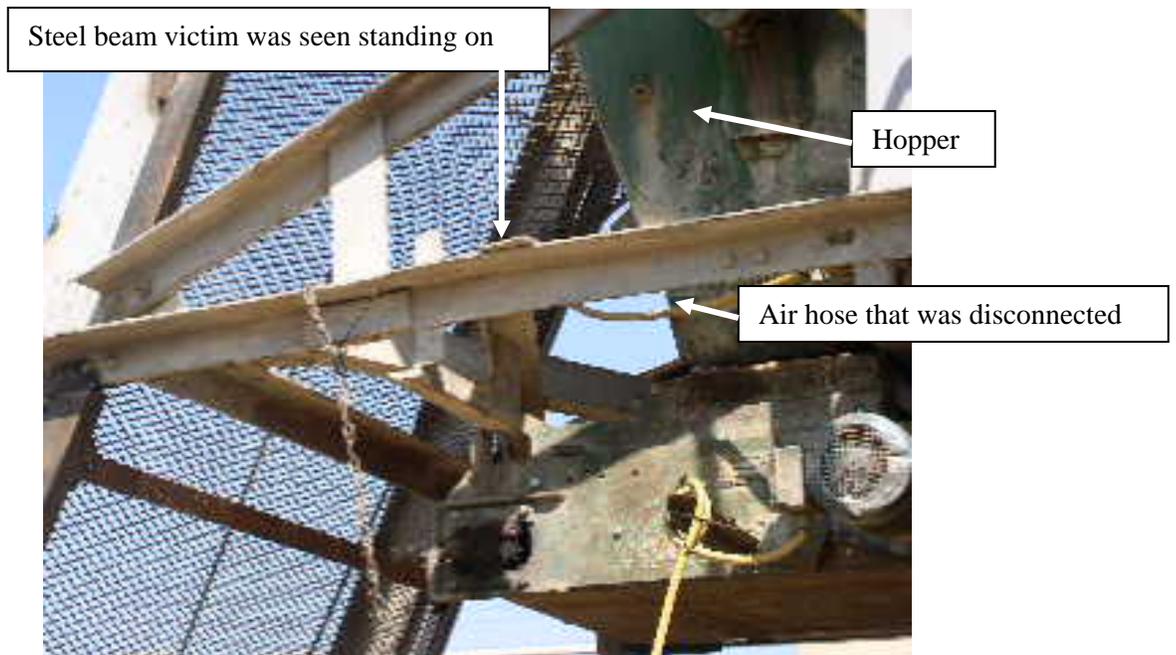
Exhibit 4: The portion of the machine frame the victim was dragged between by the skip bucket.

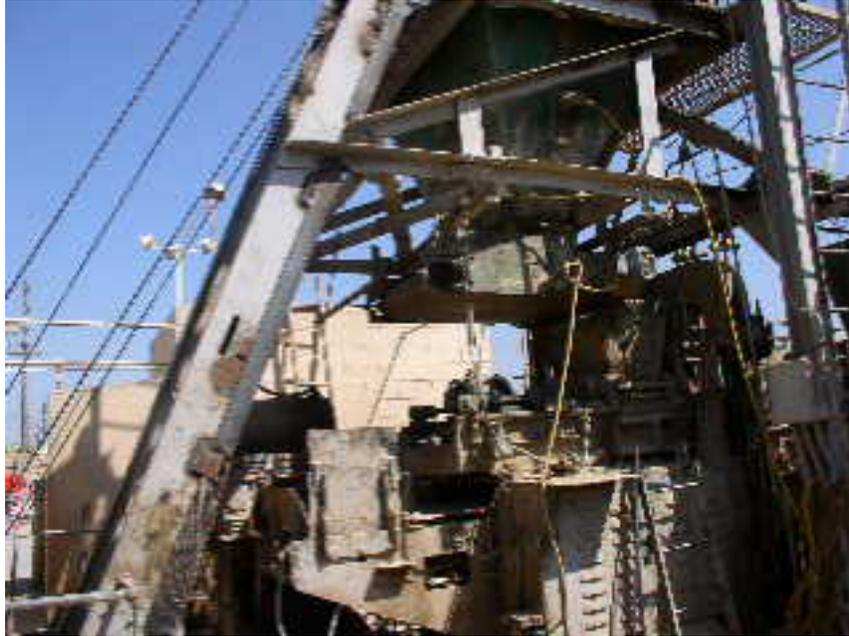
Exhibit 5: The portion of the machine the victim fell to after he was crushed by the skip bucket and machine frame.
