**SUBJECT:** A Hispanic machine operator died when struck in the abdomen by a piece of acrylic being milled on a vertical milling machine

**SUMMARY**  
**California FACE Report #06CA005**

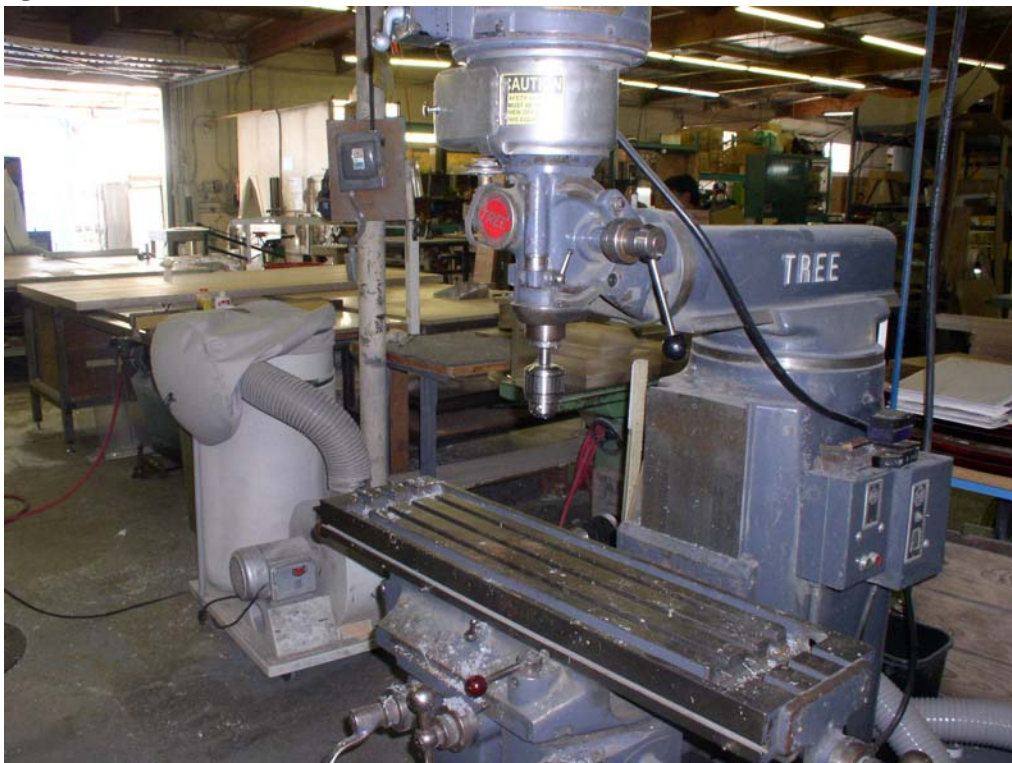
**Exhibit 1. A picture of the vertical milling machine involved in the incident.**

The site of the incident was an art studio manufacturing facility that produced pieces of art and furniture. The machine involved in the incident was a vertical milling machine (**Exhibit 1**). The machine cuts and shapes pieces by moving material along one axis and then applying rotating cutters to the material's surface. On the day of the incident, the victim was milling a piece of acrylic that was approximately 3/8" thick and 2" in diameter. The ideal spindle speed for the type and size of acrylic the victim was milling, according to the milling machine's manufacturer's specifications, was about 80 rpm (revolutions per minute). The spindle had been set to a higher speed. The victim secured a piece of acrylic into the vice that holds the material being milled. The vice was then secured to the machine table.

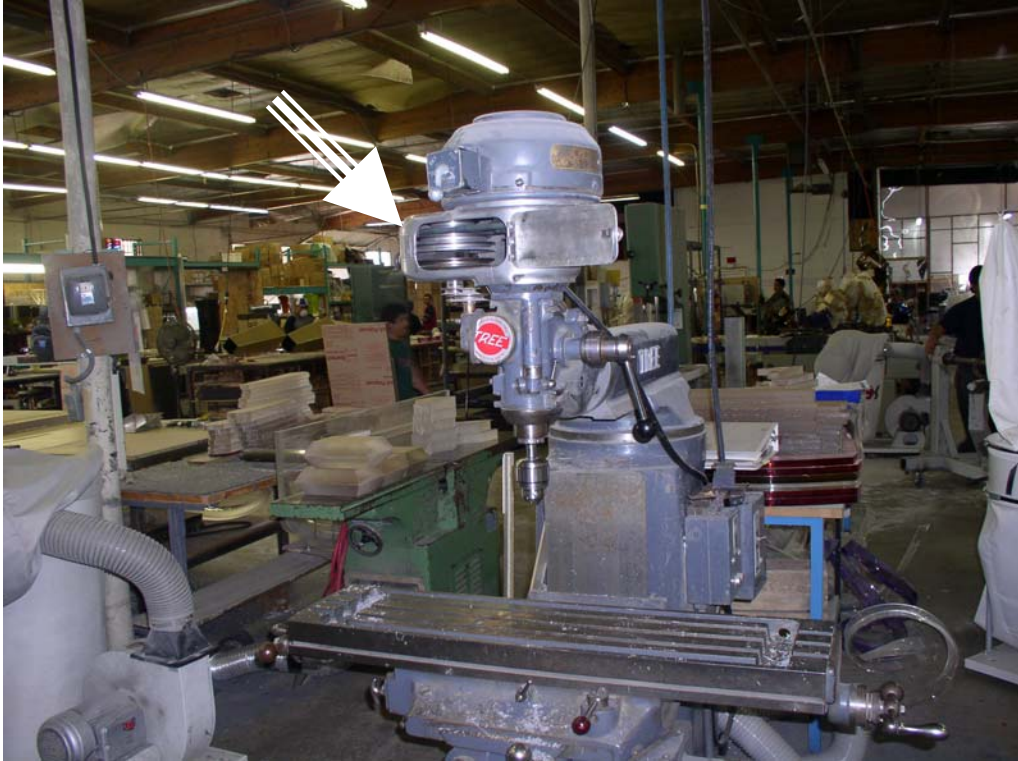
**Exhibit 2. A picture of the vertical milling machine involved in the incident with the arrow pointing to the open safety cover for the belt drive.**

Discussion: When the victim starting milling the piece of acrylic he had secured in the vice, the machine spindle was set at the wrong speed. The action of the faster rotating spindle (**Exhibit 2**) on the acrylic piece caused the acrylic to shatter, and one of the pieces struck the victim. The owner of the company stated that the victim had milled

Discussion: In this particular case, the victim was performing a task described as one of his normal duties. Only some of the moving parts of the machine were guarded. Heavy machinery with rapidly moving parts can present serious risks to employees. The risk associated with operating such machinery is mitigated by fixed or movable physical guarding, safety interlocks and sensors, and/or the use of specially adapted long handled tools. Manufacture's of heavy machinery can ensure newly made equipment has adequate guarding, and employers should consider retrofitting older equipment. Manufacturers can be contacted to see if retrofit guards are available.

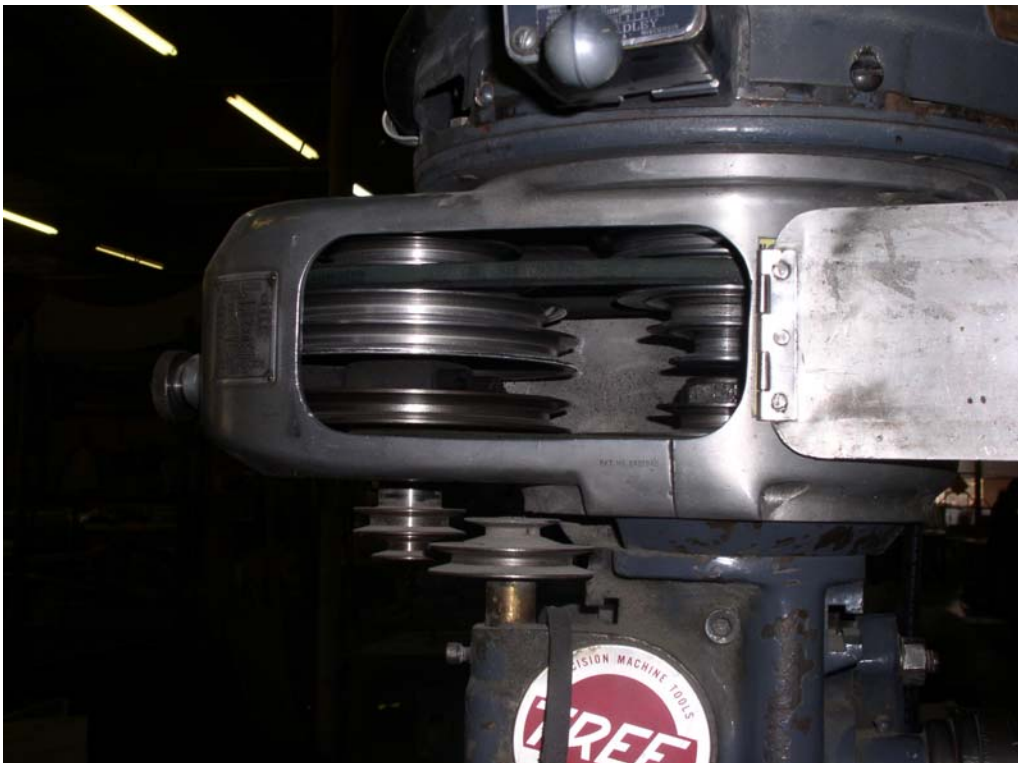
**Exhibit 3. A picture of the belt drive and different size pulleys for different speeds.**

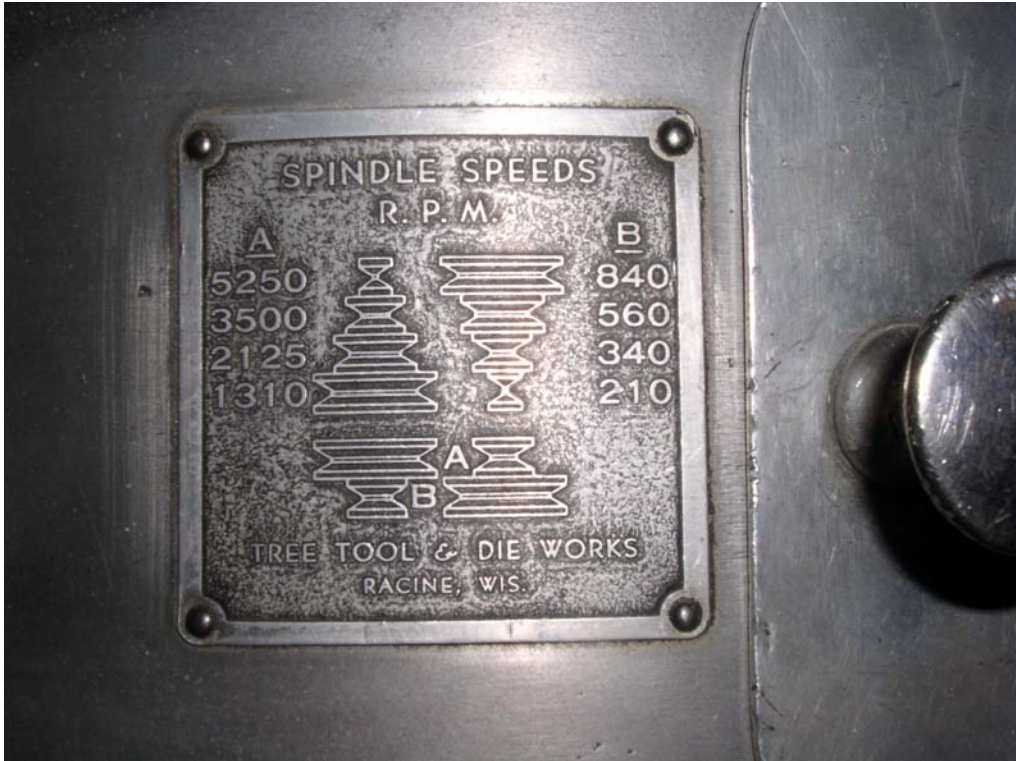
Exhibit 4. A picture of the spindle speed chart located on the side of the machine.

**Recommendation #1: Ensure employees check and set the correct machine speed, as specified by the manufacturer, on the milling machine before starting the milling process.**

acrylic pieces before without incident. One way to ensure that employees set milling machines to the proper speed before each job is to make a note of the mill speed on all job orders. This would remind the operator to check the setting prior to milling operation. Employers can enhance worker compliance with safe work practices through programs of task specific training, supervision, recognition, and progressive disciplinary measures.

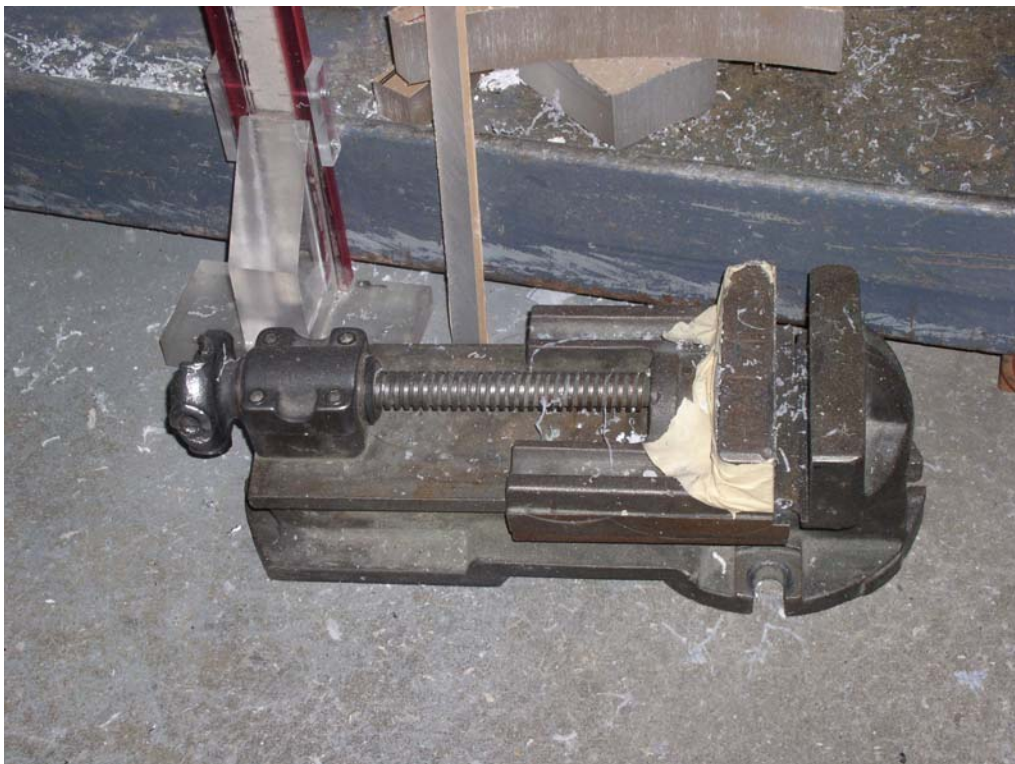
Exhibit 5. A picture of the vice that was used to hold the piece of acrylic in place.

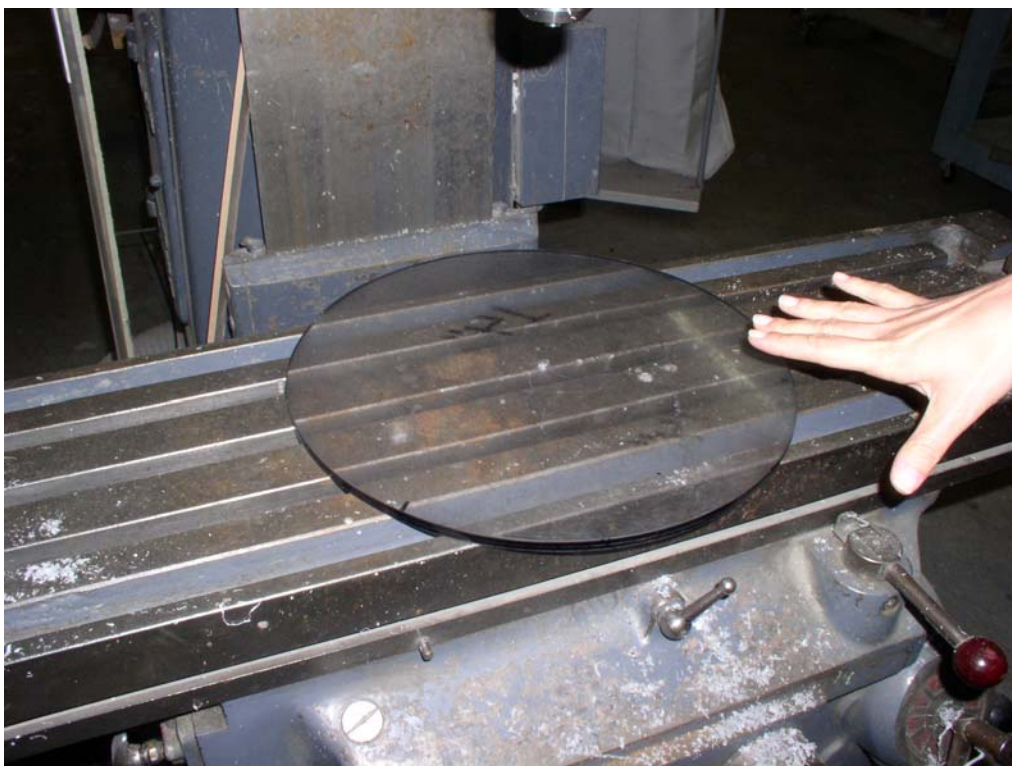
**Exhibit 6. A picture of similar piece of acrylic that was being milled by the victim when the incident occurred.**

As the victim milled the piece of acrylic at the higher speed, it broke into pieces and one of the pieces struck the victim in the abdomen. The victim fell to the floor holding his abdomen. Other employees heard the victim and went to his assistance. The paramedics were called. They examined and treated the patient and then transported him to a trauma center. On the way to the trauma unit the victim's heart and breathing stopped and CPR was administered. Upon arrival at the trauma center, the victim was taken immediately to an operating room but died during surgery.
