SUBJECT: A boat repairman dies from burns received from a fire caused by an exploding battery.

SUMMARY
California FACE Report #07CA004

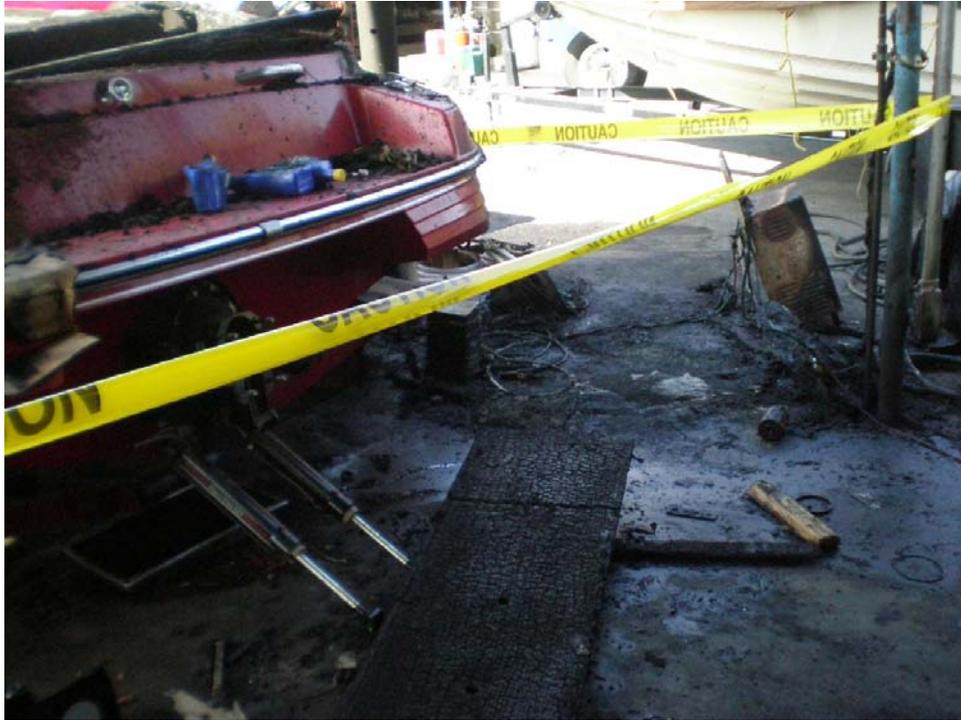
Exhibit 2. A picture of the area in the shop where the incident occurred.

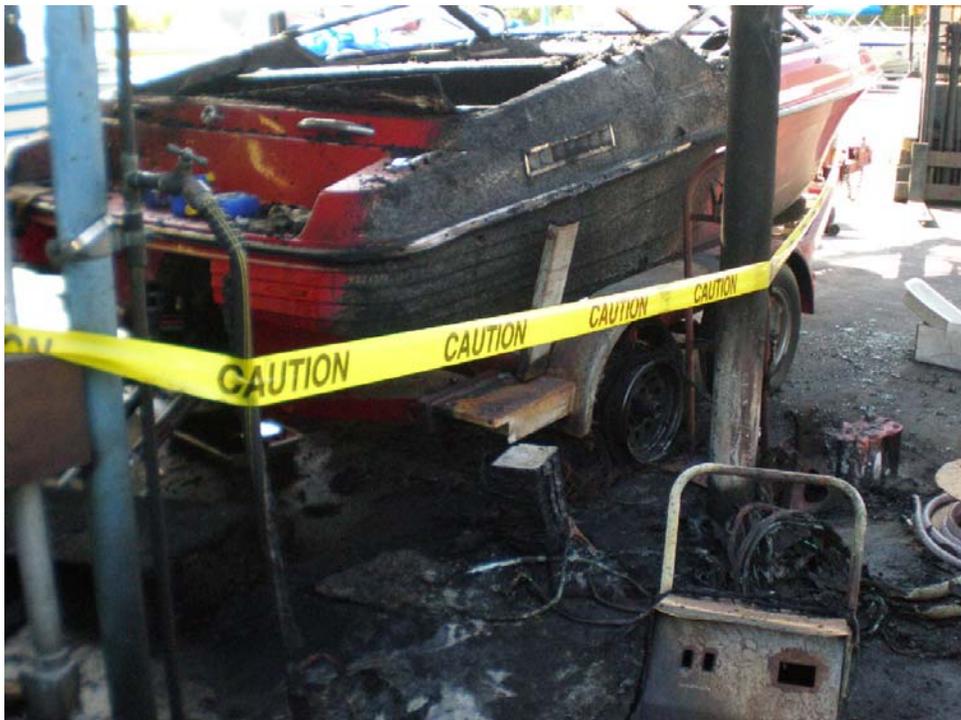
Exhibit 3. A picture of the boat that caught on fire.

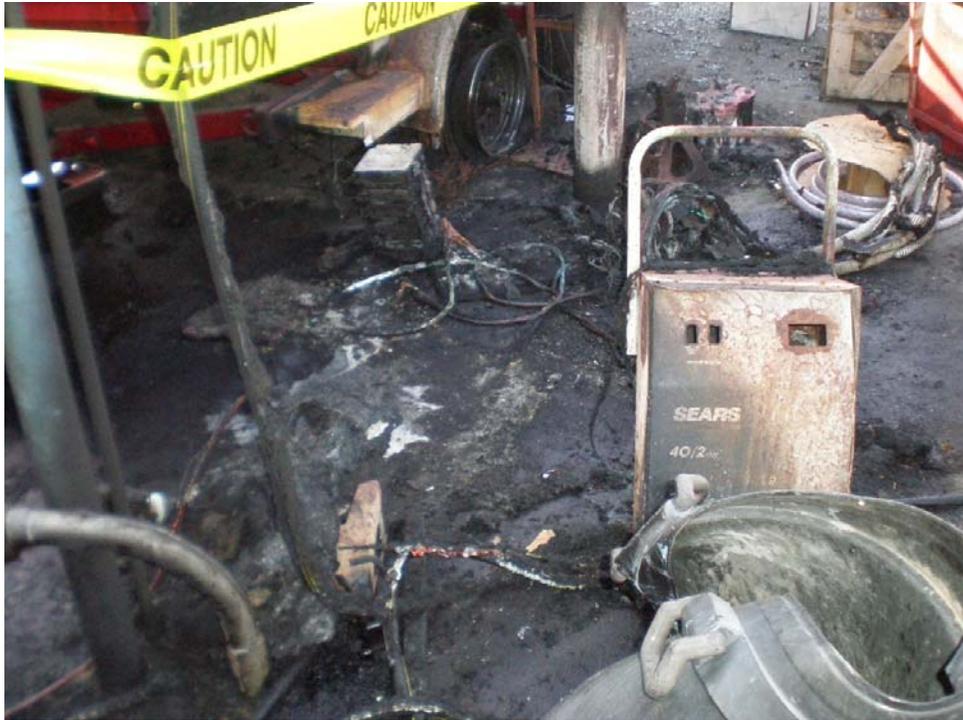
The site of the incident was a maintenance and service shop for trailed boats. On the day of the incident the victim went to the shop and let himself in with his own key. The victim placed a marine battery on the floor of the shop near a battery charger and a customer's boat. The victim was attempting to attach a battery charger to a marine battery when the battery exploded. The explosion caught the customer's boat and the victim on fire. The victim attempted to put the fire out on the boat even though he was on fire himself. Passersby saw the fire and called 911. The paramedics and fire department arrived and treated the victim, then transported him to a local hospital where he died from his injuries.

Exhibit 5. A picture of the battery charger involved in the incident.

Recommendation #1: Ensure employees follow documented battery charging guidelines.

- Always switch off the battery charger before connecting or disconnecting any battery.
