SUBJECT: A Maintenance Worker Dies When He Falls Through a Skylight

SUMMARY
California FACE Report #07CA007

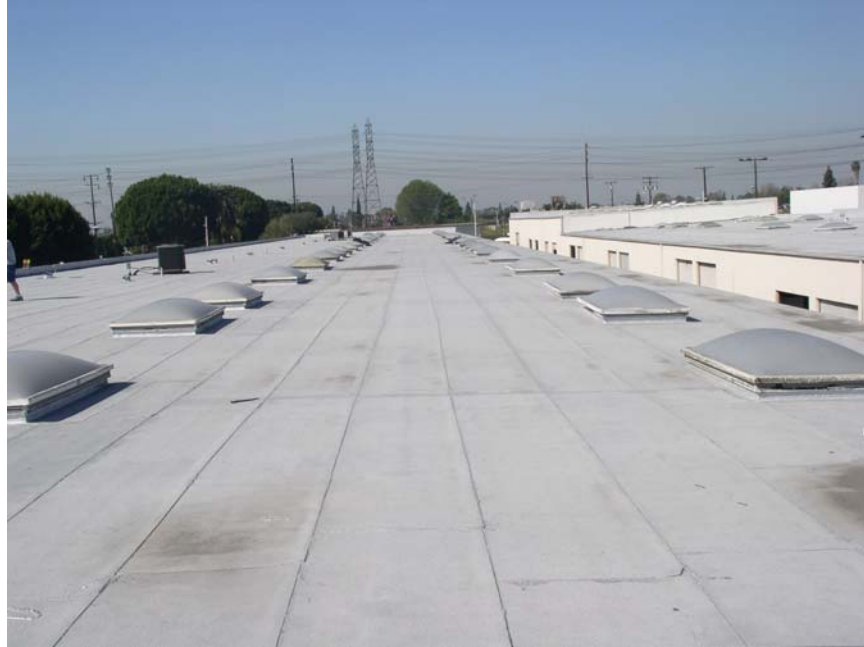
EXHIBIT 1. The roof of the building where the incident occurred.

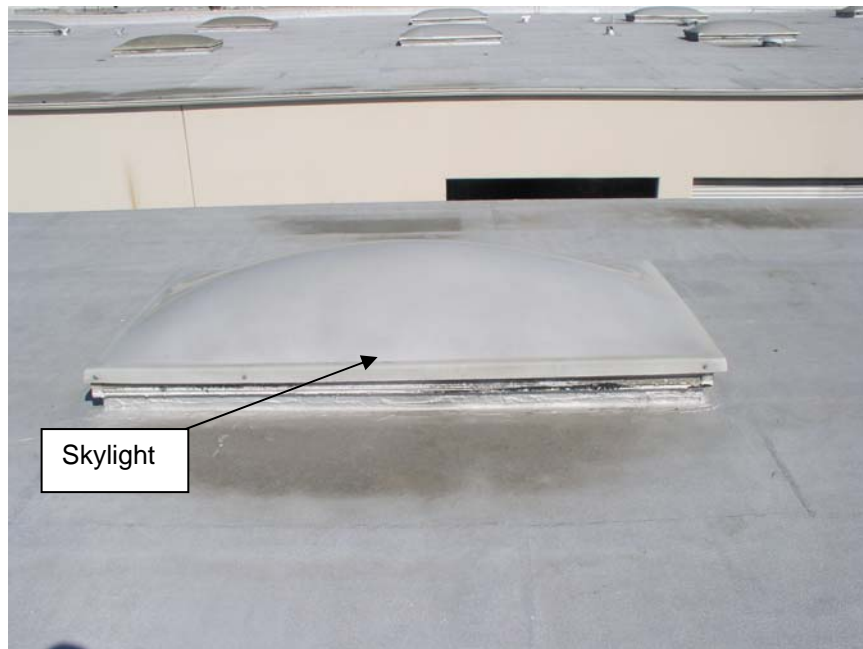
The two maintenance workers secured an extension ladder to the outside of the building to gain access to the roof. The co-worker held the ladder while the victim climbed to the roof and located the skylight that was to be cleaned. The skylight was four feet wide and eight feet long, and had a fiberglass cover. Using a push broom, the victim started sweeping the debris off the skylight. As he applied pressure to the broom handle to sweep off dried bird droppings, the broom handle broke. The victim lost his balance and fell through the skylight cover and opening. He hit a sprinkler pipe and then fell 17 feet to the floor below. The co-worker notified the maintenance supervisor, and then went to the aid of the victim. The co-worker transported the victim by private vehicle to the hospital, where he died from his injuries eight days later.

EXHIBIT 2. The skylight involved in the incident.

Recommendation #1: Develop and implement safety procedures for cleaning skylights.

Discussion: In this incident, the employer did not recognize the fall hazard for employees cleaning a skylight. Skylight cleaning safety procedures should include a site-specific safety plan (hazard analysis) that would identify employer expectations, safe work practices, and engineering safety devices and/or personal protective equipment required for the job. If a skylight or its cover is not designed to withstand at least 400 pounds/square foot, or twice the weight of the employee and his work gear, the employee must be protected from falling through the skylight. In this case, there should have been a screen, guardrails, or personal fall protection system in place. Job

sites should be evaluated by a competent person to identify safety equipment and work practices that will be utilized to accomplish the work. Any safety issues or concerns, or potential hazards, should be identified before beginning work and become part of the site work plan. In this particular case, the use of any one of the devices or methods listed above would have prevented this incident.
