SUBJECT: A Female Material Handler Dies When She is Crushed Against a Podium by a Backing Forklift.

SUMMARY
California FACE Report #07CA008

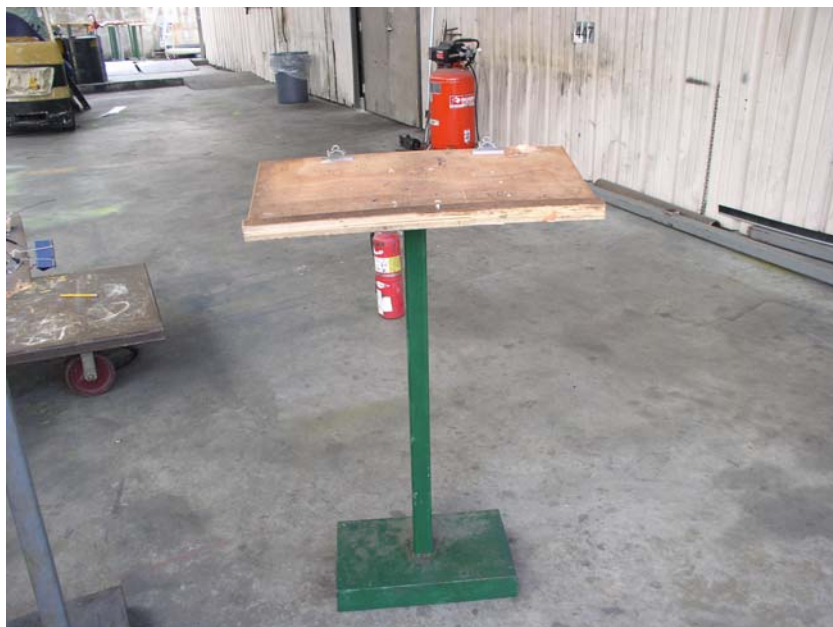
Exhibit 1. The podium that was attached to the steel column on the edge of the dock.

Recommendation #2: Engineer a podium that would have material handlers facing the activity on the dock.

Discussion: In this particular case, the podium was anchored to the steel pillar that supported the roof over the dock. These podiums had been in place since the structure had been built in the early 1970s. Part of the material handlers' responsibilities was to log on the manifest all the cargo they loaded into the trailers. This activity had been done for many years in the same manner without incident. The installation of portable clipboards attached to the steel pillars would allow material handlers to maintain eye contact with any forklift in the area and to move out of the way. Employers should always strive to limit worker exposure to moving equipment.

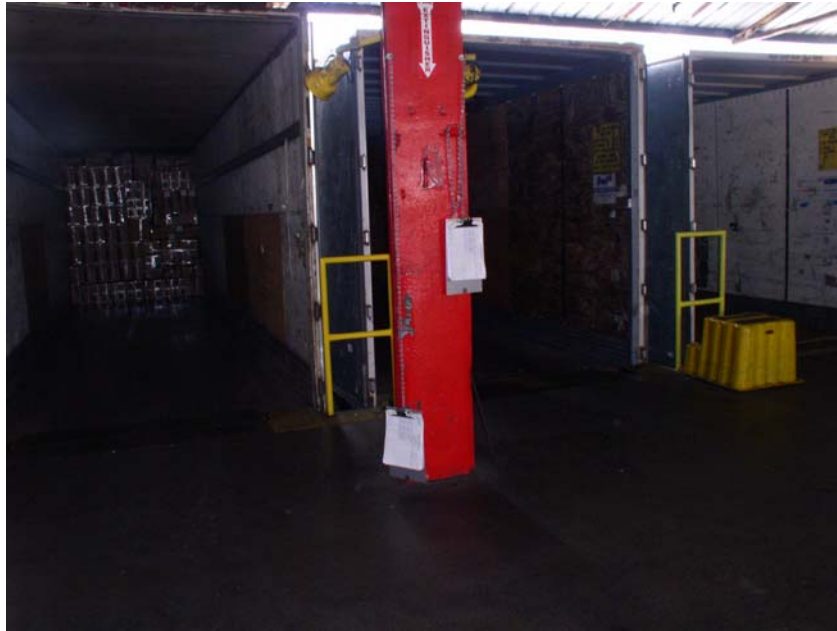
Exhibit 2. The steel column where the podium was secured.

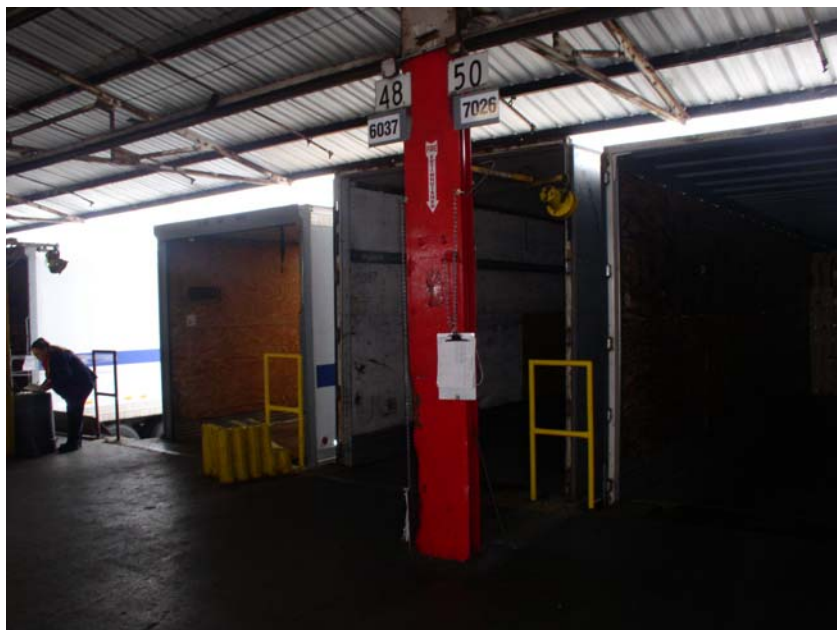
Exhibit 3. The work area where the incident took place showing the outbound trailers.

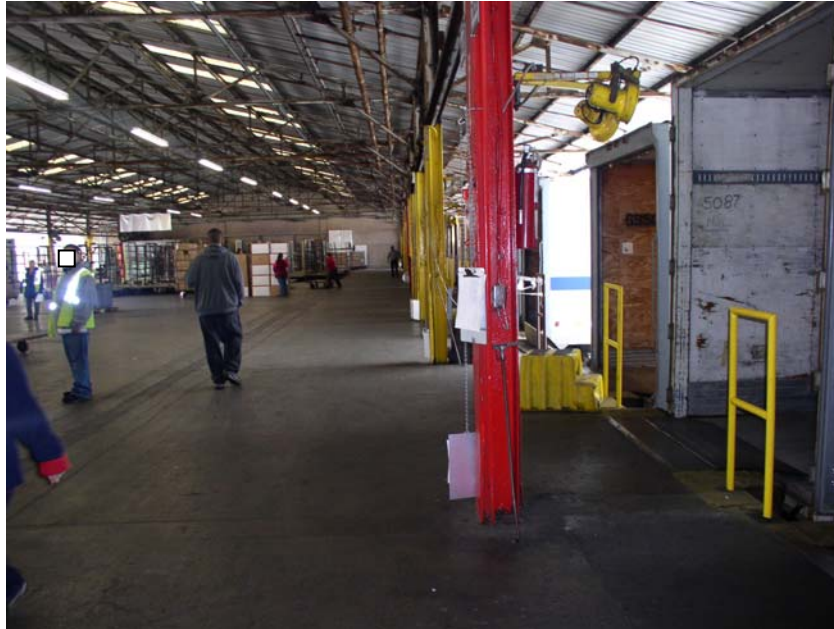
Exhibit 4. The warehouse showing the outbound trailers backed into the dock.

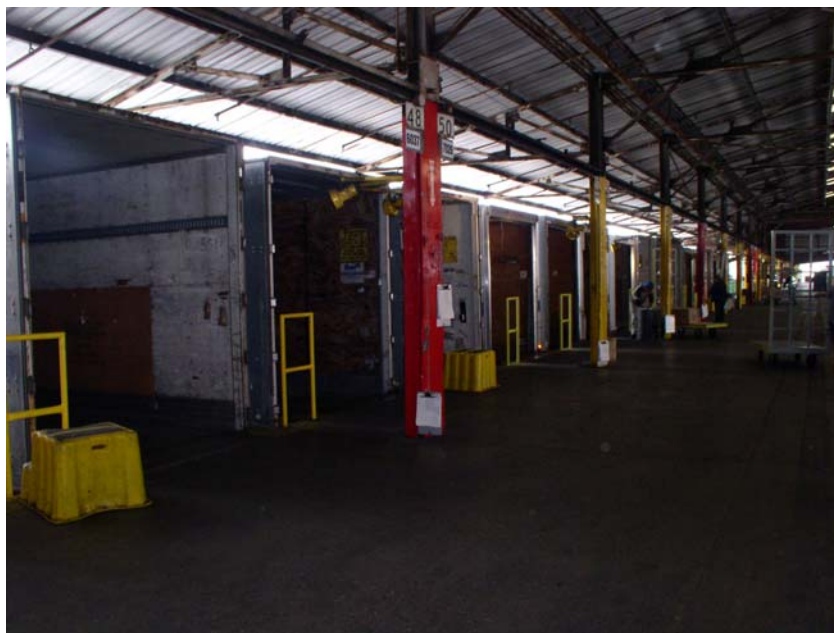
Exhibit 5. The receiving dock with trailers waiting to be loaded.

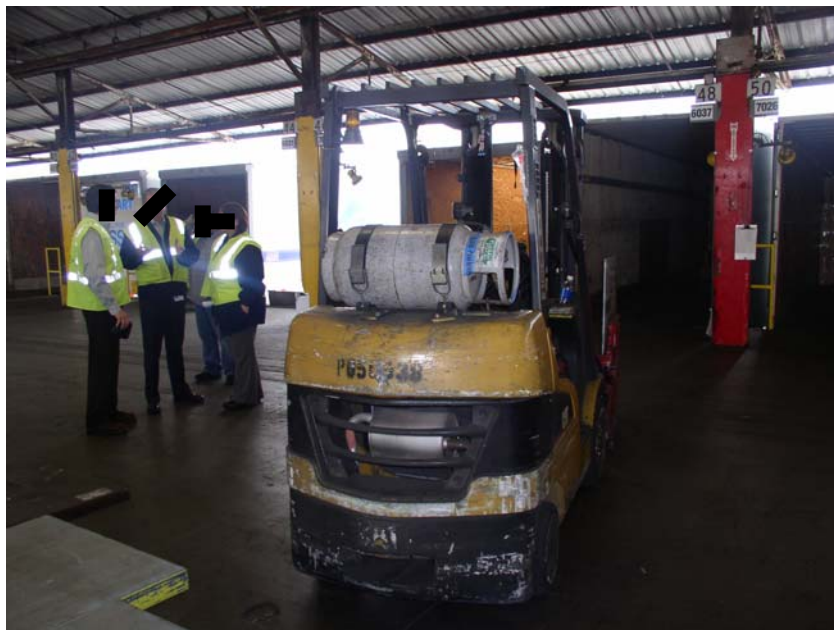
The site of the incident was a manual cross-dock warehouse operation. Trucks carrying containers from ocean carriers would dock on the inbound side of the warehouse and trucks carrying containers for transport to customers would dock on the outbound side of the warehouse. Merchandise from inbound trailers was placed in the warehouse and then packed in the outbound trailers depending on their destination. The material handlers packing the outbound trailers would log the packed material on a manifest that was placed on a podium attached to a support column on the dock. The forklift involved in the incident was a standard natural gas powered forklift that weighed approximately 8,800 pounds. The forklift was in good operating condition and the back-up alarm was working at the time of the incident. The forklift did not have any rear view mirrors.

Exhibit 6. The forklift involved in the incident.

Recommendation #3: Employers and manufacturers should consider additional warning systems for forklifts.

Discussion: Workers on shipping and receiving docks often work in close proximity to moving forklifts. Being exposed on a daily basis to the noise and warning devices of backing equipment can desensitize individuals to the presence of such vehicles. Other devices such as a strobe light or different noises should be considered as additions to the standard back-up alarm to warn workers of a backing vehicle. There are also devices available that can detect the presence of persons in the blind spots of vehicles and provide a warning to the driver. A hazard assessment of forklift operations should be conducted to determine the potential for failure of standard back-up alarms to prevent injuries to other workers. The use of other warning systems in this incident might have alerted the victim to move out of the way of the backing forklift in her work area.

Recommendation #4: Employers should consider changing the type of forklift being used on docks to those where the operator stands sideways.

Discussion: The standard sit-down type of forklift used in most industry is very versatile. However, one of the drawbacks of this type of machinery is that the operator sits in the direction of forward travel and the machine travels in reverse as much as it does in forward. Being able to see in the direction of travel at all times is essential to the safety of all workers in the area. When backing the standard sit-down forklift, the operator is required to look over either their right or left shoulder, depending on the direction of rear travel. In either case, the view is restricted and there will always be a blind spot, and a safety risk.
