SUBJECT: Truck Driver Dies When He Falls Off the Top of a Tank Trailer

SUMMARY
California FACE Report #08CA002

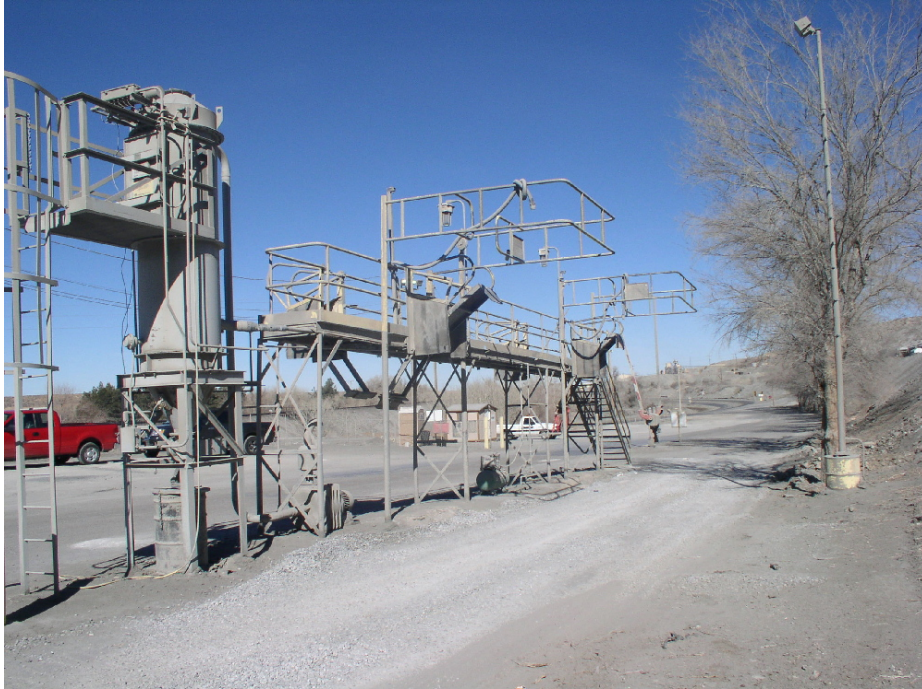
Exhibit 1. The catwalk used by truck drivers to gain access to the top of their tank trailers.

The site of the incident was a catwalk and gangway station at a cement plant. The station was designed to allow truck drivers to gain access to the top of their tank trailers to open or close the lid on top. After loading or unloading materials from their tank trailer, the drivers would park their trucks parallel to the catwalk in order to close the top lids. The catwalk was designed with gangways that were weighted on one end and extended in a perpendicular direction from the catwalk out toward the tank trailer (see exhibit 1). The gangway was designed to lower to the top of the tank trailer with the weight of an individual. A fixed guard rail extended out from the catwalk at each gangway (see exhibits 2 & 3).

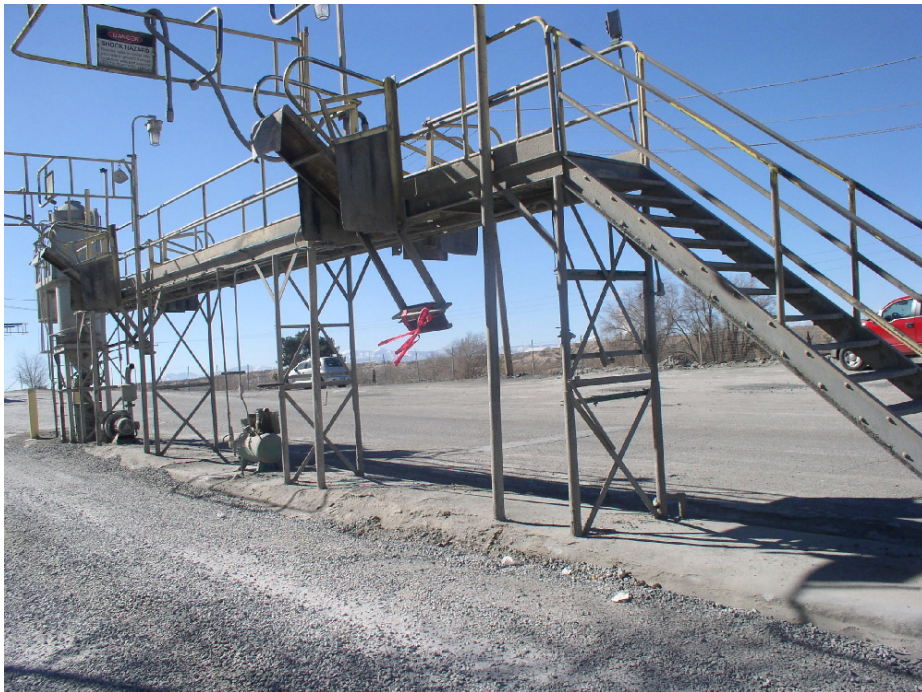
Exhibit 2. The stairs used to gain access to the catwalk and the weighted gangway.

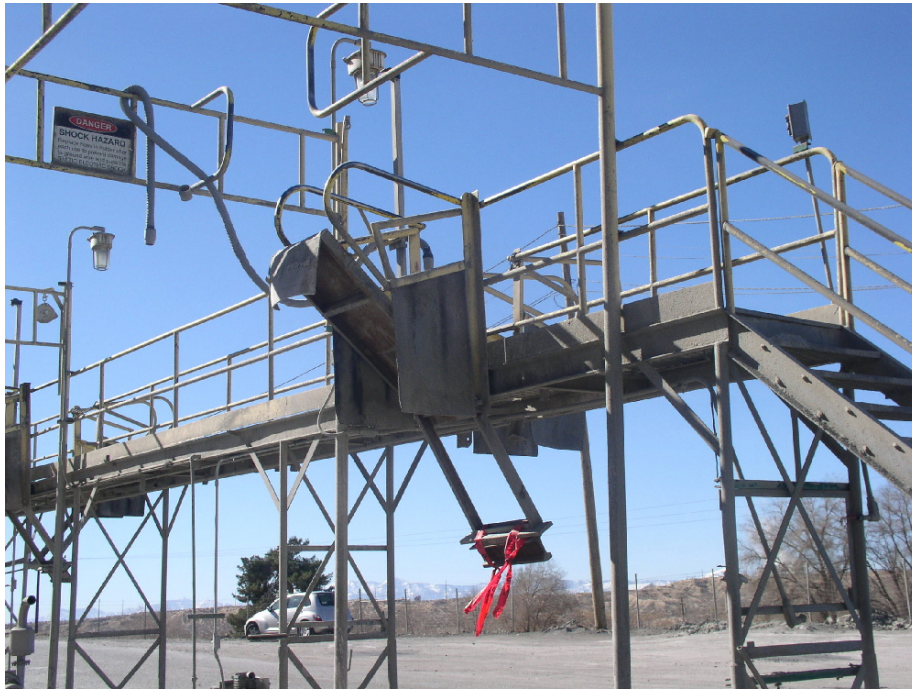
Exhibit 3. The weighted gangway and safety guardrail that extends over the top of tank trailers parked below.

Depending on the tank trailer design and distance from the catwalk, with the gangway fully lowered to the top of the tank trailer there was a gap of approximately 24 to 36 inches from the bottom of the guardrail to the top of the tank trailer. On the day of the incident, the victim drove his tank trailer to the catwalk area in order to close the top lids. The victim parked his rig alongside the catwalk and under the weighted gangway. According to the victim's employer, the tanker was correctly parked next to the catwalk. The victim climbed the catwalk and walked out on the gangway to close the tank trailer lid. The victim fell approximately 12 feet from the gangway to the ground below. The victim may have slipped off the gangway while attempting to close the lid of the tank trailer.

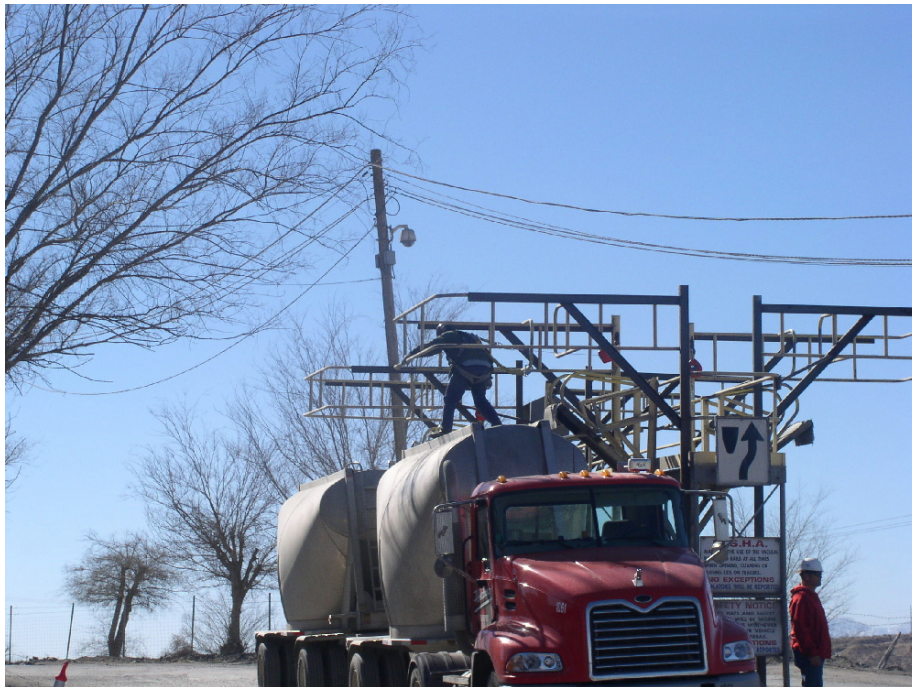
Exhibit 4. An employee using the catwalk and gangway to gain access to the top of a tanker trailer to close the lid.

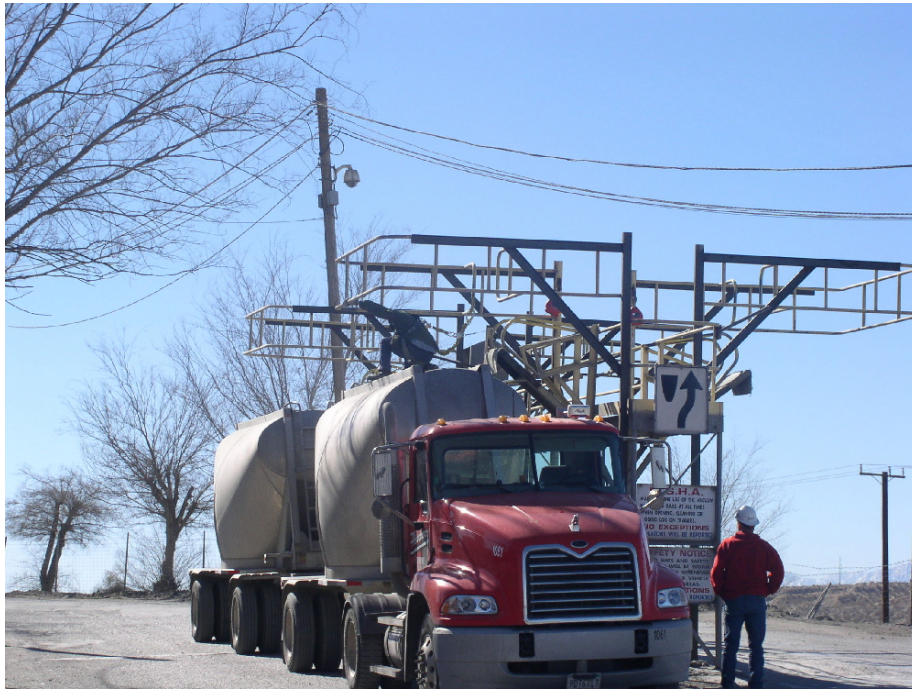
Exhibit 5. An employee utilizing fall protection and the guardrail as he closes the lid on top of the tanker trailer.

Had the victim been using fall protection (see exhibit 5), this would have prevented him from falling to the ground after slipping off the gangway.

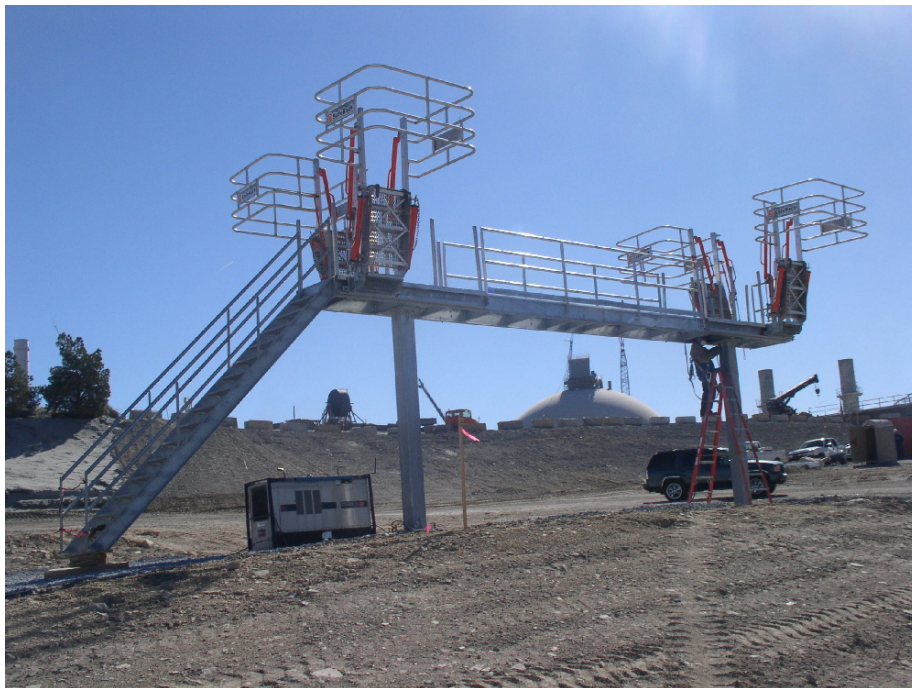
Exhibit 6. A picture of the new catwalk and guardrail system.

Discussion: Several manufacturers provide engineered systems for facilities that need to routinely provide access to the top of tanker trucks. In this incident, a system was used that did not adjust to the truck height and minimize the gap between the guardrail and the truck top. A guardrail system that can adjust to the height of the different tank trailers might have prevented this incident by minimizing or eliminating this gap. One such system has been installed by the facility where this incident occurred (see exhibit 6).
