SUBJECT: An Electrical Worker Dies When He Falls Through a Skylight While Installing Solar Panels on the Roof of a Warehouse.

SUMMARY
California FACE Report #09CA003

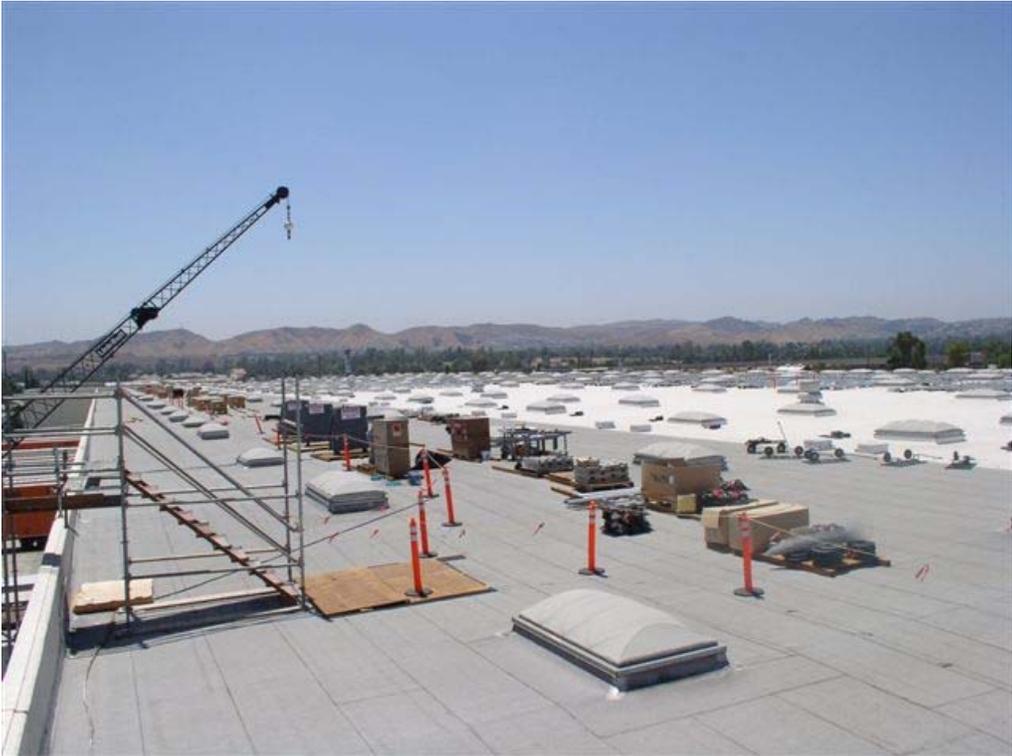
Exhibit 1. The rooftop looking south.

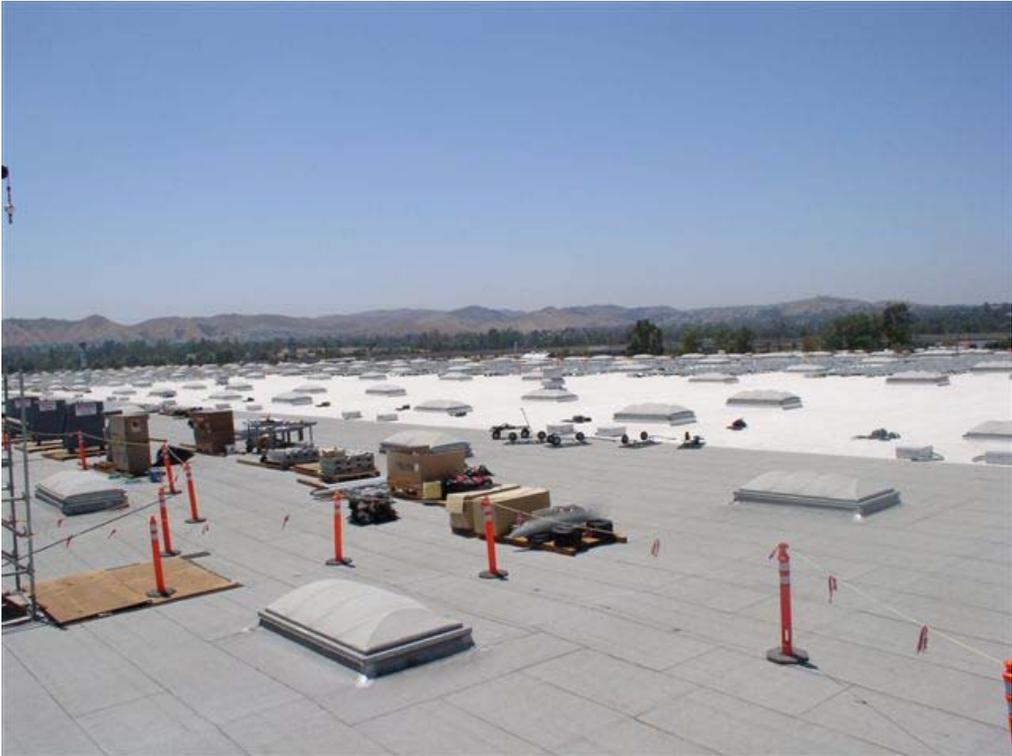
Exhibit 2. The rooftop looking west.

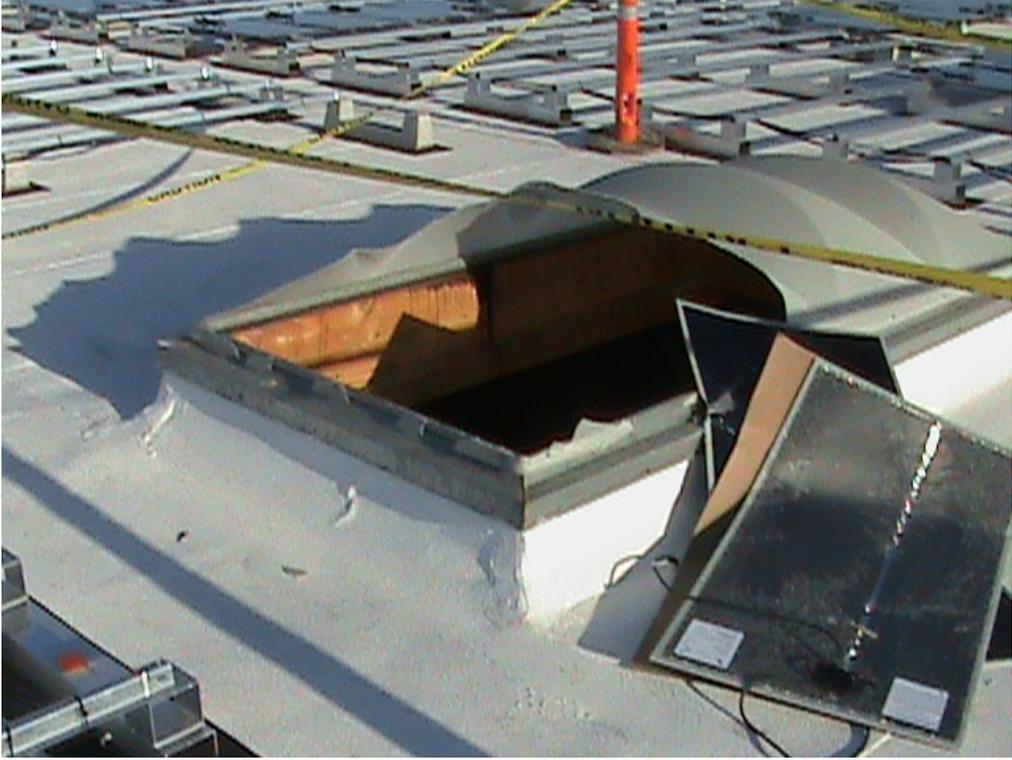
The site of the incident was a flat roof of an active warehouse with a surface area of approximately 650,000 square feet. There were a total of 357 skylights on the roof. Alternate rows of skylights were sealed closed and had stamped ratings; the other rows had skylights that opened and had antitheft grating underneath. This solar panel rooftop installation was designed to produce approximately one megawatt of electricity for the Southern California area. In order to do this, 16,272 solar panels were being installed on the vacant area of the roof between the rows of skylights. The foundations for the solar panels were in close proximity to the skylights and workers had approximately 18 inches of clearance to maneuver around the skylights as the system was being built. The workers also had to be aware of the weight restriction on the roof, as they were not allowed to exceed 300 pounds per square foot.

On the day of the incident, the victim and his co-worker were carrying and installing electrical solar panels on the roof of the warehouse. No fall protection was used as the skylights were marked as being in accordance with OSHA fall protection standards. The solar panels were boxed and placed on the roof by a crane. Each panel was approximately two feet wide by four feet long, and weighed 24 pounds. At approximately 2:00 p.m., the victim and co-worker were carrying two panels at a time. As they approached a skylight, they had to maneuver around it using the 18 inches of clearance. The victim turned and walked backwards, and tripped on the raised edge of the skylight. He landed on the skylight in a sitting position and then, without warning, the plastic dome glazing broke. As the victim started to fall, a co-worker reached out and tried to grab his foot, but was unable to reach him in time. The victim fell approximately 40 feet to the warehouse floor below. Numerous workers with radios immediately called the office to report the incident and those with cell phones immediately called 911. The paramedics and fire department responded within minutes and pronounced the victim dead at the scene.

Exhibit 3. The skylight the victim fell through.

Discussion: In this particular incident, the skylight was marked by the manufacturer that it was “tested in accordance” with OSHA fall protection standards. According to the employer’s risk manager, the general contractor had reviewed the job safety requirements including fall protection plans. Based on the information that the skylight had been tested in accordance with OSHA standards, no other fall protection measures were implemented on this job site. There are currently no uniform test criteria to determine material strength of skylights to withstand worker impact. Such test criteria would include the degradation of plastic or plastic containing materials after several years of sun exposure and the ability to withstand a point impact. One organization, ASTM International, is currently developing such testing guidelines. At this time, employers should not assume that manufacturer testing ensures that a particular skylight can sustain the impact of a worker. In order to prevent falls through skylights, employers should implement and maintain a fall protection program that includes:

- Skylight screens capable of safely supporting the greater of 400 pounds or twice the weight of the employees plus his equipment and materials, or
- Guardrails around the skylight at least 45 inches in height with a top rail and mid rail which should be half way between the bottom surface and top rail. The rails should be able to withstand a live load of 20 pounds per square foot.

If these two methods are not feasible, then the use of personal fall protection should be utilized. A personal fall protection system consists of a body harness, lanyard and anchor points. Had any of these fall protection methods been used at this job site, the victim would not have fallen through the skylight to the ground below.

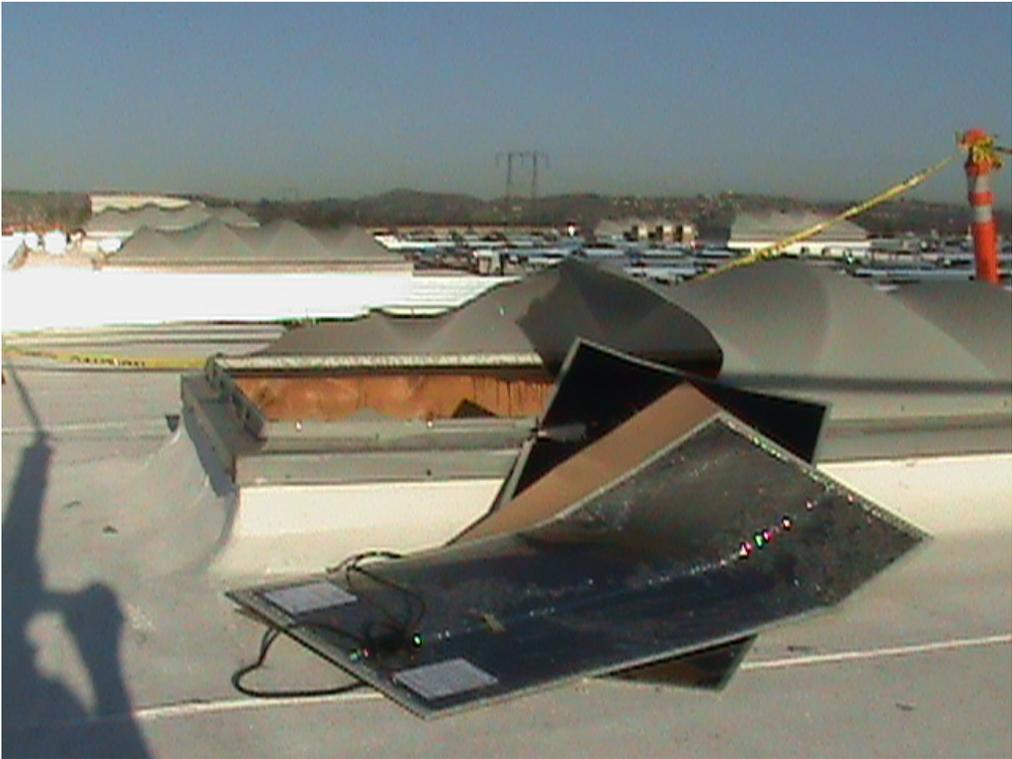
Exhibit 4. The solar panels that the victim was carrying when he tripped.

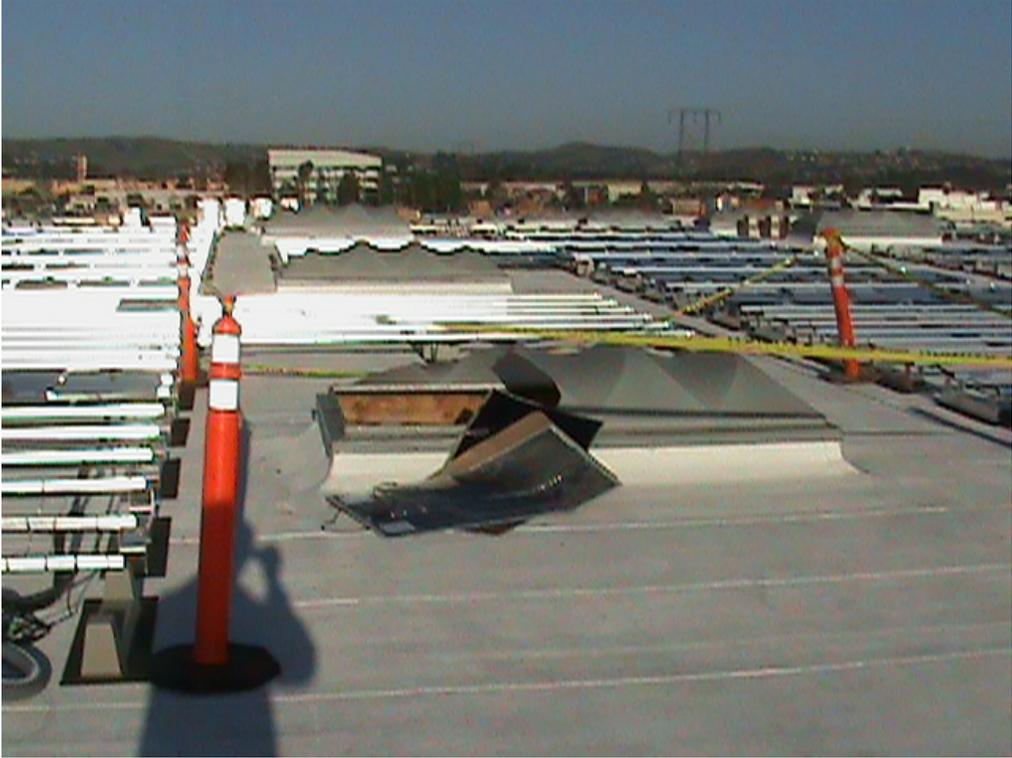
Exhibit 5. A view of the incident scene and the base foundations for the solar panels.

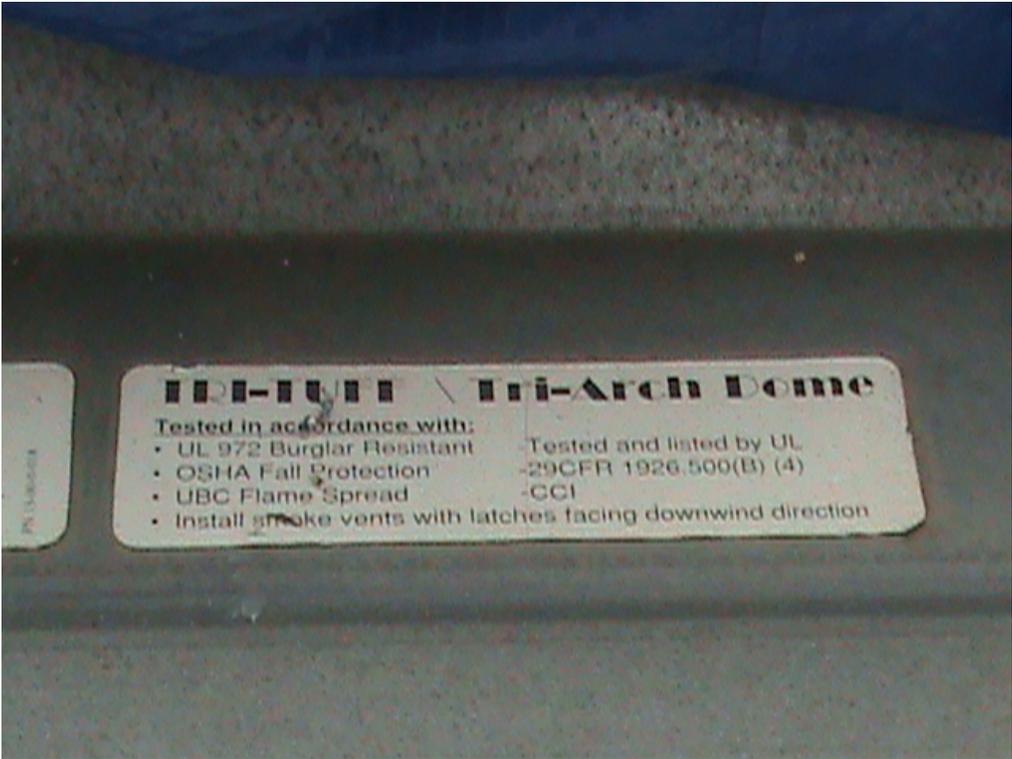
Exhibit 6. The identification tab on the skylight the victim fell through.
