SUBJECT: A Laborer Dies When He is Struck By an Exploding Forklift Multi-Piece Rim

SUMMARY
California FACE Report #10CA001

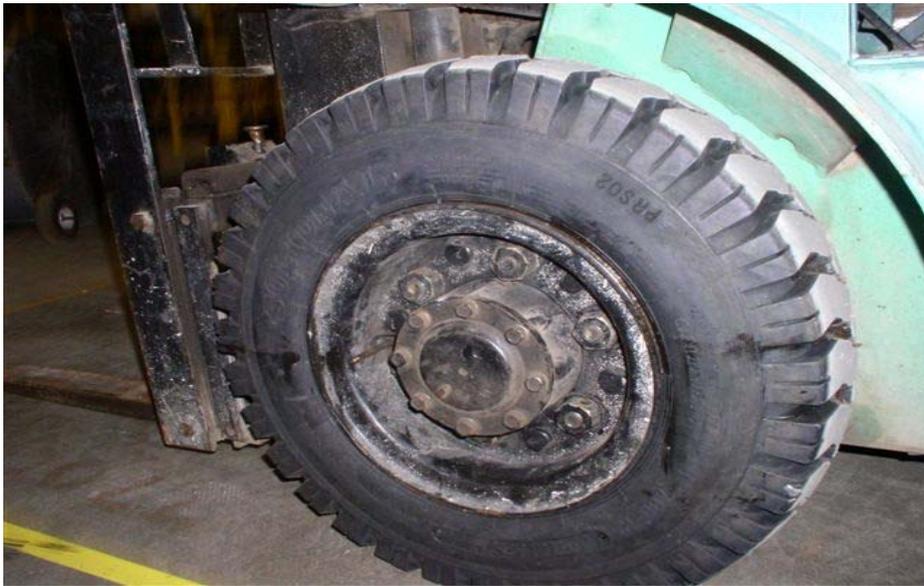
Exhibit 1. A forklift multi-piece rim and tire assembly similar to the one involved in the incident.

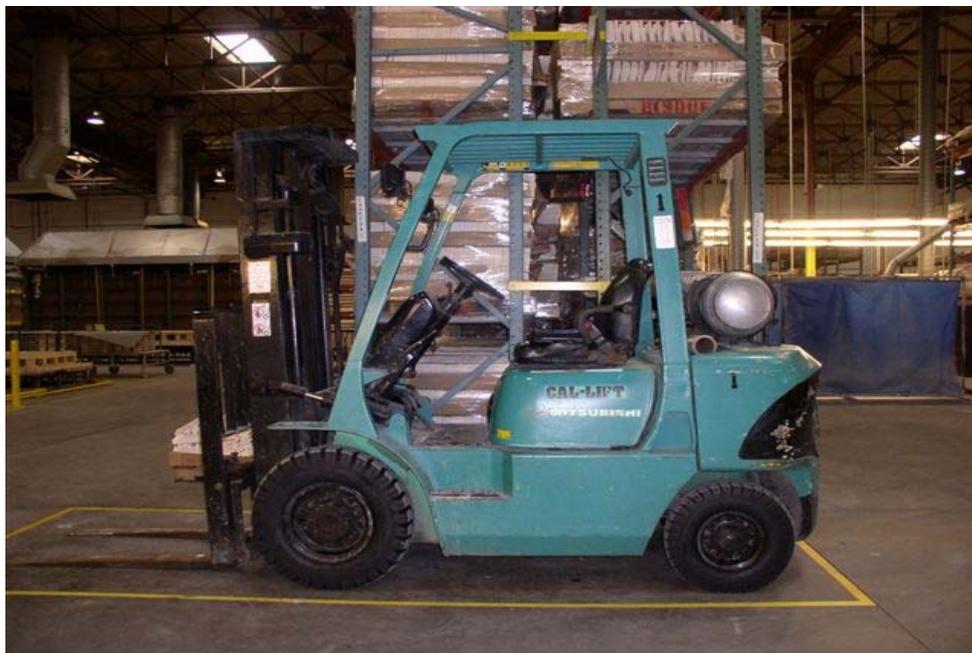
Exhibit 2. The forklift involved in the incident.
