FROM: California Fatality Assessment and Control Evaluation (CA/FACE) Program

SUBJECT: A Solar Panel Installer Dies When He Falls Off a Roof

California FACE Report #10CA003

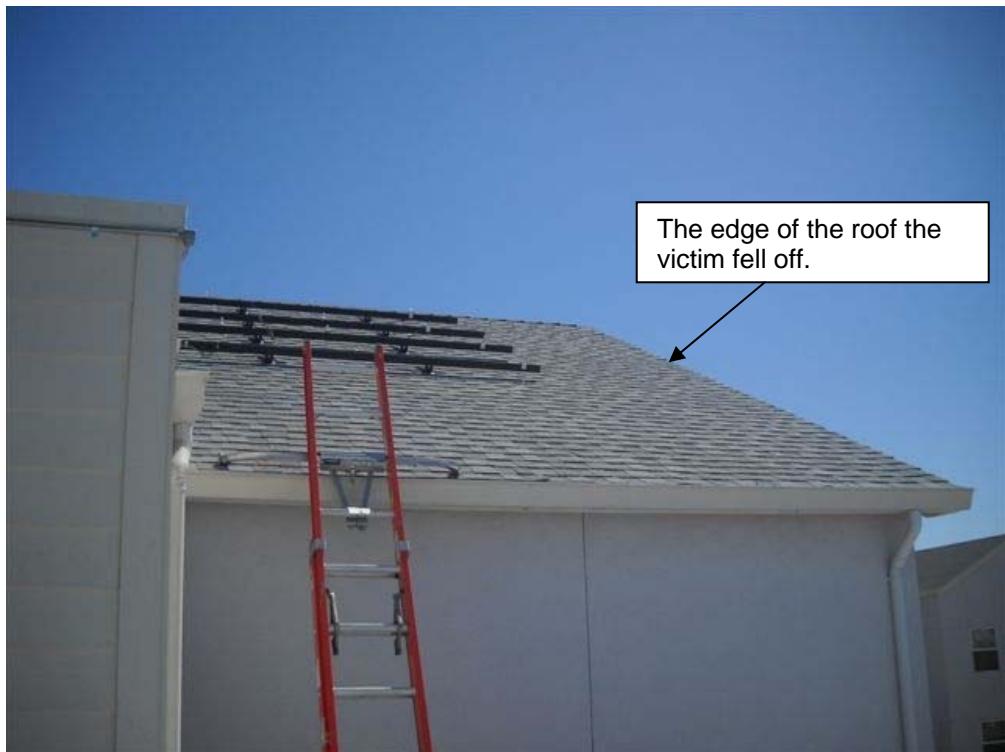
The location of the incident was a housing unit with multiple three-story apartment buildings. Solar panels were being installed on the sloped roofs of the apartment buildings. On the unit where the incident occurred, access to the roof was gained by a stairwell up to a third floor landing and then a straight ladder from the landing to the bottom of the sloped roof. The distance from the bottom of the sloped roof to the landing was approximately eight feet. The distance from the sides of the sloped roof to the ground below was approximately 45 feet. The slope of the roof was approximately 9:12 or 37 degrees.

Exhibit 1. The roof edge the victim fell from.

Recommendation #1: Employees wear fall protection when working on sloped roofs with identified fall hazards.

Fall protection should be worn by employees on sloped roofs greater than 30 degrees, or whose work exposes them to a risk of a fall in excess of 7 ½ feet. The two types of fall protection systems commonly used on roofs are a personal fall restraint (PFR) system and a personal fall arrest (PFA) system. A PFR system is used to prevent an employee from falling. It consists of anchorages, connectors, lanyards, and body harness. A PFA system is used to stop an employee during a fall from a working level. This system consists of an anchorage, connectors, a deceleration device, and a body harness. Had the victim been wearing the required fall protection, his death would have been prevented.

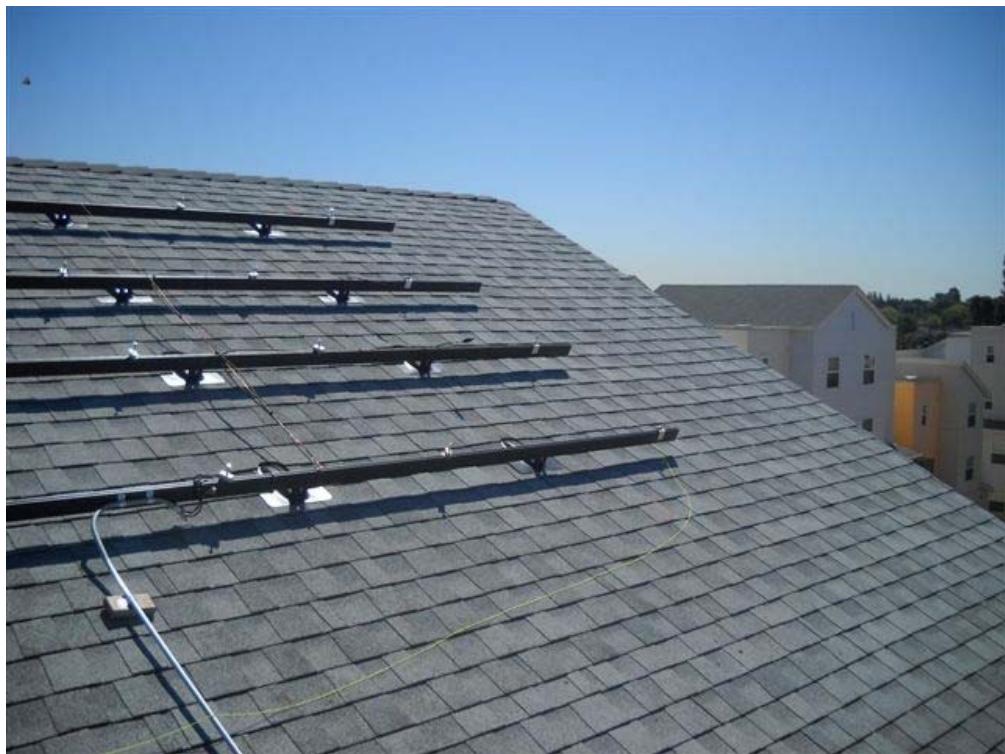
On the day of the incident, the victim along with his supervisor and co-worker were on the sloped roof checking the alignment of the brackets for the support structure of the solar panels. This was their second day on the job. The victim was working within four to five feet of the roof edge and was probably walking backwards as he performed this task. Neither the work crew nor the victim were wearing fall protective equipment and was tied off, and there were no guard rails or safety nets in place. The co-worker and supervisor heard the victim say something, and then looked over at the spot where they last saw the victim. By that point, the victim had fallen over the edge of the roof onto to the concrete sidewalk below. The co-worker immediately called 911. The fire department and paramedics arrived at the location within minutes of the call. The victim was air lifted to the hospital where he was pronounced dead.

Exhibit 2. The mounting brackets for the solar panels and the roof's edge where the victim fell.

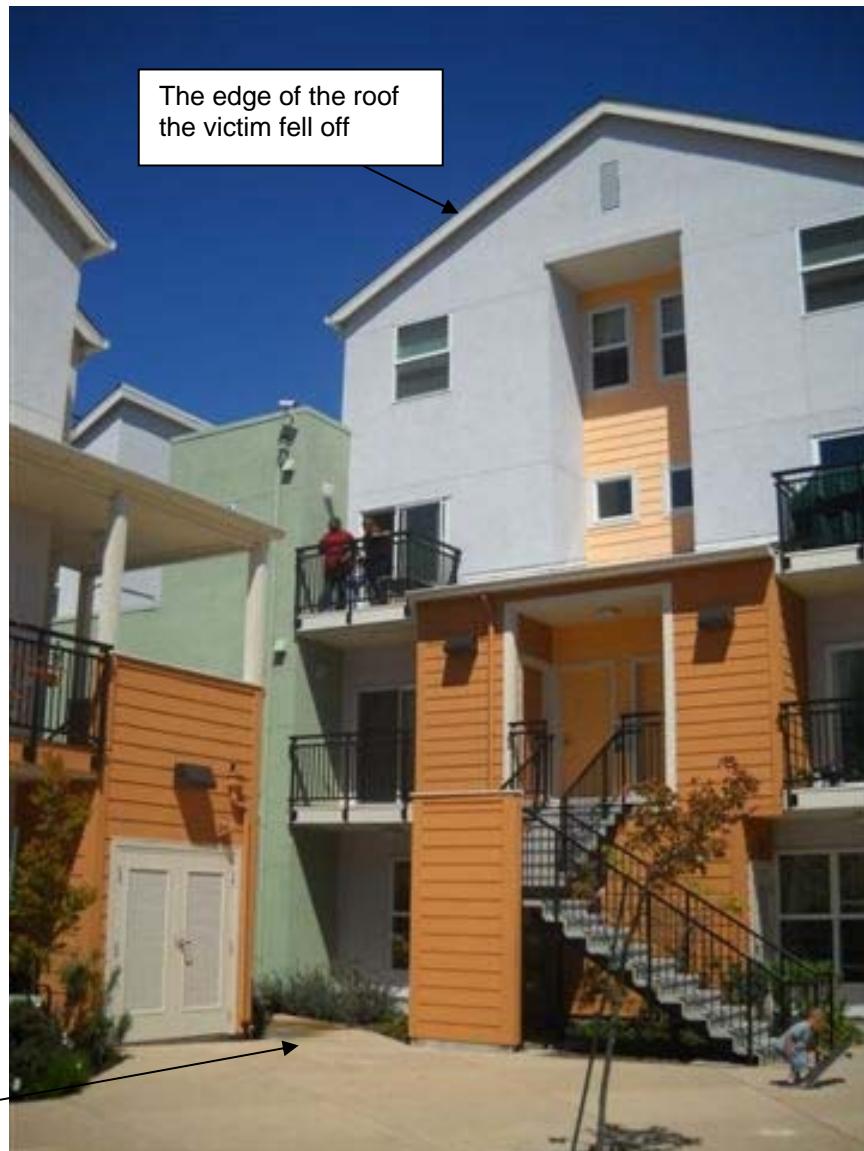
Exhibit 3. The three-story apartment building involved in the incident.
