SUBJECT: A Groundsman Working on a Tree Trimming Crew Dies When He is Dragged or Propelled onto a Wood Chipper Feed Table

SUMMARY
California FACE Report #10CA010

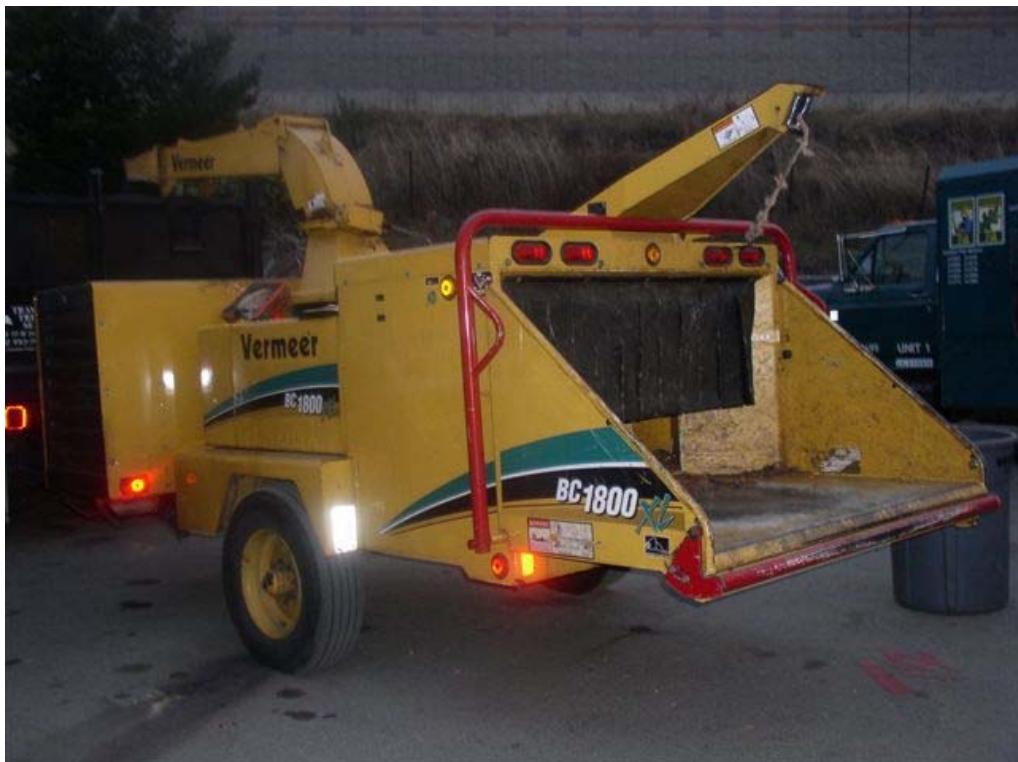
Exhibit 1. The wood chipper involved in this incident.

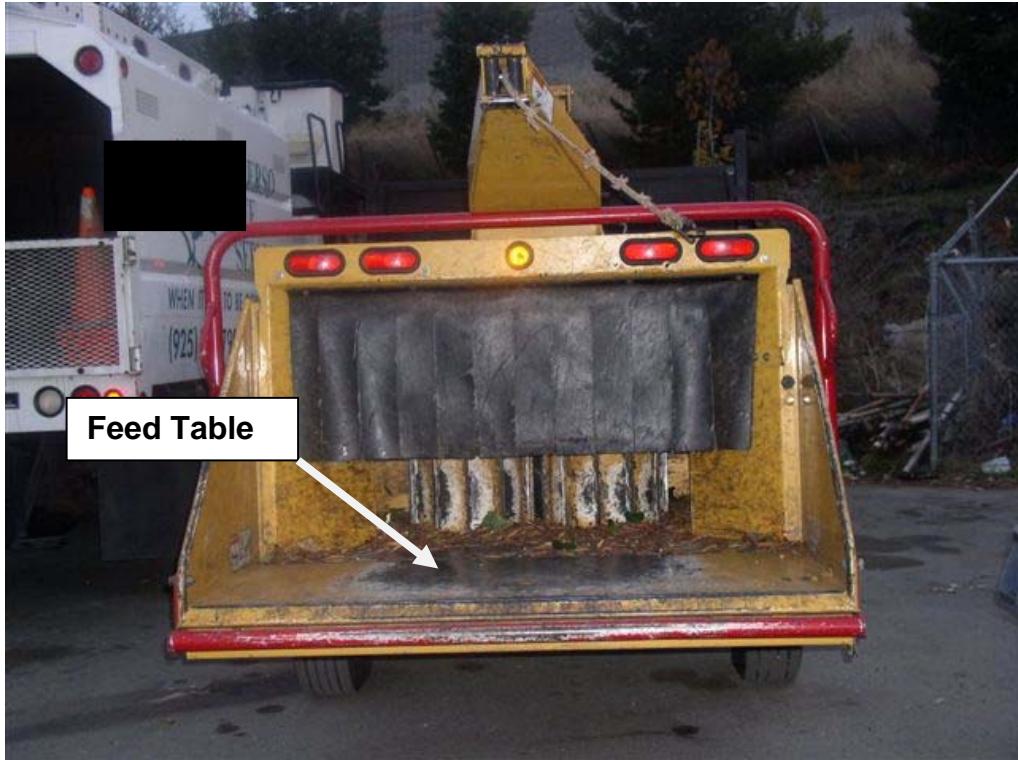
At approximately 1:30 p.m., the victim was dragging a branch from the base of a eucalyptus tree to the wood chipper which was approximately 40 feet away. As he passed another tree, the branch became entangled in the white colored climbing rope of the tree trimmer in that tree. When the victim reached the wood chipper, he fed the branches into the chipper with the climbing rope. Although this incident was not witnessed, evidence suggests that as the rope went through the wood chipper it immediately went taut. The victim was either dragged or thrown onto the chipper, striking his head. As his body landed on the feed table, it most likely struck the safety bar located on the front and shut the machine down.

Exhibit 2. The feed table where the victim landed.
