**SUBJECT:** An Orchard Caretaker Dies When He is Pulled into a Wood Chipper

**SUMMARY**  
**California FACE Report #10CA011**

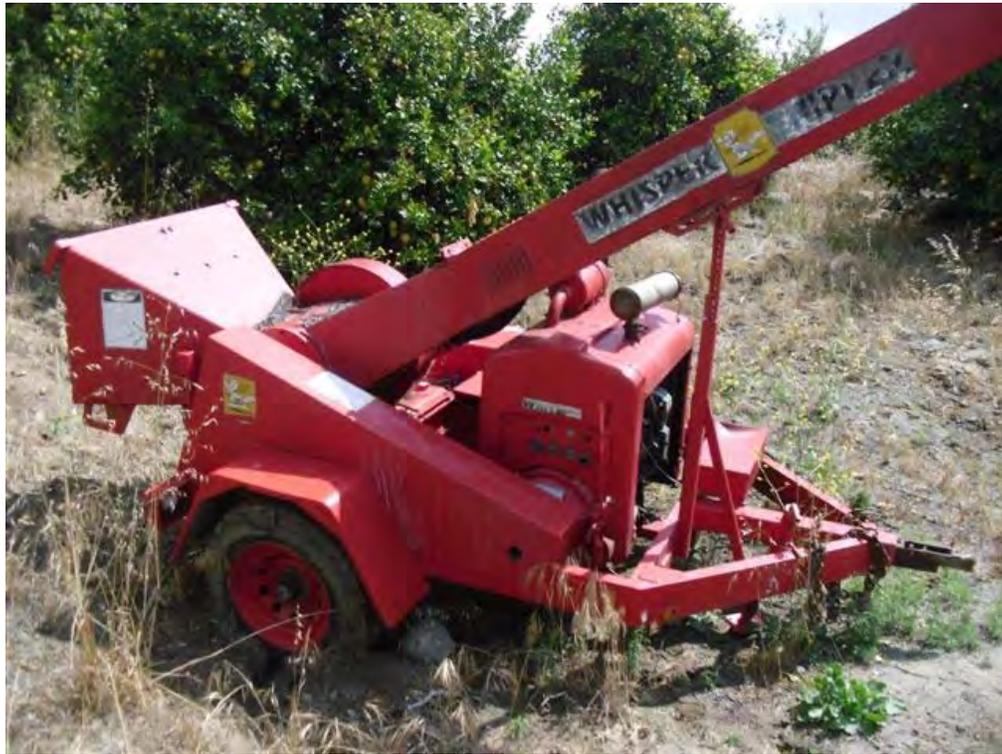
**Exhibit 1. The wood chipper involved in this incident.**

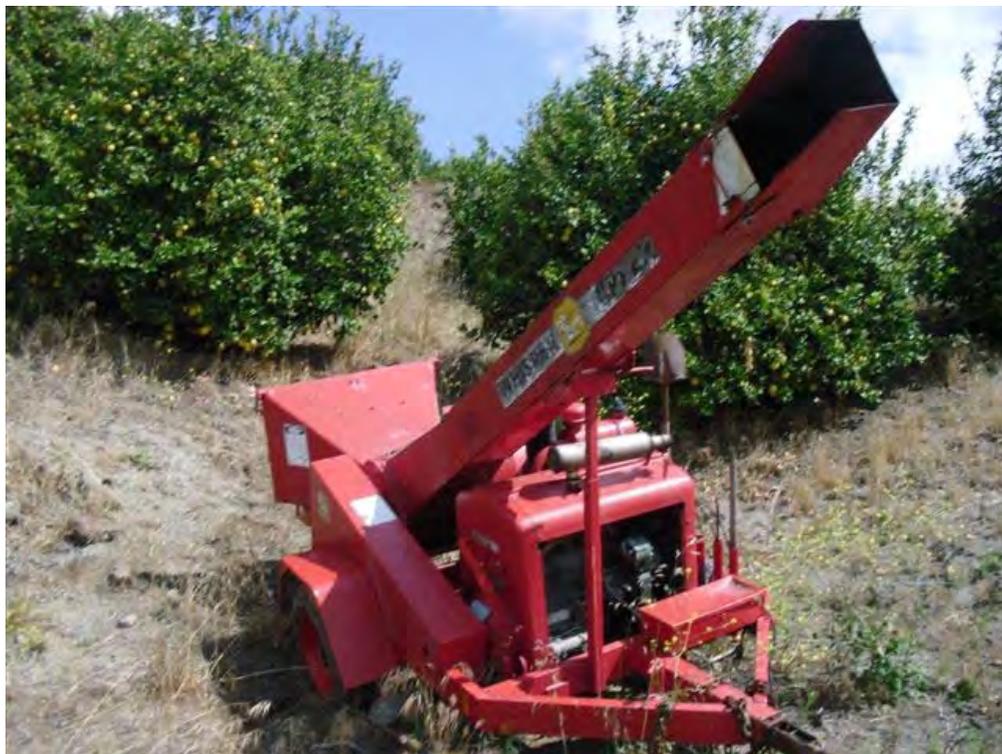
**Exhibit 2. Front view of the wood chipper.**

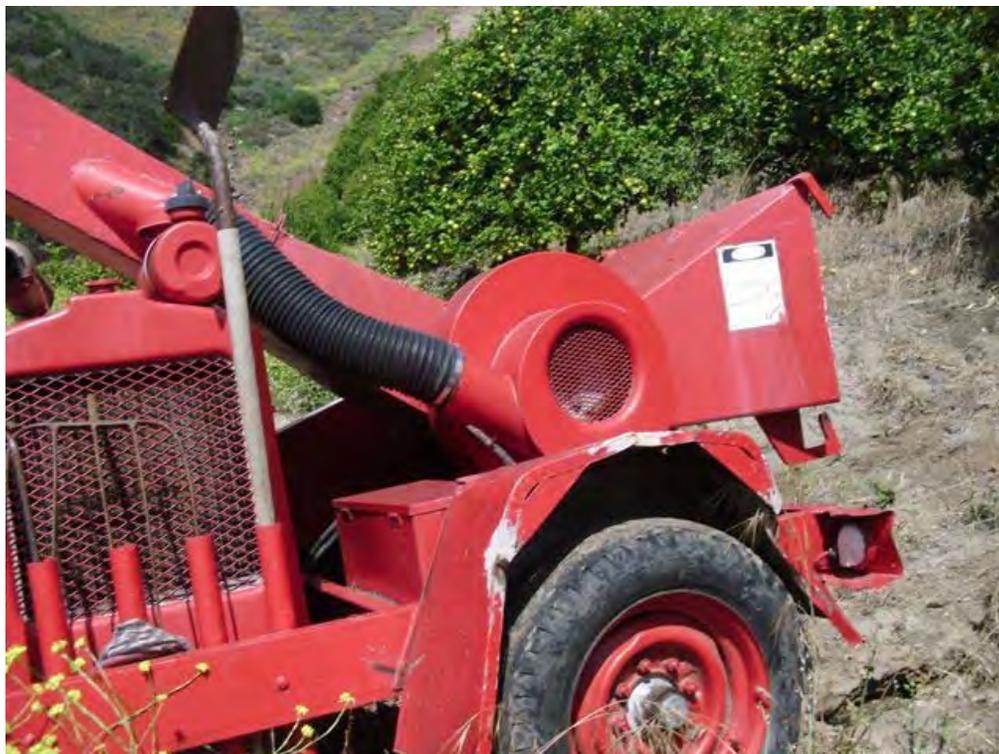
**Exhibit 3. Side view of the wood chipper.**

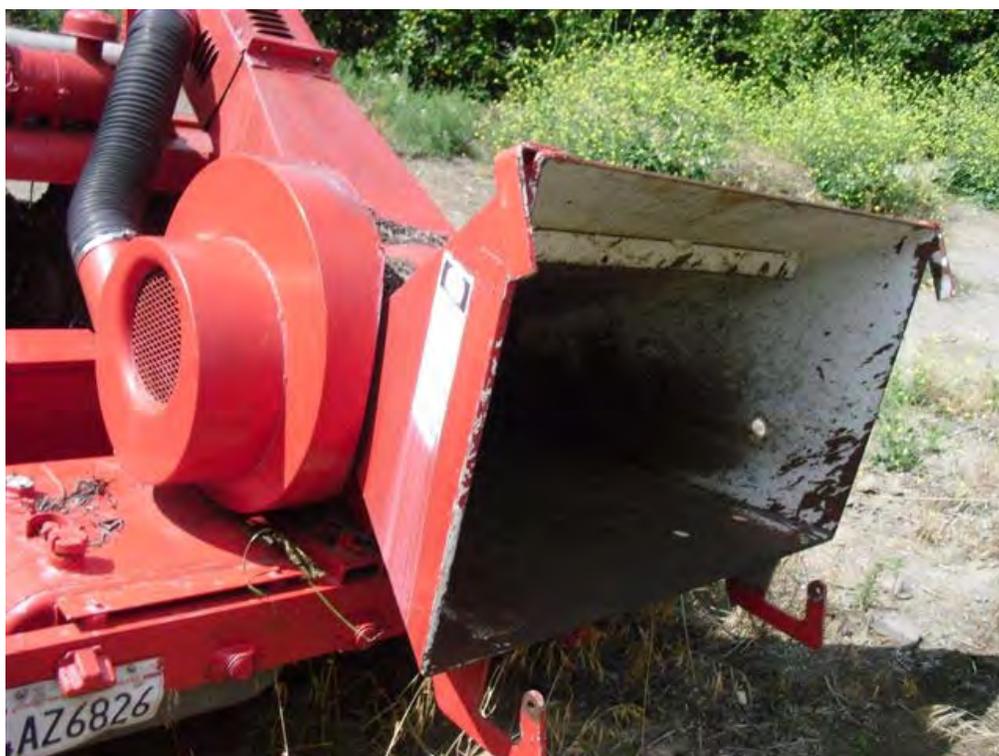
**Exhibit 4. A rear view of the wood chipper.**

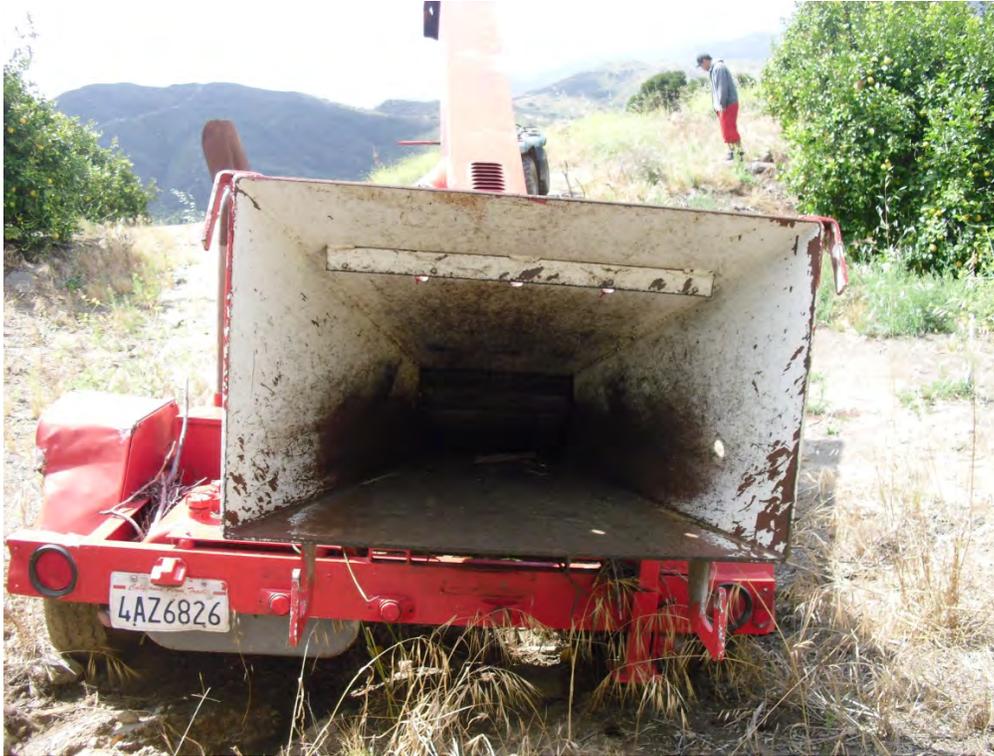
**Exhibit 5.**

**The in-feed hopper where brush and limbs are fed into the wood chipper.**

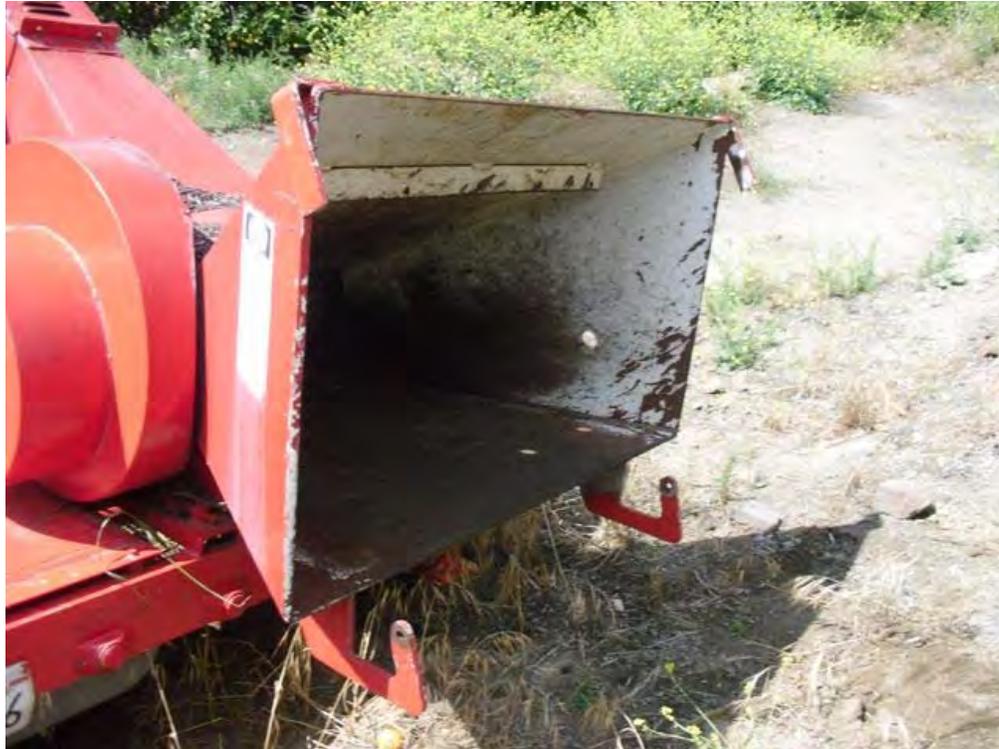
**Exhibit 6.**

Discussion: The wood chipper involved in this incident did not have any type of safety device installed on it that would have shut the machine off in case of an emergency. The wood chipper machine's hopper was missing its feed table that would have extended the reach distance to the drum-mounted rotating chipper blades. All wood/brush chippers not equipped with a mechanical in-feed system should be fitted with an in-feed hopper not less than 85 inches long, and have sufficient height on the side panels to prevent personnel from contacting the blades of the machine during normal operations. In this case, because there was no self-feeding device on the wood chipper, the brush had to be fed directly into the rotating blades. Based on the location of the victim at the time of the incident, he likely tried to kick in the material with his feet. Had a feed table been in place, this would not have been possible and the victim would not have been caught in the rotating blades.

**Alternate view of the in-feed hopper without a feed table.**

Other safety devices that are used to prevent wood chipper injuries include feed roller control bars/switches and engine kill switches. If the wood chipper in this incident been equipped with these safety devices, the victim may not have been able to contact the blades or his injuries might have been less severe.

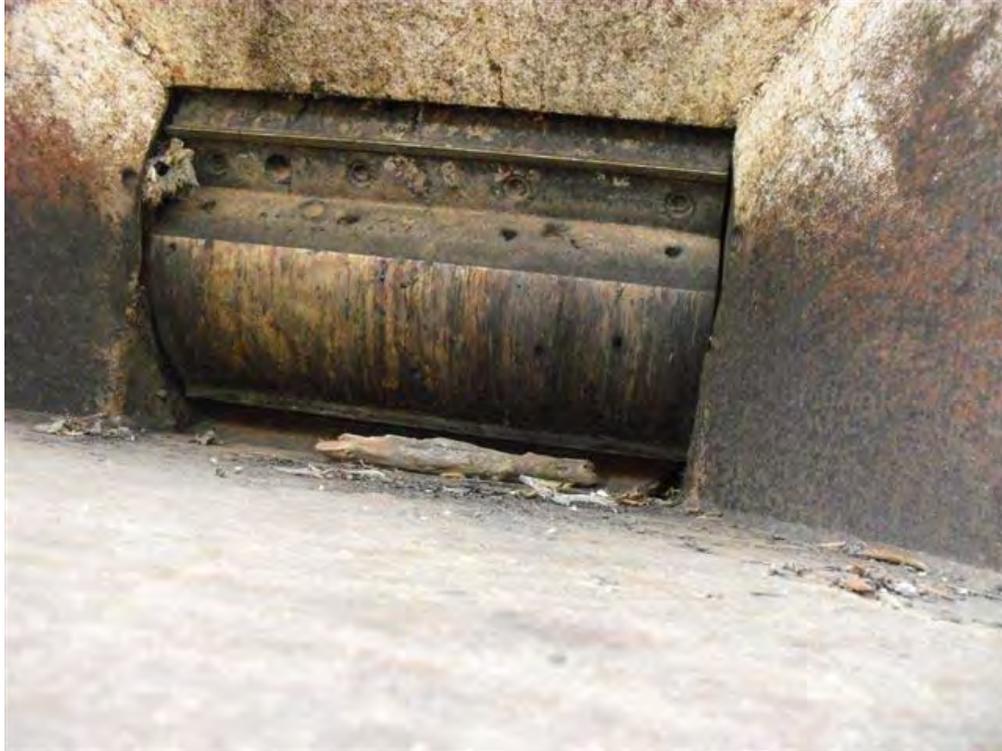
**Exhibit 7. The blades attached to the rotating drum that chip brush.**

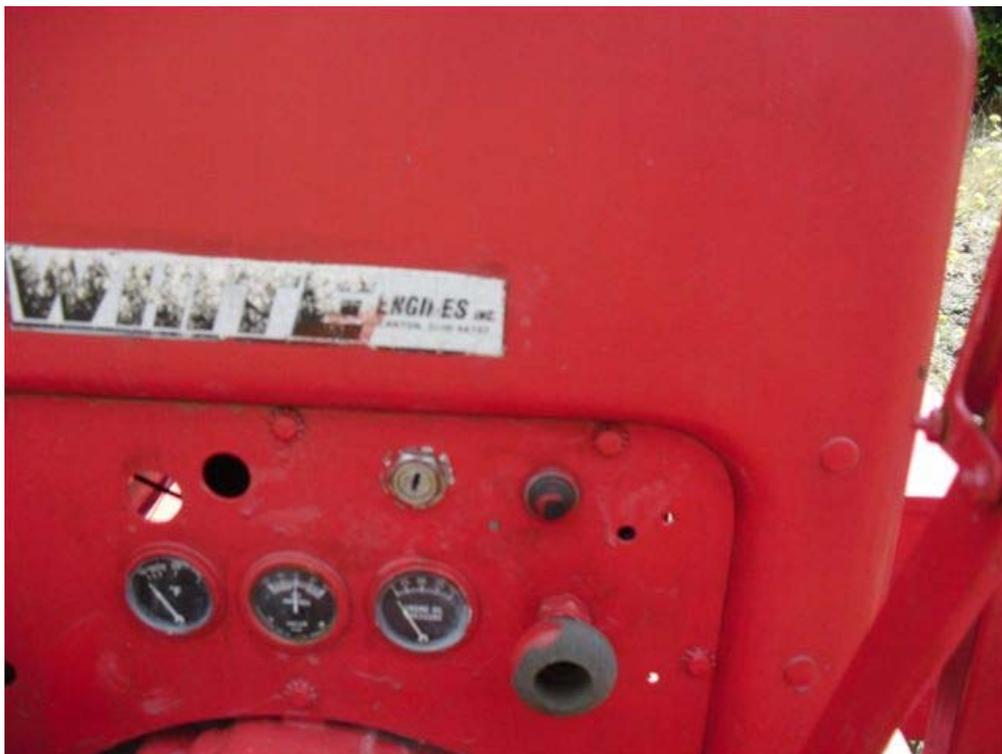
Feeding with this type of wood chipper can be difficult. If the limb being fed into the chipper approaches the chipper drum at certain angles, or if blades are too dull or the material is too large, the cutting action may not be able to pull the branches into the cutting blades. When this happens the user must re-feed or push the material back into the chipper. The chipper had originally been equipped with a feed table attached to the hopper. It is not known if the feed table was present when the victim purchased the machine. The feed table not only serves as the conduit for the material being fed into the chipper; it also extends the reach distance, preventing the operator from contacting the blades or knives or kicking material into the chipper. The wood chipper did not have an emergency shut-off switch.

**Exhibit 8. The control panel on the wood chipper.**

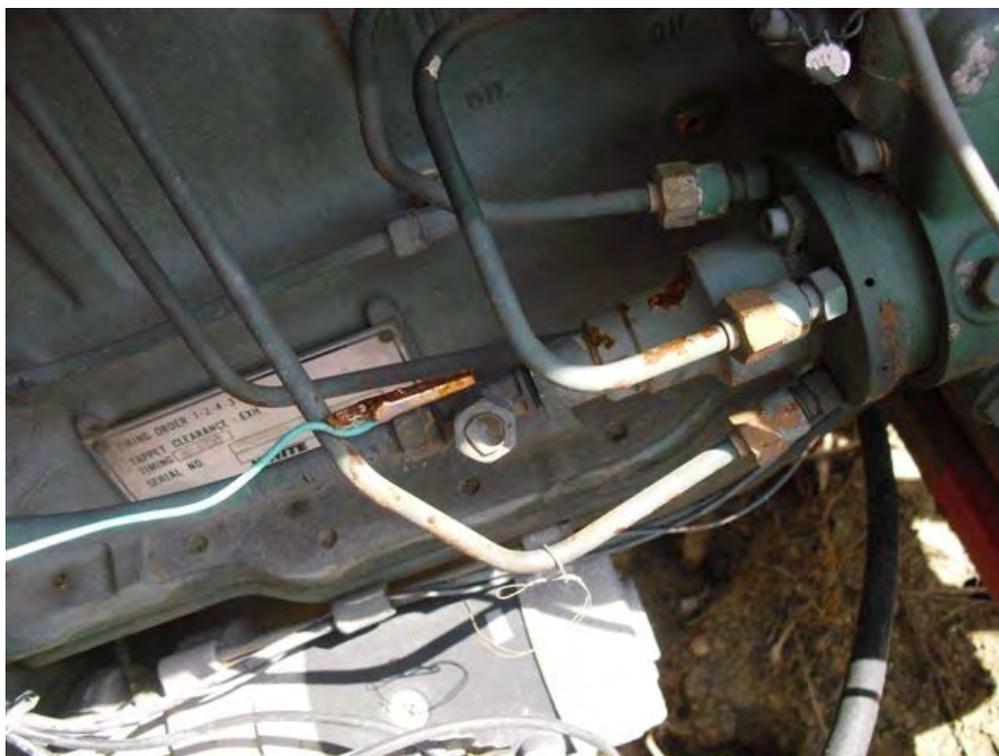
**Exhibit 9. The wire clip used to shut off power to the wood chipper.**

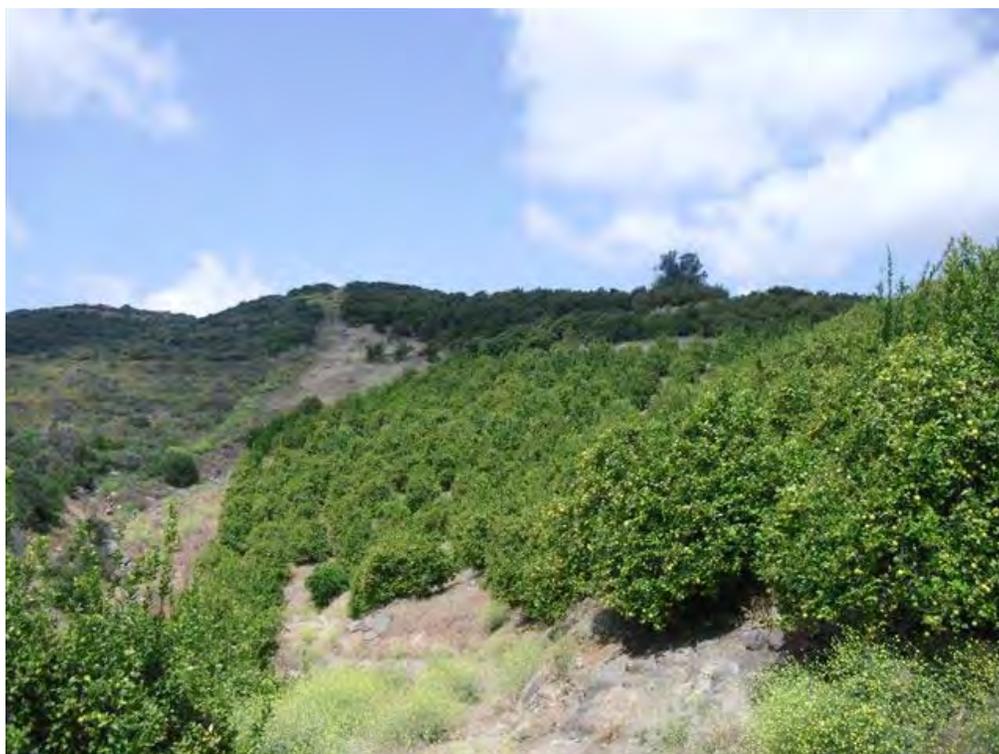
The location of the incident was a vacant lot adjacent to an avocado grove on a steep hillside in a remote farm area. The property owner hired the victim to clear the land and cultivate it for future planting of flowers. The drum-type wood chipper involved in the incident was an Asplundh drum-type non-self-feeding wood chipper, Model JEY D12. The victim had purchased this used machine three years earlier. The victim's son stated that the wood chipper was purchased in an "as is" condition and there were no accompanying books, manuals, or instructions. The manufacturer refers to this type of machine as self-feeding. Brush and tree branches are fed into the machine's feed chute by hand until the drum-mounted rotating chipper blades catch the material. The material is then "self-fed" through the machine by the action of the chipper blades passing a cutting anvil as the wood is cut into chips. The chips are then propelled through a discharge chute which can be directed at different angles.

**Exhibit 10. The steep hillside where the incident occurred.**
