SUBJECT: A Roofing Supervisor Dies When He Falls Through a Skylight

SUMMARY
California FACE Report #11CA004

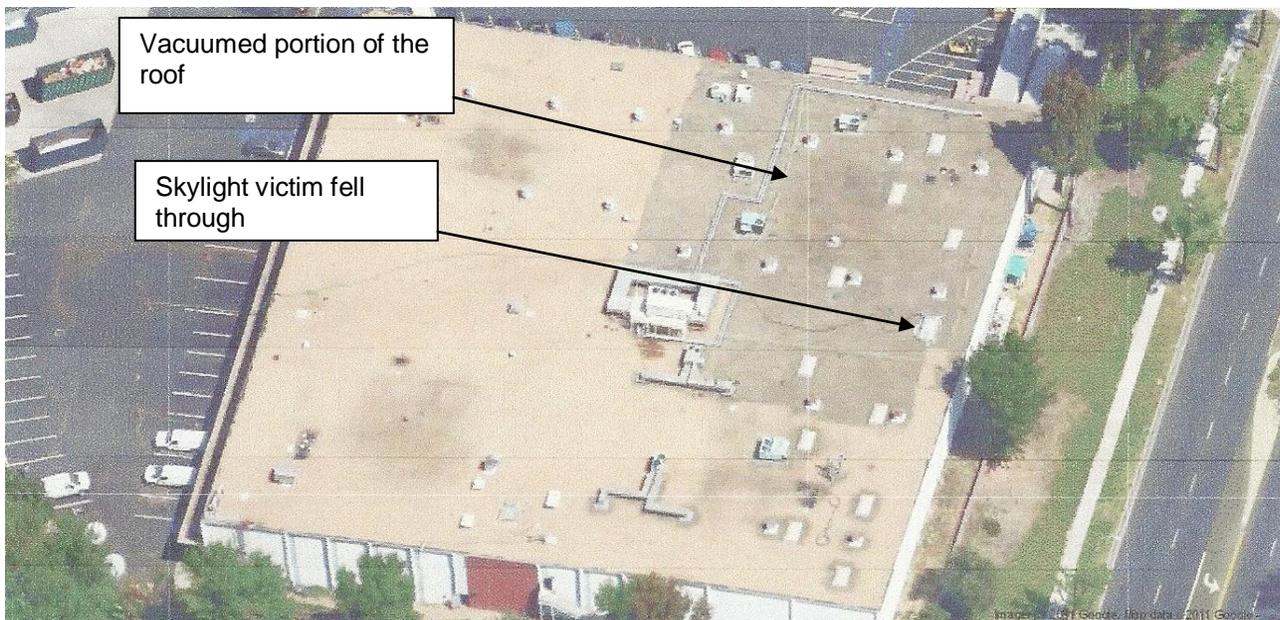
The location of the incident was a large industrial flat roof of a warehouse that measured approximately 150 feet long and 150 feet wide (**Exhibit 1**). The roof housed many air conditioning units, skylights, vents, and other plumbing and electrical fixtures.

Exhibit 1. The warehouse rooftop where the incident occurred showing the vacuumed portion of the roof.

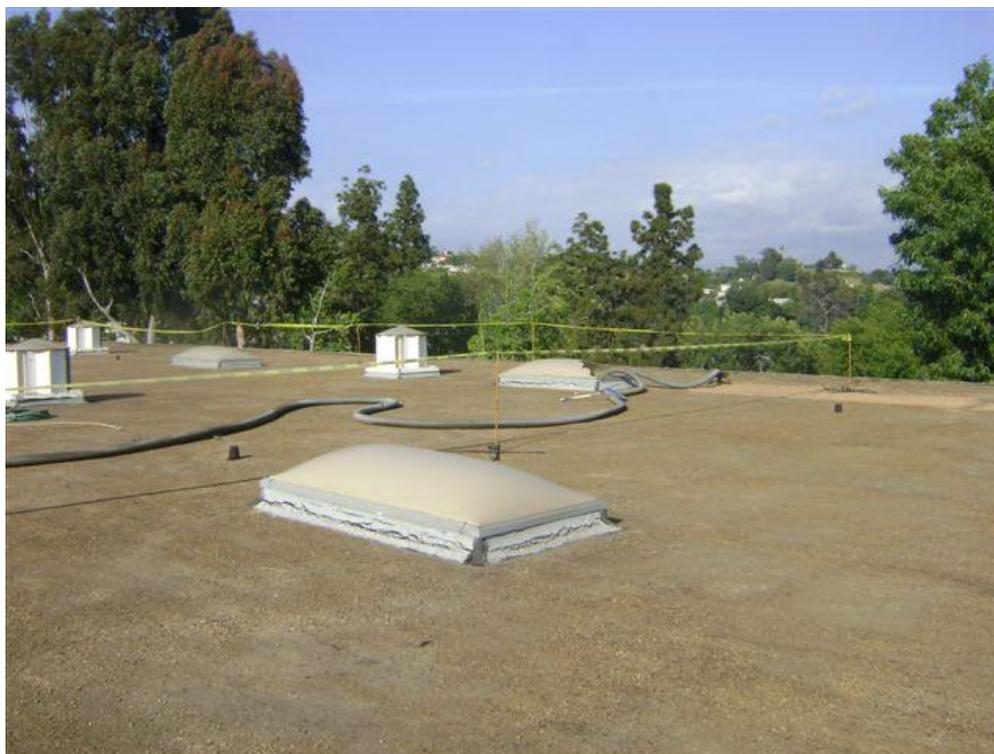
Exhibit 2. The work area on the roof.

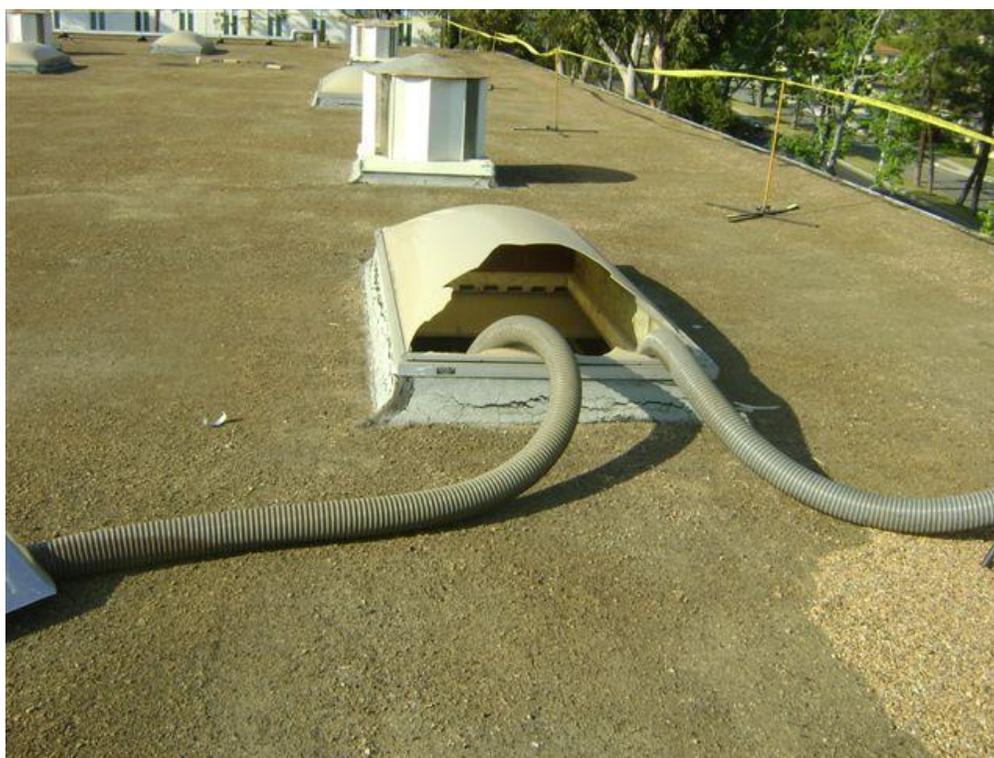
- The victim was working within six feet of an unguarded skylight.

Exhibit 3. The skylight the victim fell through.

Recommendation #1: Fall protection measures such as skylight screens or covers, guardrails, or a personal fall protection system are used for employees working within 6 feet of a skylight.

- Skylight screens or covers capable of withstanding the impact of a worker plus the weight of his/her equipment.
- Guardrails around the skylight with a top and midrail and a vertical height within the range of 42 inches to 45 inches from the upper surface of the top rail to the floor. The rails should be able to withstand a live load of 20 pounds per linear foot applied either horizontally or vertically downward at the top rail.
- A personal fall protection system consisting of a body harness, lanyard, connectors, and anchor points.

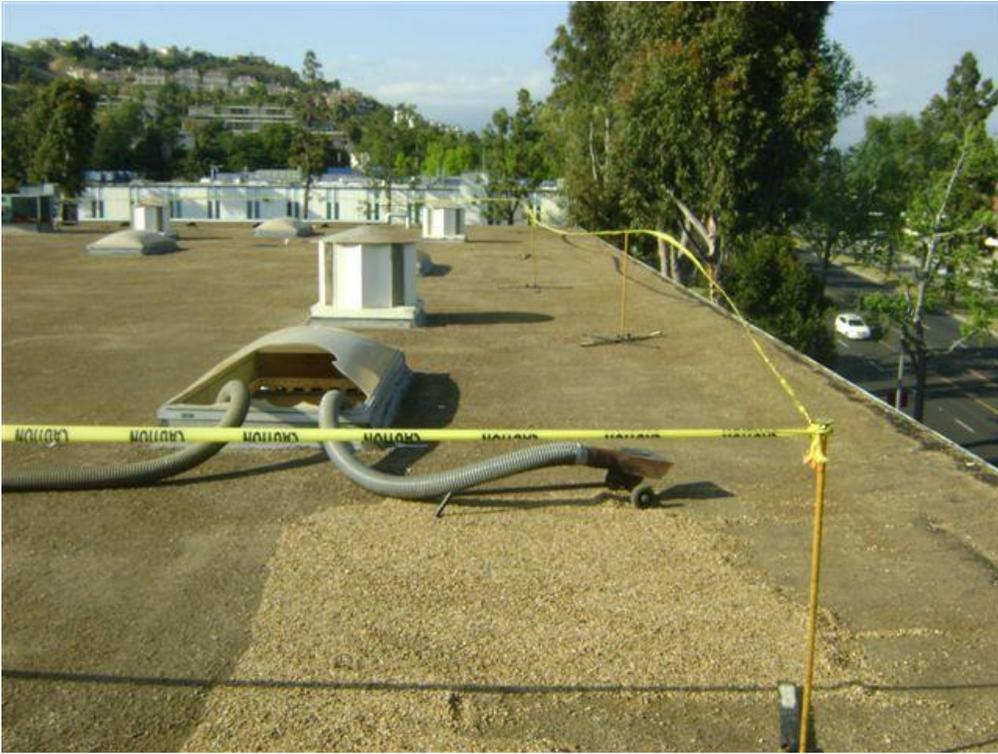
Exhibit 4. The incident scene.

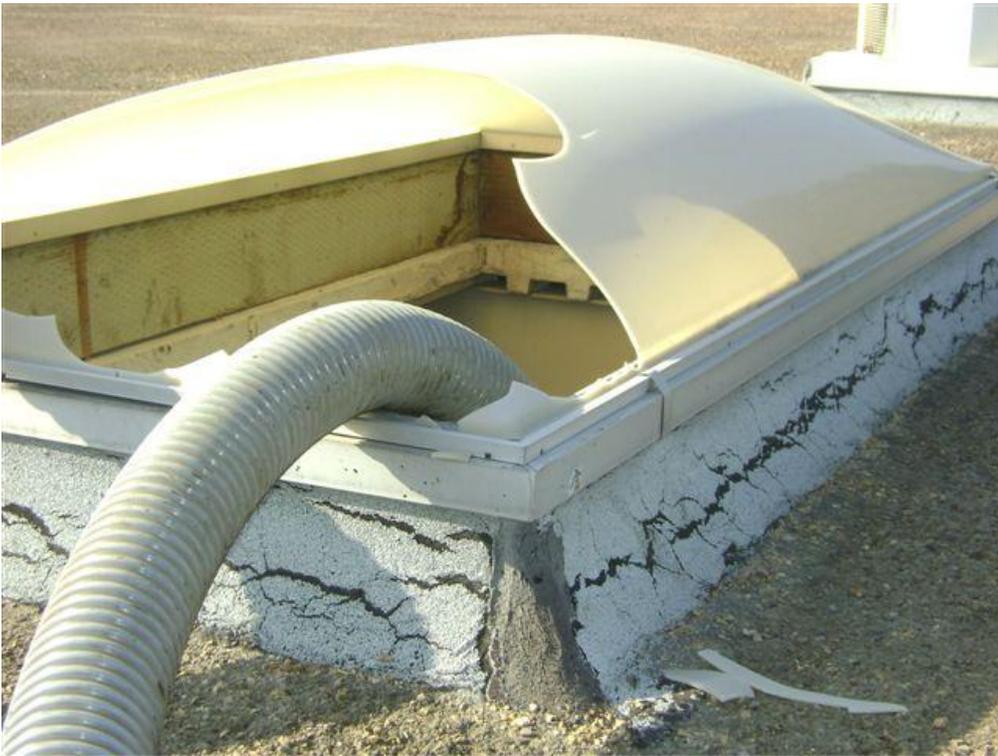
Exhibit 5. The base of the skylight.

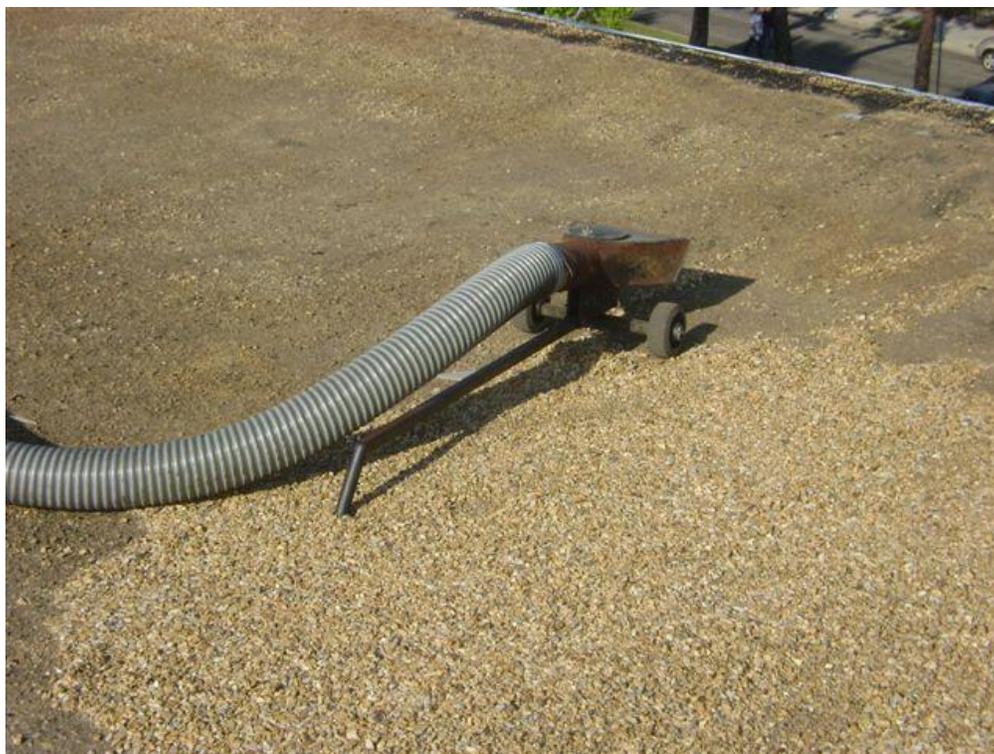
Exhibit 6. The vacuum nozzle.
