SUBJECT: A Paint Maker Dies from Exposure to Dichloromethane (Methylene Chloride) while Cleaning a Paint Tank

SUMMARY
California FACE Report #11CA009

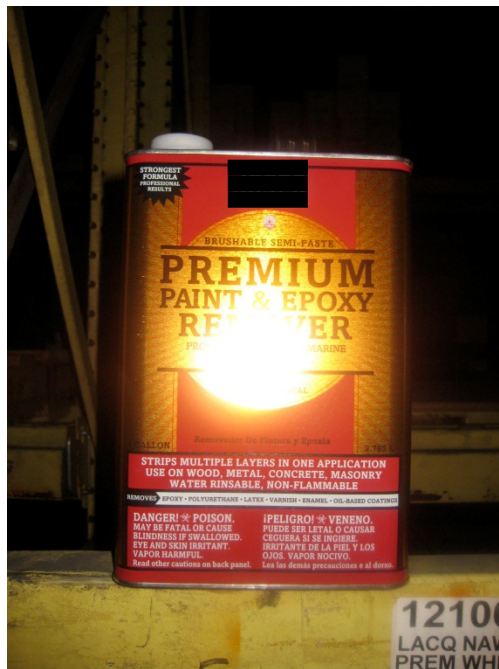
Exhibit 1. A container of the premium paint epoxy remover that was used in this incident.

The product involved in this incident was a semi-paste paint remover purchased by the company in one gallon containers (Exhibit 1). The intended use of this product included the removal of paint, adhesives, mastics, and contact cement from wood, concrete, metal, and masonry surfaces. The product contained a mixture of ingredients including methylene chloride, methanol, and Stoddard solvent. The Material Safety Data Sheet (MSDS) for this product listed the following ingredients and their concentration:

<u>Ingredient</u>	<u>Concentration</u>
Methylene Chloride	60 - 100%
Methanol	10 - 30%
Stoddard Solvent	1 – 5%

The MSDS stated that this product could be fatal and should be used only with adequate ventilation to prevent the buildup of vapors.

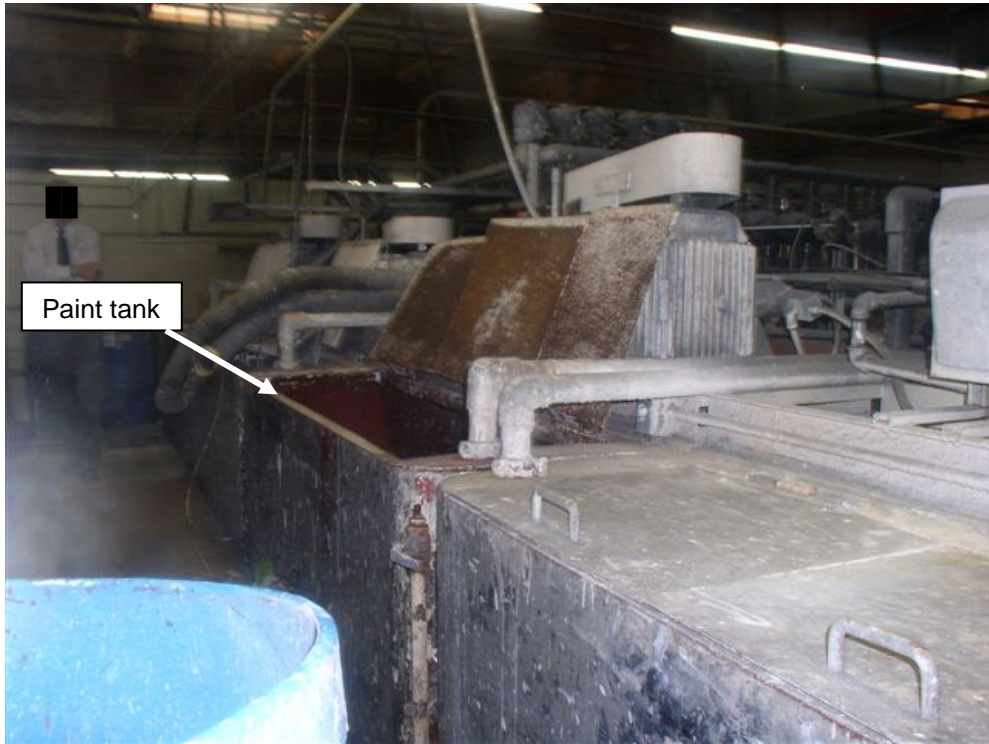
Exhibit 2. The paint tank the victim was cleaning.

platforms for employees to gain access to the top of the tanks. The tank involved in this incident measured seven feet wide by seven feet long and nine feet deep. The opening lid at the top of the tank measured two feet wide by seven feet long.

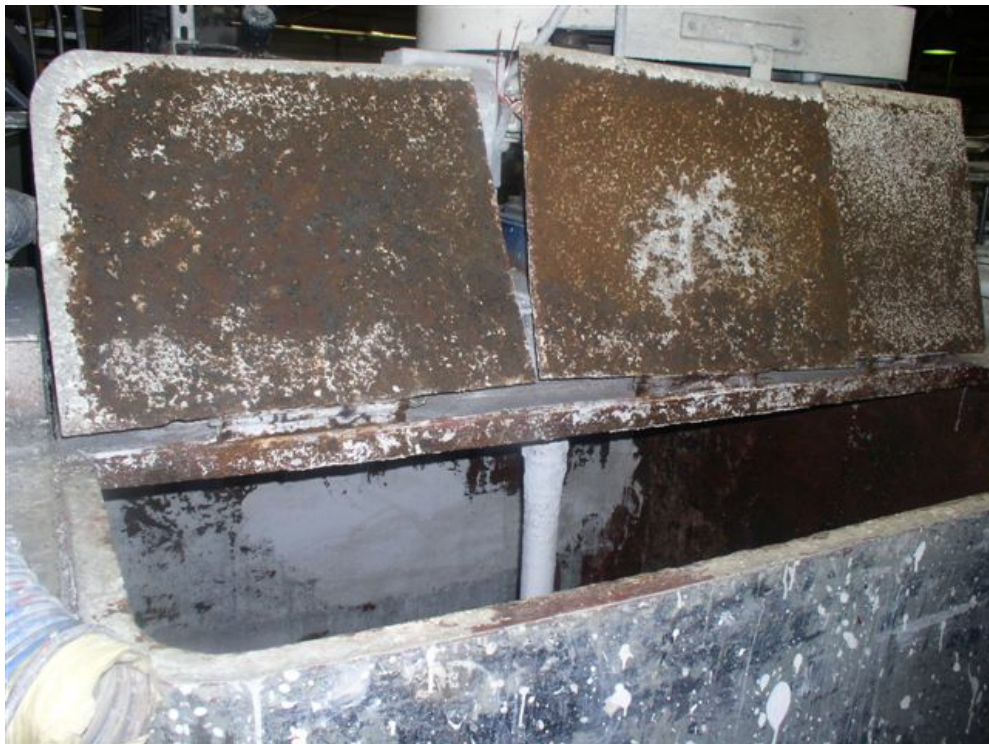
Exhibit 3 - The paint tank opening.

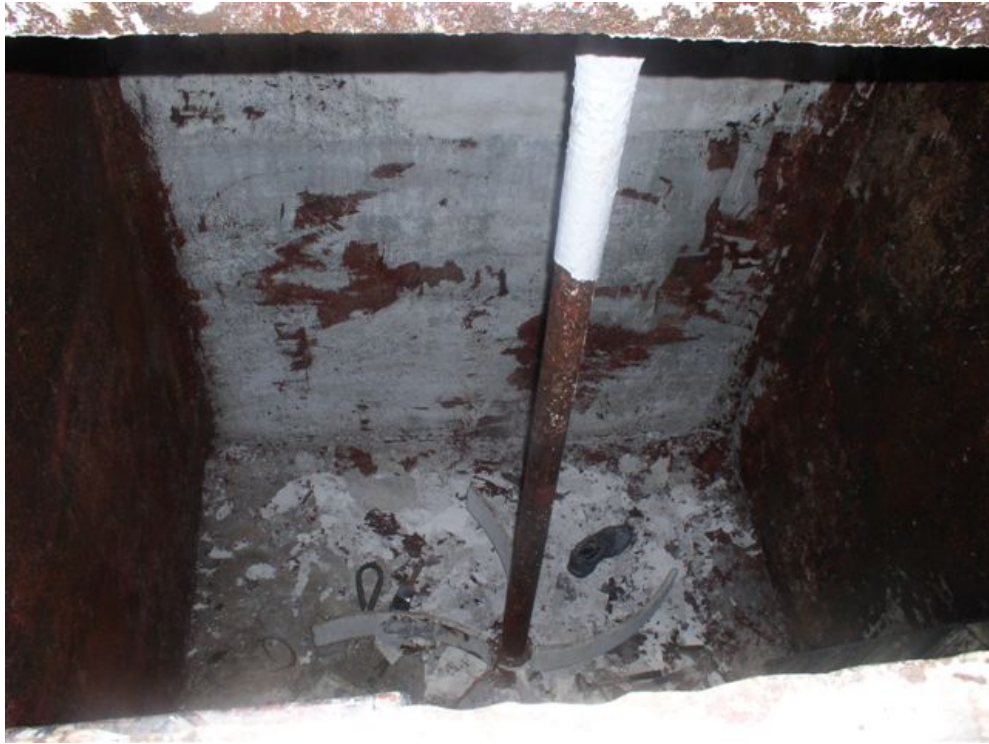
Exhibit 4 - The interior of the paint tank.

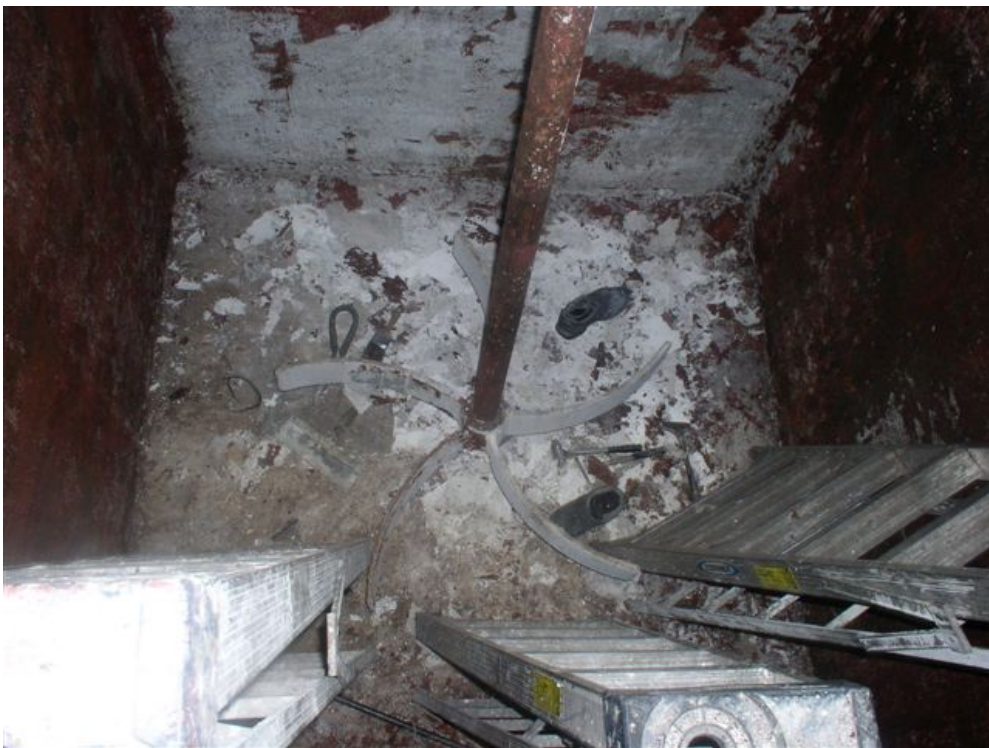
Exhibit 5 – The ladders used to enter the tank.

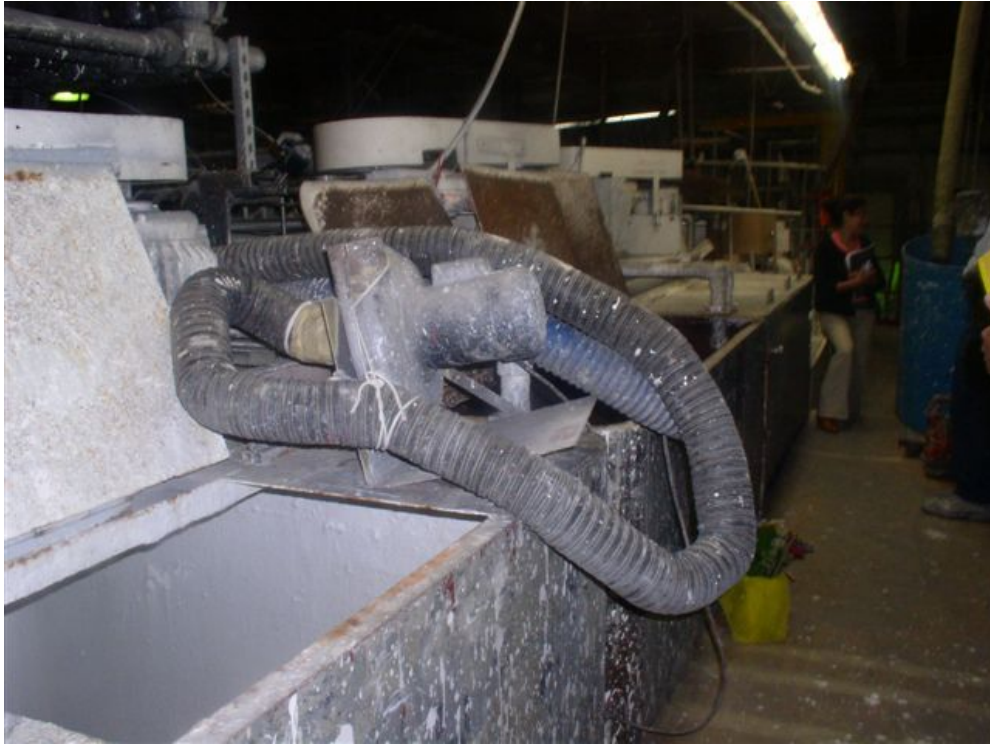
Exhibit 6 - The air pump and hoses that were used to remove contaminated air from the tank.

The end of a six-inch diameter flexible hose was placed four feet down into the tank to provide ventilation. The hose was connected to an air pump of unknown make and capacity in order to draw air from the tank and expel it into the general work area. There was no air testing or monitoring of the tank's atmosphere. The workers wore

half-mask respirators which were not adequate for use with methylene chloride (supplied-air required at a minimum).
