SUBJECT: A Day Laborer Dies when He is Pinned Between a Loading Dock and a Backing Truck

SUMMARY
California FACE Report #12CA009

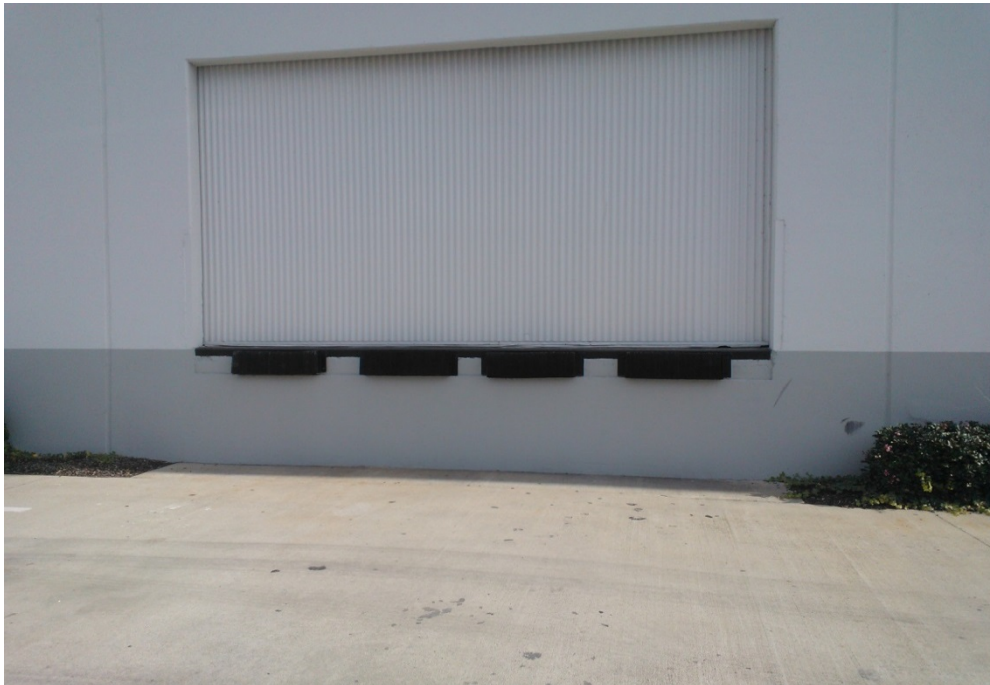
Exhibit 1. A truck loading dock identical to the one involved in the incident. Trucks back up to the dock in order to load and unload product.

- Install concave mirrors on the dock for drivers of backing trucks to see objects or individuals within their blind spots.
- Install other engineering controls on loading docks such as motion detectors, strobe lights, or gates which restrict access.
- Assign an employee as a spotter in clear view of the driver to direct the backing truck and to alert the driver whenever an obstruction occurs within the blind spot.
- Prohibit all foot traffic in the work area.
- Retrofit all trucks with cameras for the drivers to see their blind spots when backing.

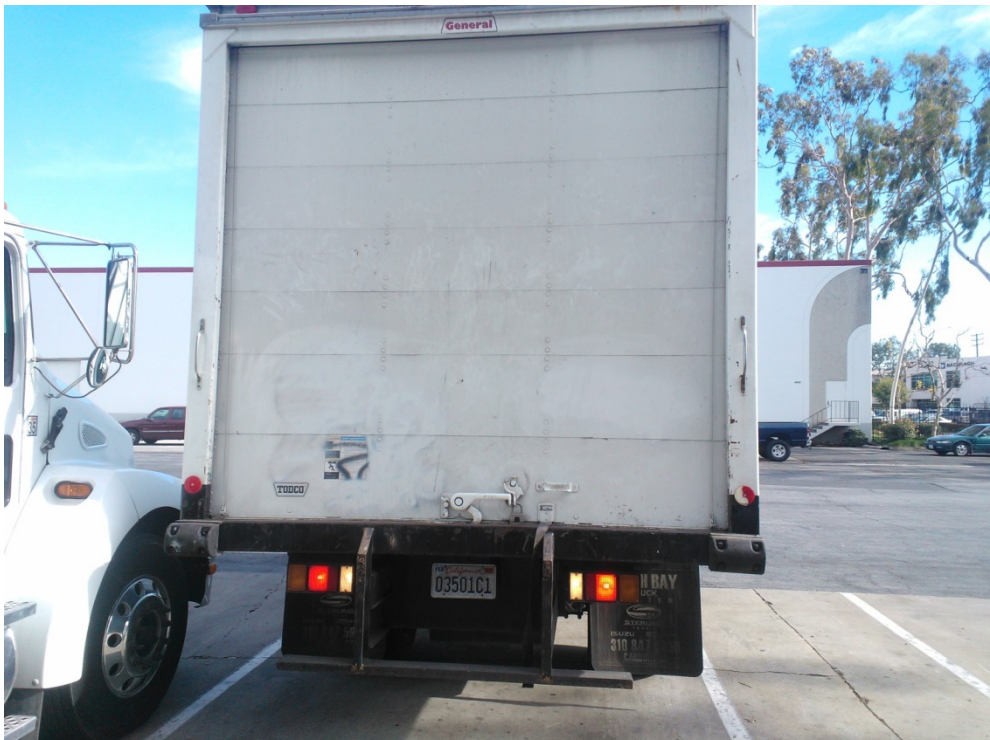
Discussion: In this incident, the victim was in the blind spot of the backing truck. The truck had the proper mirrors as well as a functioning back-up alarm; however there was still a blind spot directly behind the truck where the driver could not see. This was the area the victim placed himself as the truck was backing. The supervisor was observing the operation but didn't stop the truck driver when the victim jumped off the dock and entered the backing zone. In order to prevent these types of incidents from recurring, employers should consider the following options:

Exhibit 2. The rear of a truck similar to the one involved in this incident.
