**SUBJECT:** A Machine Operator in a Food Processing Plant Dies When Trapped

Inside a Steam Pressure Cooker

# SUMMARY California FACE Report #12CA012

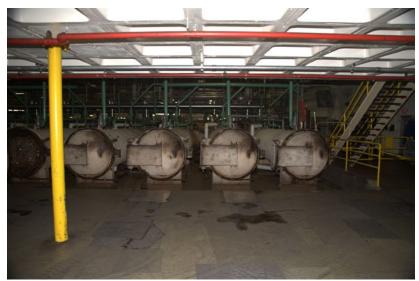
EXHIBIT 1. The pressure cooking and sterilization section of the processing plant.

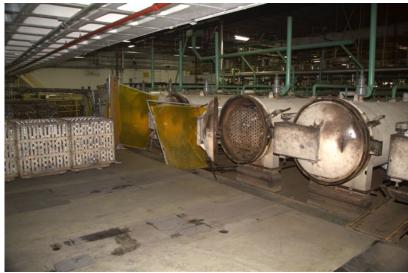
The machine operator's responsibilities are to load and unload retorts with crates of canned tuna. A retort is a large cylindrical steam pressure cooker used to sterilize and cook tuna in aluminum cans. The cans of uncooked tuna are loosely packed inside perforated carts on wheels.

Exhibit 2. The large cylindrical steam pressure cooker called a retort.

Discussion: The employer had written procedures for confined spaces and permit-required confined spaces for other vessels in the plant. However, the retorts were not identified as confined spaces and there were no written policies or procedures for loading the retorts. The company's safety supervisor was responsible for reviewing their safety program annually to ensure its ongoing adequacy, effectiveness and accuracy as well as to identify any opportunities for improvement. This included review of all safety policies, programs, procedures and training records and other available written safety materials. The company safety supervisor never identified the retorts as confined spaces. As a consequence, the employees working with the retorts never received confined space or permit-required confined space training. Had the employer conducted and documented periodic safety audits and inspections that identified all hazardous work areas for employees, the retorts would have been classified as a permit-required confined space. If the retorts had been identified as a permit-required confined space, there would have likely been the proper procedures, controls and training to safely load the pallets.

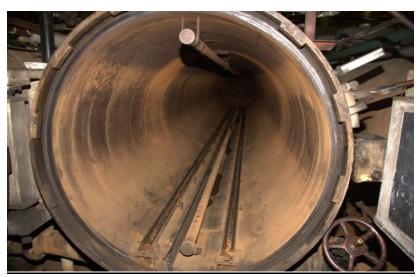
Exhibit 5. The inside of the retort
