**FATALITY ASSESSMENT AND CONTROL EVALUATION  
PROGRAM (CA/FACE)**

**Laborer Dies of Carbon Monoxide Poisoning  
When He Operates a Gasoline-Powered Concrete Saw Indoors  
Case Report: 17CA001**

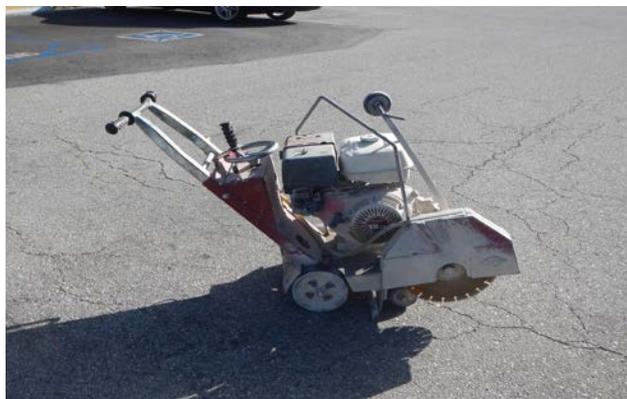
The plumber reported that he had about seven years of experience using concrete saws and had always used gasoline-powered saws for indoor work. Eighteen months prior to the job, he purchased the used 13 HP gasoline-powered, walk-behind concrete saw that was involved in the incident (Exhibit 1). The plumber stated that he had been concerned about the exhaust fumes from the concrete saw. Sometimes the plumber experienced headaches when using the saw indoors. He reported always using a large fan to ventilate the space, and he owned a large pedestal fan for that purpose (approximately 3 ft. diameter).

Exhibit 1: The gasoline-powered concrete saw used by the victim.

**Recommendation #1: Only electric-powered concrete saws should be used in enclosed spaces. If a generator powers the electric saw, the generator must be placed outdoors, well away from the enclosed space.**

Therefore, electric concrete saws should only be used for all work in enclosed spaces. Some amount of prior planning is sufficient to overcome the barriers to their use. Electric saws are currently available for all applications, and are as powerful as fuel-powered saws. If adequate electrical power is not readily available onsite, an electrician can be brought in to wire a temporary circuit. If no electrical power is available, a generator can be brought in to power the tool. This generator should be located outdoors and at a sufficient distance so as to not contaminate the enclosed work area. If the victim had used an electric concrete saw, there would not have been the accumulation of carbon monoxide inside the enclosed space, thereby preventing his death.

**Recommendation #3: Concrete saw manufacturers should label fuel-powered concrete saws with a clear warning. For example: *WARNING -- DO NOT USE INDOORS OR IN ENCLOSED SPACES -- CARBON MONOXIDE PRODUCED DURING USE CAN KILL.* Equipment rental companies should also attach such warning labels to all fuel-powered concrete saws.**

Discussion: There was no label on this fuel-powered concrete saw warning of the hazards of fatal carbon monoxide exposure if operated in enclosed spaces. In the absence of such a label, the plumber and the victim were not alerted to the dangers of operating the saw. If warning labels were placed in a clearly visible location on the saw (both in English and Spanish), they may have avoided running the concrete saw in the enclosed space, thereby preventing this death.

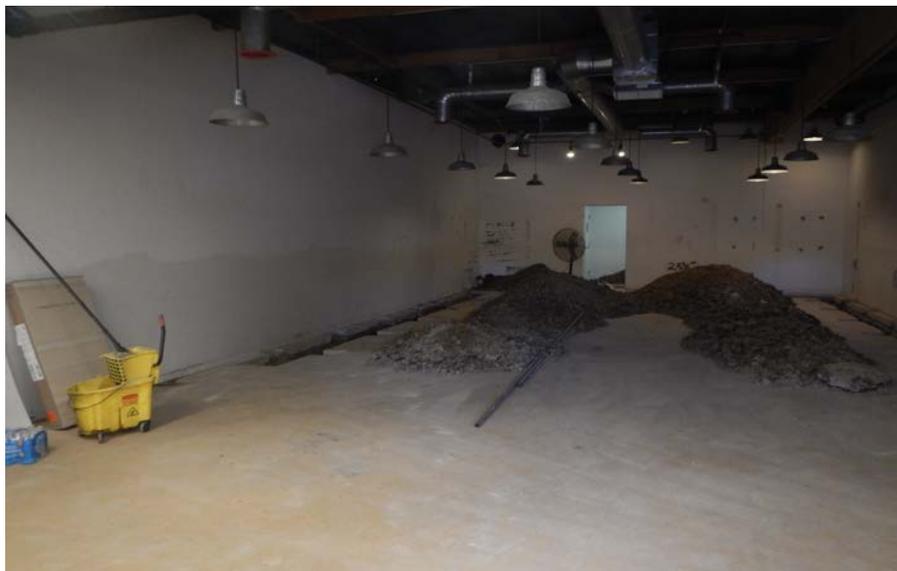
At 4:15 pm an employee of the general contractor arrived at the worksite to pick up the victim. He opened the door and found the victim lying face up in the rear left corner of the store (Exhibit 2). He was wearing his respirator and had fallen backwards while operating the vacuum. The vacuum was running, but the concrete saw had been turned off. The employee called 911.

Exhibit 2: The rear left corner of the store space where the victim died.  
Note: The trenches were dug after the fatality.

The fire department paramedics pronounced the victim dead at 5 pm. The coroner's office later reported that the victim's carboxyhemoglobin level was 69% -- a very elevated level which confirmed carbon monoxide poisoning as the cause of death.
