**REPORT#:** 23CA006

**REPORT DATE:** April 22, 2025

## A Warehouse Worker Dies after Falling from an Order Picker Forklift — California

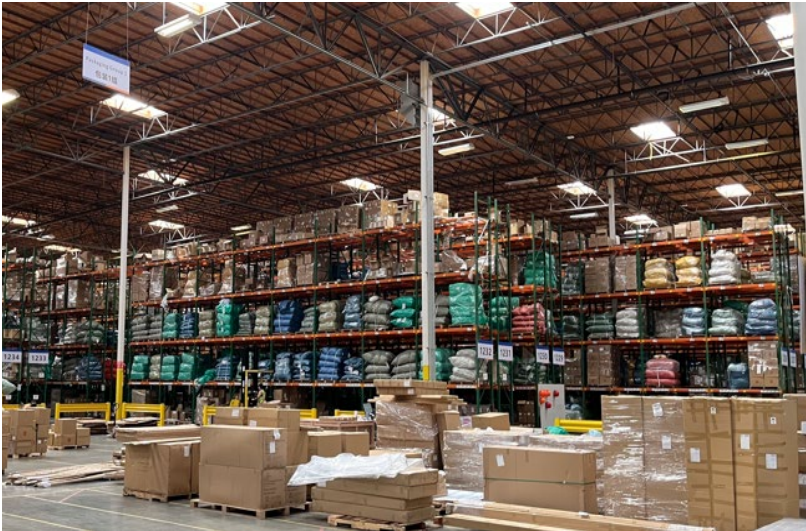
The warehouse was approximately 200,00 square feet with 85 aisles and six packing and shipping areas. The company stored, packed, and shipped a variety of items from small toys to large pieces of furniture. Each aisle had up to five levels of shelving racks as seen in Exhibit 1. According to the employer, heavy items were typically stored on lower racks. If there happened to be a heavy item on an upper rack, employees would lower the entire pallet down using a forklift and implement a buddy system to move the item as needed.

**Exhibit 1: Warehouse with storage racks.**

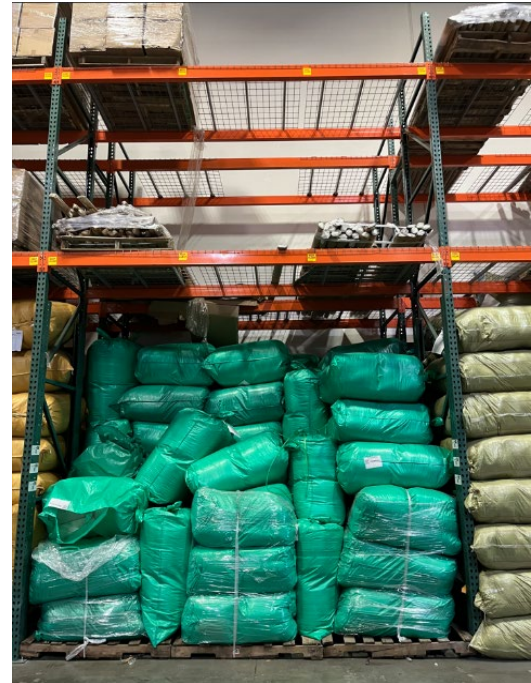
**Exhibit 2: Closeup of the storage racks.**

At the time of the incident, the victim was operating an order picker forklift to get an item from a shelving rack three levels up, approximately 20 feet high (Exhibit 2). Co-workers reported that their usual practice was to stand on the platform of the order picker to retrieve an individual item.

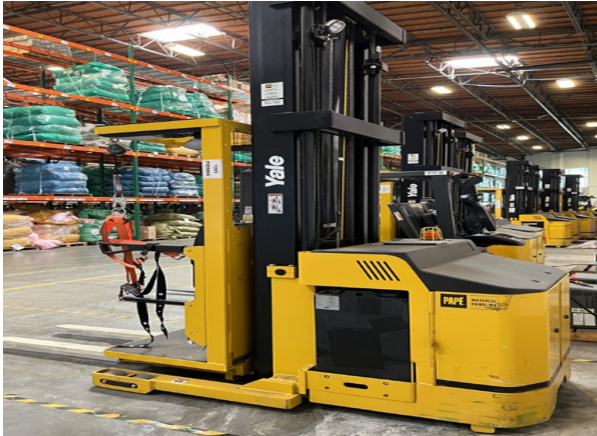
The warehouse had different forklifts that were operated from a sitting or standing position. Employees used a specific forklift according to the item that was to be placed or retrieved from the racks. On the day of the incident, the victim was operating a Yale electric high lift stand-up order picker forklift (model unknown) (Exhibit 3). The order picker forklift was equipped with a multifunction control handle, a telematics system to complete pre-shift inspections, a red operator sensing button located on the platform to energize the system, and lateral arms. There was a full body harness and a self-retracting line attached to the forklift anchor point.

**Exhibit 3:** The order picker forklift involved in the incident. The arrow indicates where the self-retracting lanyard connected to the body harness was hooked to the forklift. Photo courtesy of CA/FACE program.

Discussion: In this incident, the victim raised the platform of the order picker forklift so he could reach or check an item on the third level storage rack. Since he was working at a height above 4 feet, the operator should have worn a body harness and a self-retracting line which was tied-off to the harness and the forklift. The lanyard length for a personal fall arrest system should be such that the operator has freedom of movement in the working area and should be rigged such that an employee can neither free fall more than 4 feet nor contact any lower level.

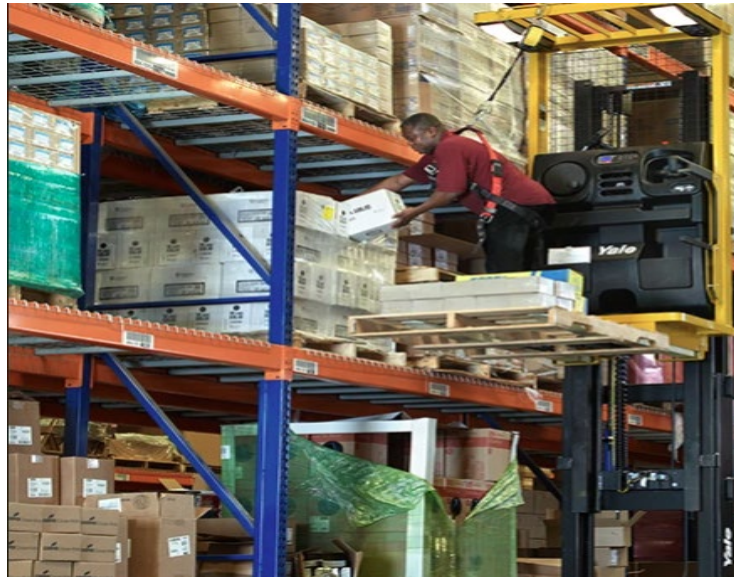
**Exhibit 4: Worker retrieving item off shelf using a order picker forklift. Photo courtesy of Yale.**

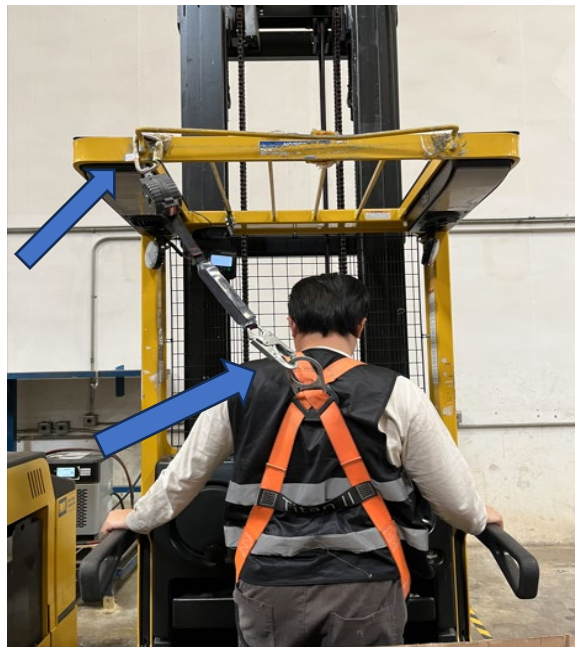
**Exhibit 5: The arrows indicate an adequate tie off when operating the order picker. Photo courtesy of CA/FACE program.**

At least one partially Integrated system is now available that prohibits the forklift from being raised if the operator's lanyard is not connected. These systems activate audible and visual alarms if the operator unhooks either end of the lanyard when the lift is raised. This type of warning system used in conjunction with a strictly enforced mandatory tie-off/no unhook policy may have prevented the victim from using the order picker forklift without fall protection.
