RADIOLOGIC HEALTH BRANCH

California Department of Public Health

HUNTERS POINT SHIPYARD, PARCEL A-2 HEALTH AND SAFETY SURVEY

April 24, 2019

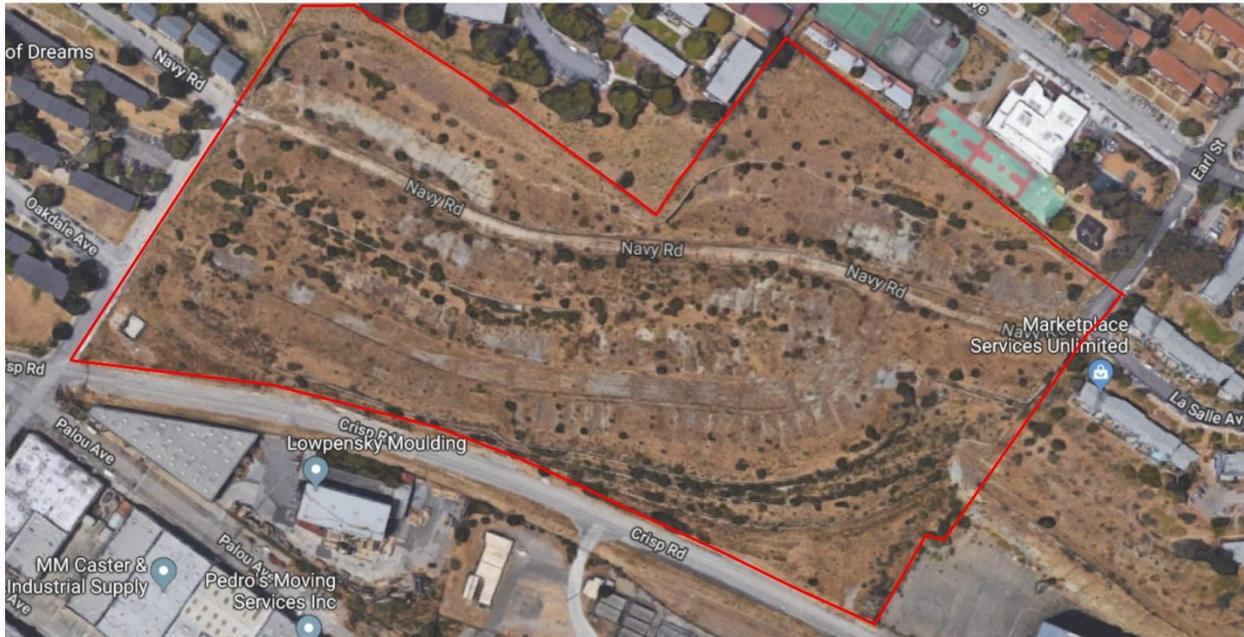
Figure 2 Aerial View of Parcel A-2

The area labeled Parcel A-2 in Figure 1 is currently open land without buildings, paved roads or sidewalks. The topography of Parcel A-2 includes extremely steep slopes, retaining walls, and natural barriers. Accessibility of these steep slopes is dependent on staff safety considerations. The red line on Figure 2² shows the approximate border of Parcel A-2.

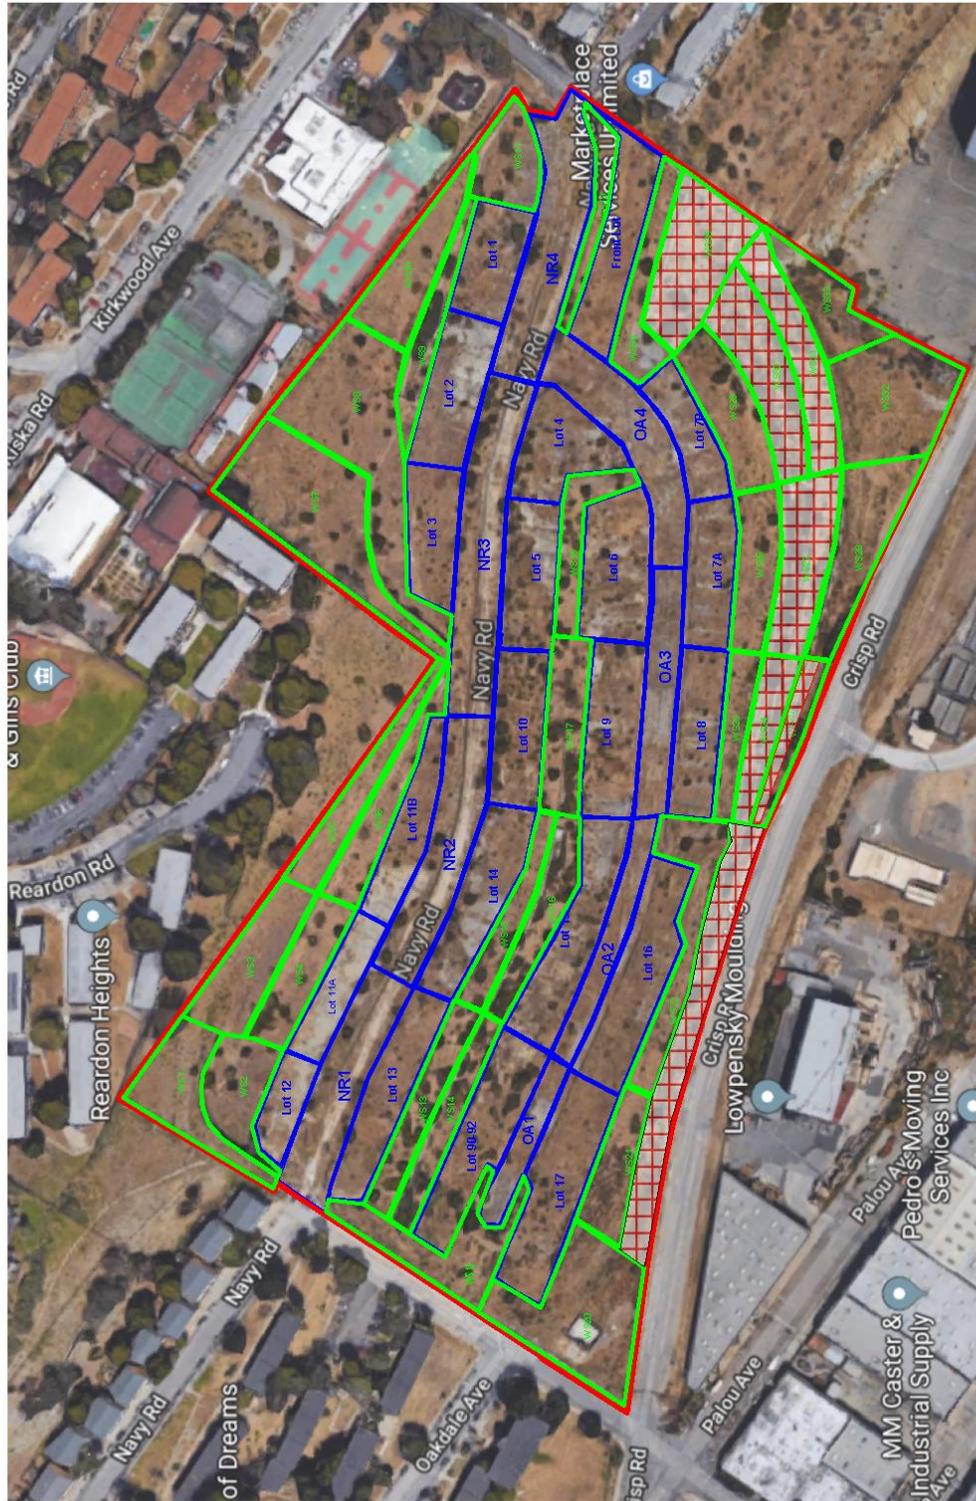
Map 1: Master (All) Survey Units Map

**Hunter's Point Parcel A-2
Master Survey Units Map**

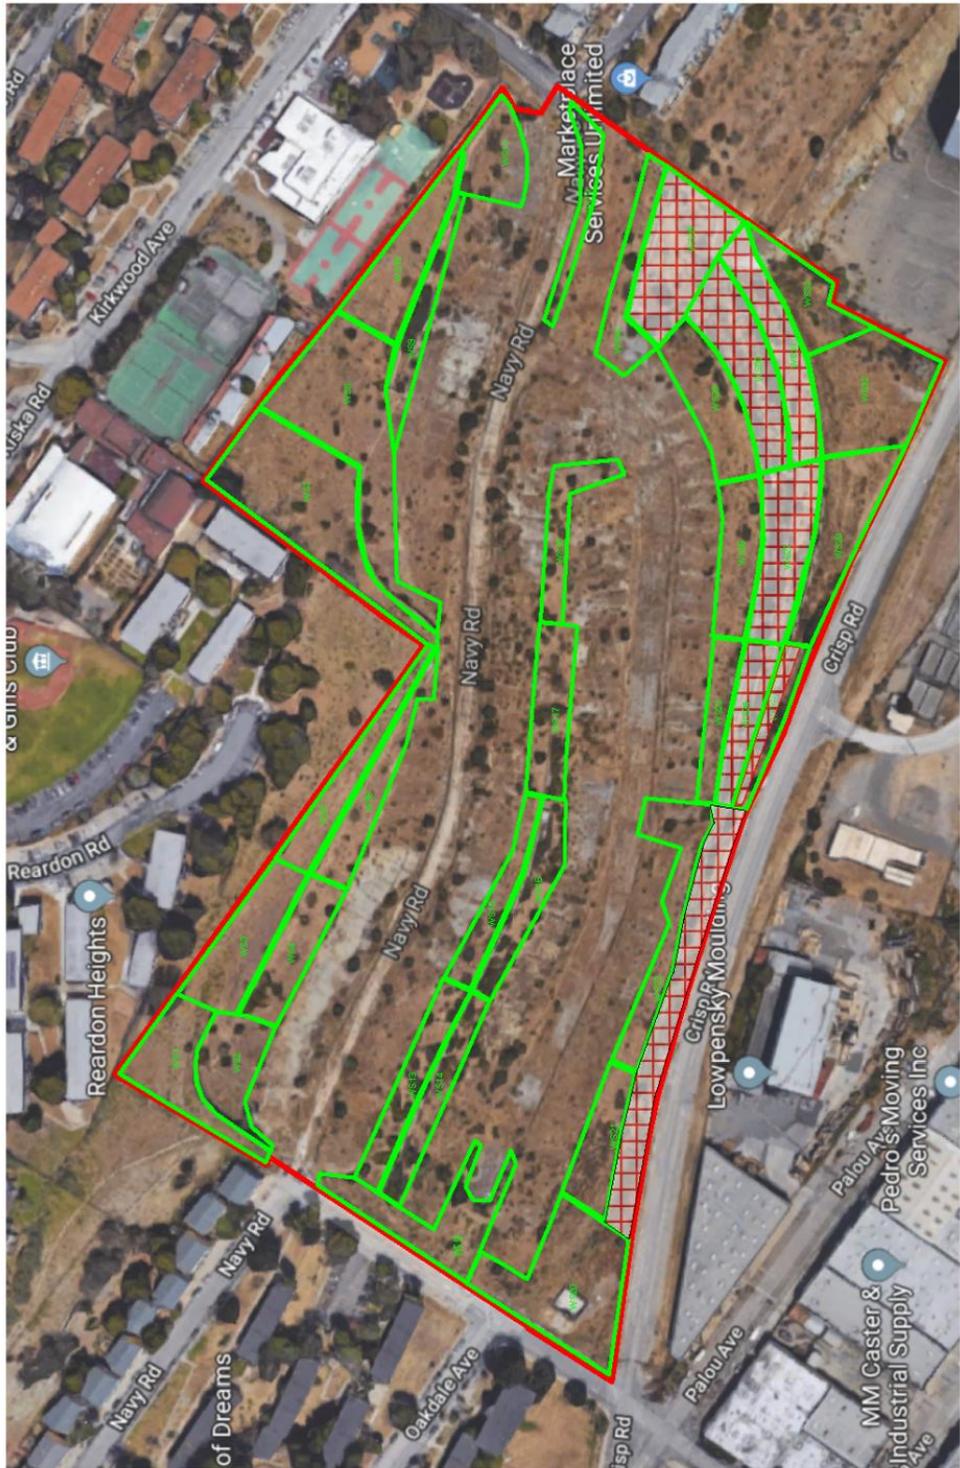
Map 2: Gamma Walkover Survey Units Map

- Technical Basis Document, RS-701 Radiation Mapping System
- Survey Units
 - Gamma Walkover Survey Units
 - Survey units for Gamma Walkover Survey were drawn and outlined in green color on the map. No RS-700 scanning was possible on these areas due to the topography and natural barriers on the parcel. These areas were only accessible by foot. Accessibility to some areas of these units was limited due to retaining walls and steep slopes. Five of these units were inaccessible to survey.

**Hunter's Point Parcel A-2
Gamma Walkover Survey Units Map**

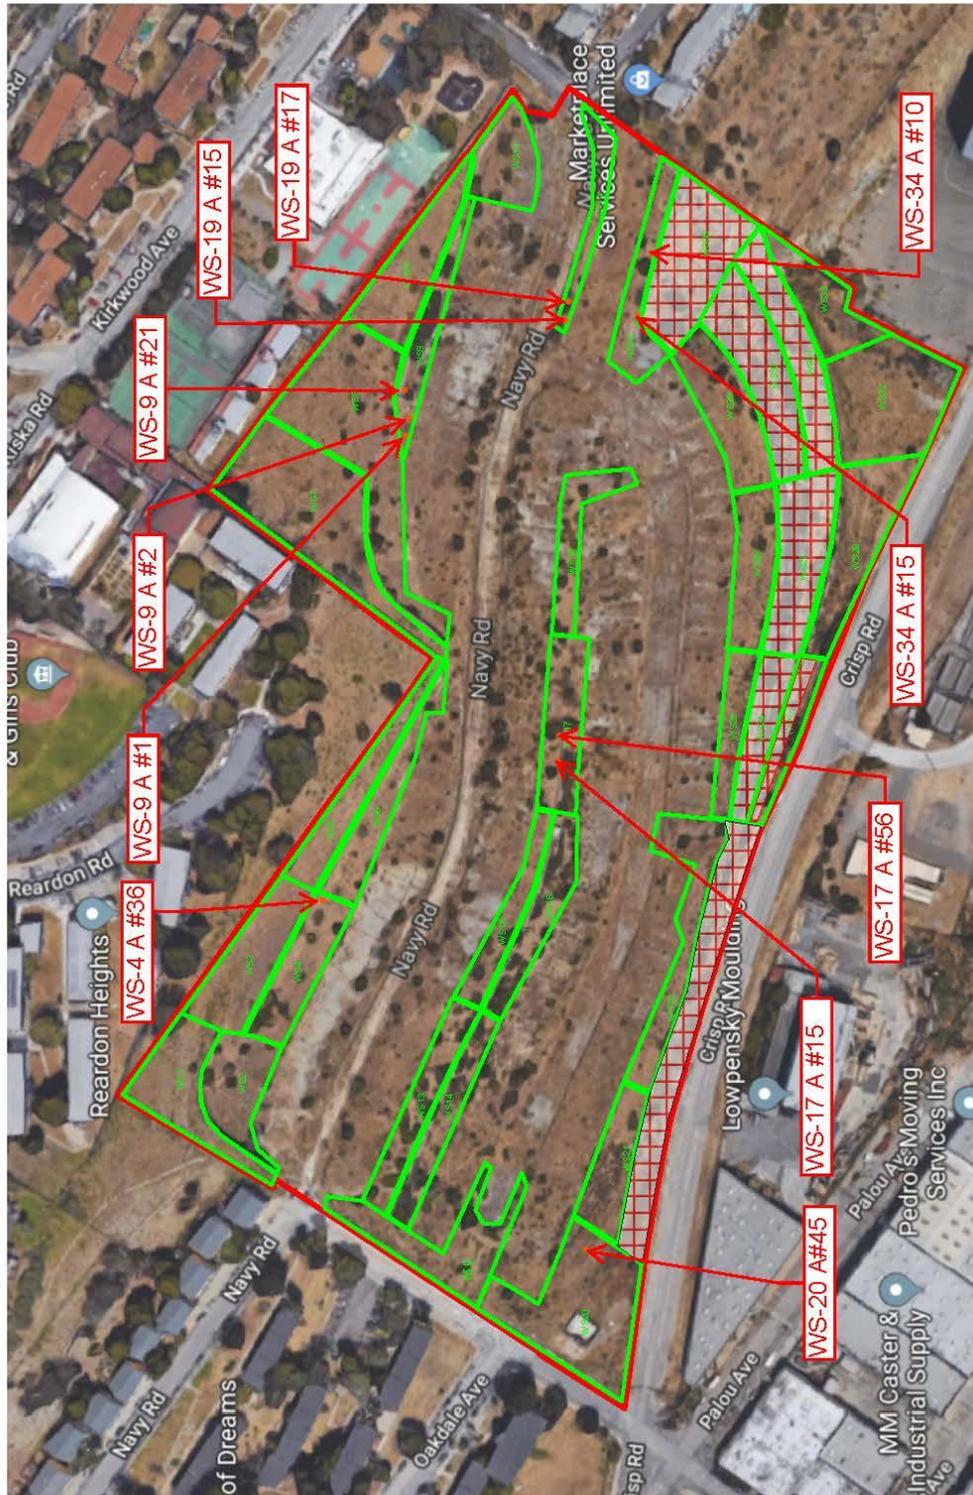
Map 3: Walkover Survey – Inspector 1000 Spectroscopy Locations

A total of eleven anomalies were found (9 previously reported and 2 anomalies found during data quality check) and were further investigated by an Inspector 1000 to analyze the spectrum and identify the radionuclides. All anomalies were determined to be potassium-40, which is a naturally occurring radiological material (NORM). No radionuclide of concern was identified in these follow-up investigations.

Inspector 1K Shot Locations

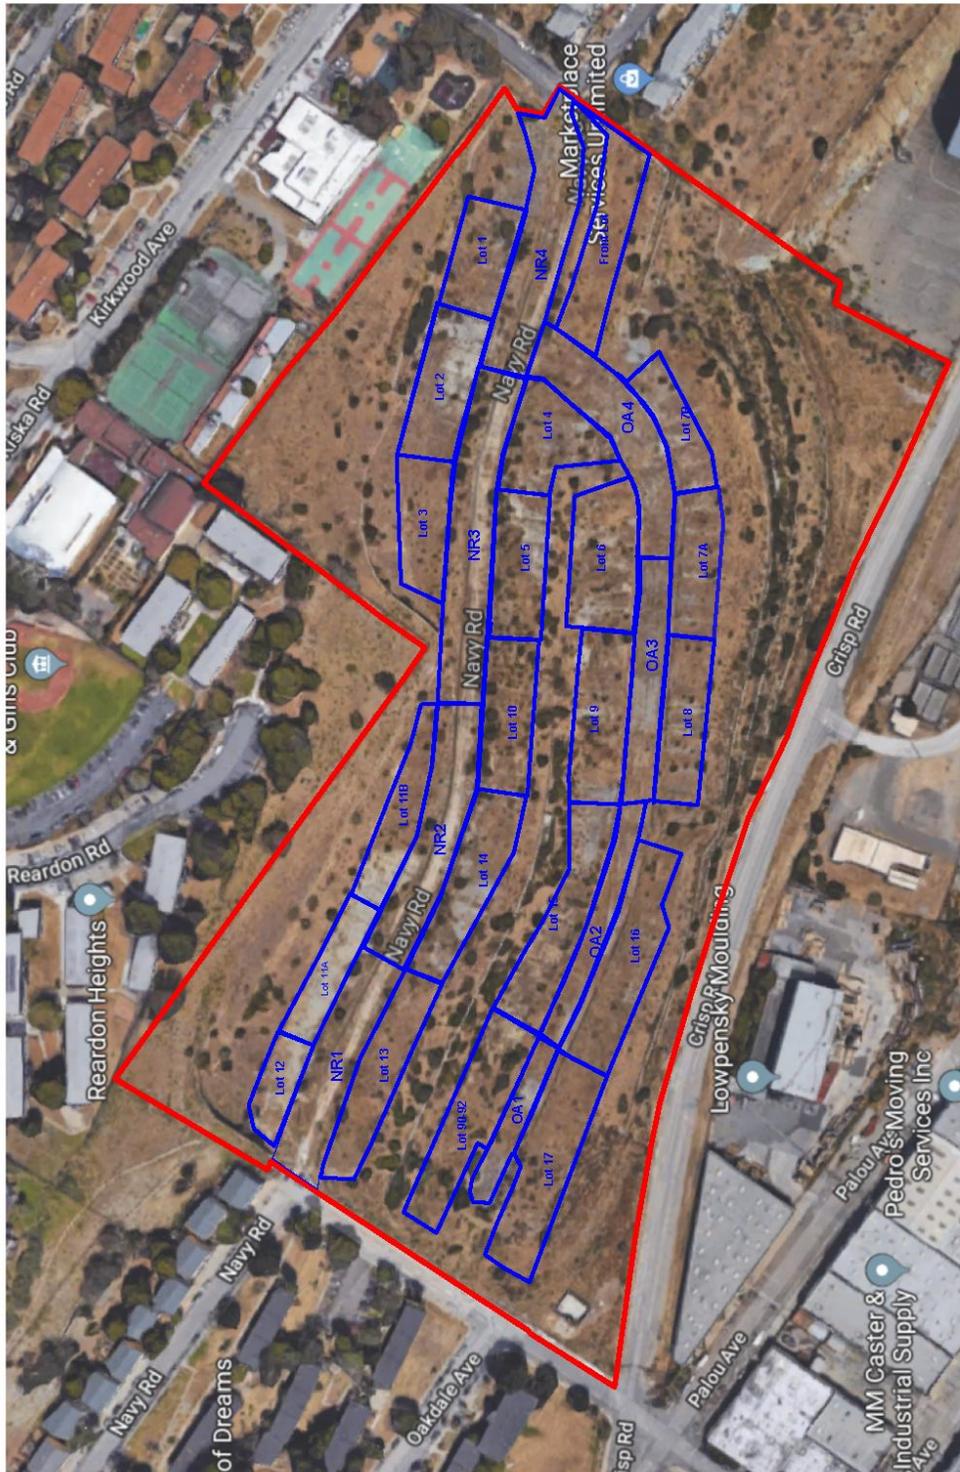
Map 4: Towed Array Survey Units Map

- RS-700 Survey Units
 - RS-700 Survey Units were drawn considering the drivability of the RS-700 survey equipment. These units were outlined in blue color on the map. Safety was a consideration for driving on uneven ground conditions.

**Hunter's Point Parcel A-2
RS 700 Survey Units Map**
