**SUBJECT:** A security guard is killed when he was run over by a heavy-duty industrial forklift while directing traffic in a cargo container storage yard.

**SUMMARY**  
**California FACE Report #02CA007**

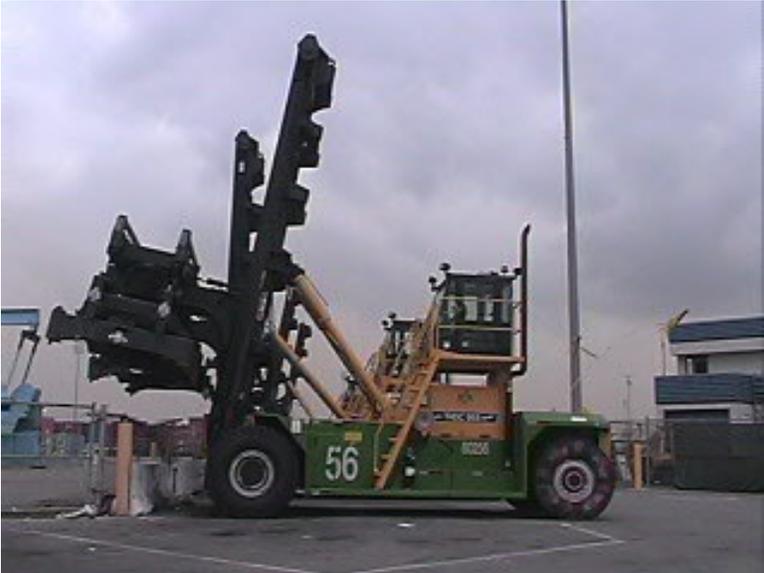
Exhibit #1

A side view of a forklift “top handler” similar to the one involved in the incident.

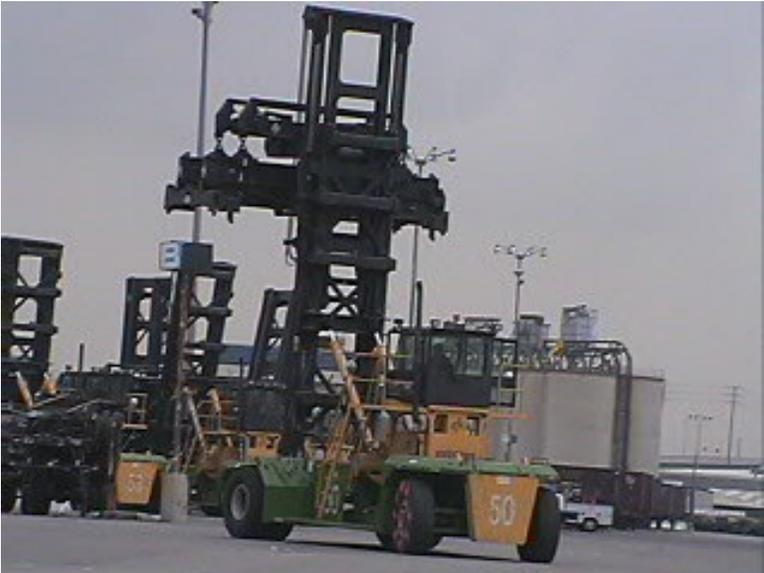
Exhibit #2

A rear view of a forklift “top handler” similar to the one involved in the incident.

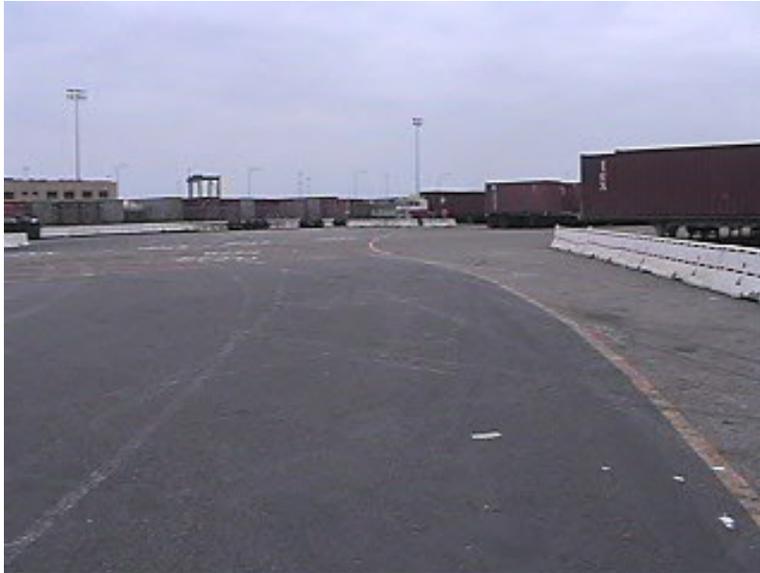
02CA007  
Exhibit #3

A picture of the incident scene looking west. The forklift came from the area to the right of the picture.

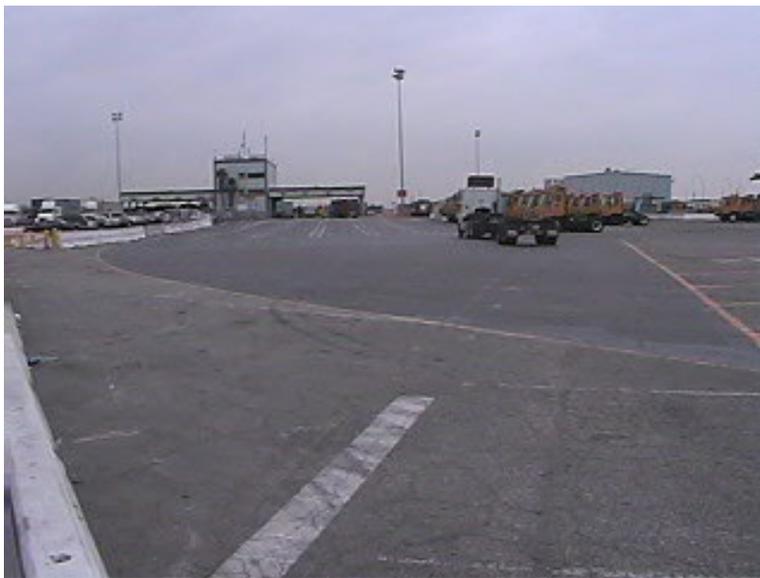
02CA007  
Exhibit #4

A picture of the incident scene looking east. The forklift parking area is on the right of the picture. The employee parking lot is on the left of the picture. The top handler was headed to the area on the left of the picture.
