SUBJECT: A Machine Operator Dies When Crushed Inside a Knitting Machine.

SUMMARY
California FACE Report #04CA001

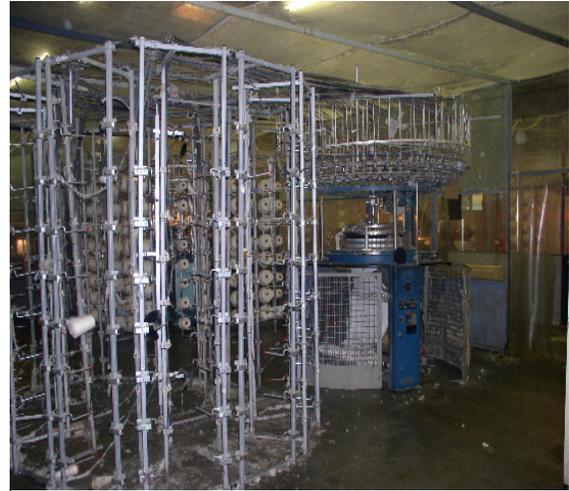
The site of the incident was a large commercial building used to manufacture fabric. The machine involved in the incident was a fully automated circular knitting machine manufactured in Italy (**Exhibit 1**). The machine consisted of a fixed frame base with three support columns. Inside the machine base was a rotating turntable with two upright arms that supported a roller which collected the finished fabric. The turntable rotated at approximately 24 revolutions per minute. On top of the base was the knitting machine with thread guides. A large rack of threaded spools was located next to the machine. In between the three support columns were safety gates which protected employees from contact with the rotating turntable (**Exhibit 2**). Each gate was equipped with a safety interlock switch that shut the machine down when the gate was opened. The controls for the machine consisted of three colored buttons marked green, red, and yellow. The green button turned the machine on, the red button shut it off, and the yellow button jogged the rotating turntable (**Exhibit 3**).

Exhibit 1:
The knitting machine involved in the incident.

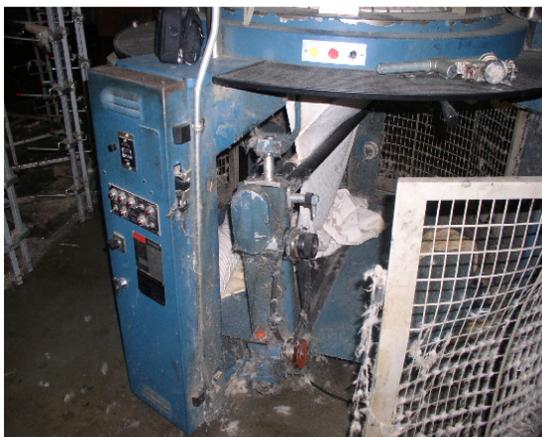
Exhibit 2:
Support columns and safety gate.

Discussion: Every time the rotating turntable passed by a support column of the knitting machine, it created a pinch point. The purpose of the safety gates between the columns was to protect employees from contact with the pinch points. Each gate was equipped with a safety interlock that would shut the machine down when opened. If the machine needed to be operated, then the safety gate should have been reinstalled.

Recommendation #1: Ensure employees stay out of machine's pinch points.

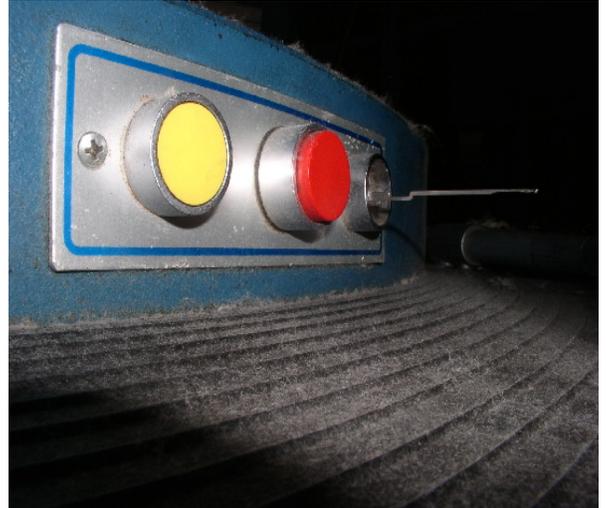
The paramedics were called and pronounced the victim dead after removing him from the machine. One of the co-workers stated that he found a sewing needle wedged in the machine's "on" button (**Exhibit 3**). He said he removed it when he shut down the machine. The purpose of the needle in the "on" button was to allow the machine to continue to operate with the safety gates open.

Discussion: In this incident, the victim knew how to override the safety features of the knitting machine and totally defeat the purpose for which they were intended. The victim's co-workers admitted that this was a common practice in the industry. The company president said he was aware of the unsafe practices taking place, but took no action to stop it. Employees that have developed unsafe work practices will continue to use them as long as there is no corrective action taken.

Exhibit 3:
The control buttons with a needle stuck in the green button.

Recommendation #3: Ensure employees do not bypass safety interlocks.
