SUBJECT: Two heavy equipment mechanics electrocuted while working on a large earth moving piece of construction equipment called a scraper.

California FACE Report #04CA004

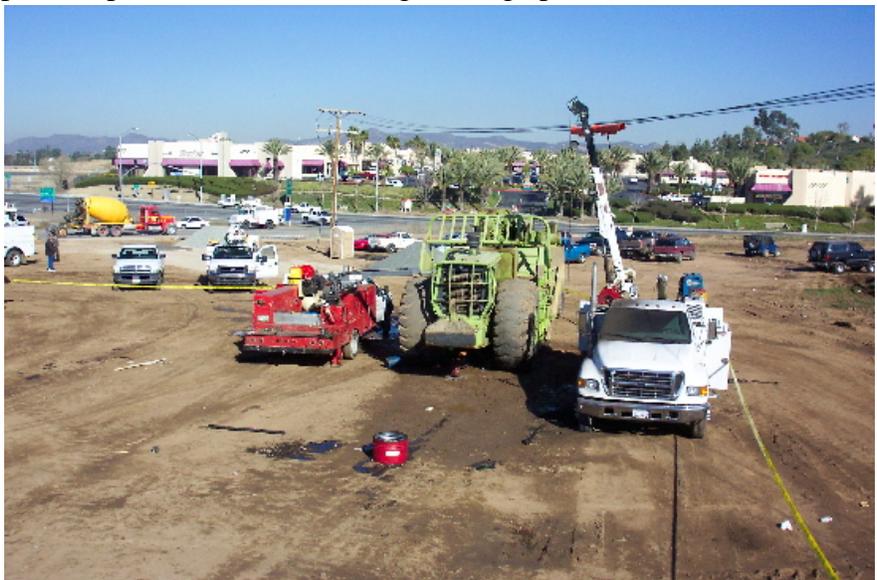
The site of the incident was a 45-acre construction site being graded for commercial development. On the day of the incident the victims were dispatched to the site to perform repairs on a scraper. The scraper was parked underneath a high voltage power line that

contained 12,000 volts of electricity (12 kv) and ran directly through the construction site. The victims arrived at the incident site and parked their trucks approximately four feet away on opposite sides of the scraper. The victims disconnected and removed the rear differential from the scraper using the truck-mounted crane on one of the trucks to lift it out of the scraper. The controls for the truck crane were portable and connected to the truck by an

Exhibit 1. A view of the construction site and equipment involved in this incident.

Discussion: Employers should conduct initial jobsite surveys to identify potential worker hazards. Once potential hazards have been identified, appropriate control measures can be implemented prior to the start of any work. Control measures in this incident could have included positioning the truck-mounted crane so the crane boom would not come within ten feet of the power line, or posting an observer to ensure the crane operator did not move the boom within ten feet of the power line. Other control measures could have included contacting the power company and having them de-energize the power line, or insulating ("sleeving") the power line phases with line hoses, or moving the scraper from underneath the power line.

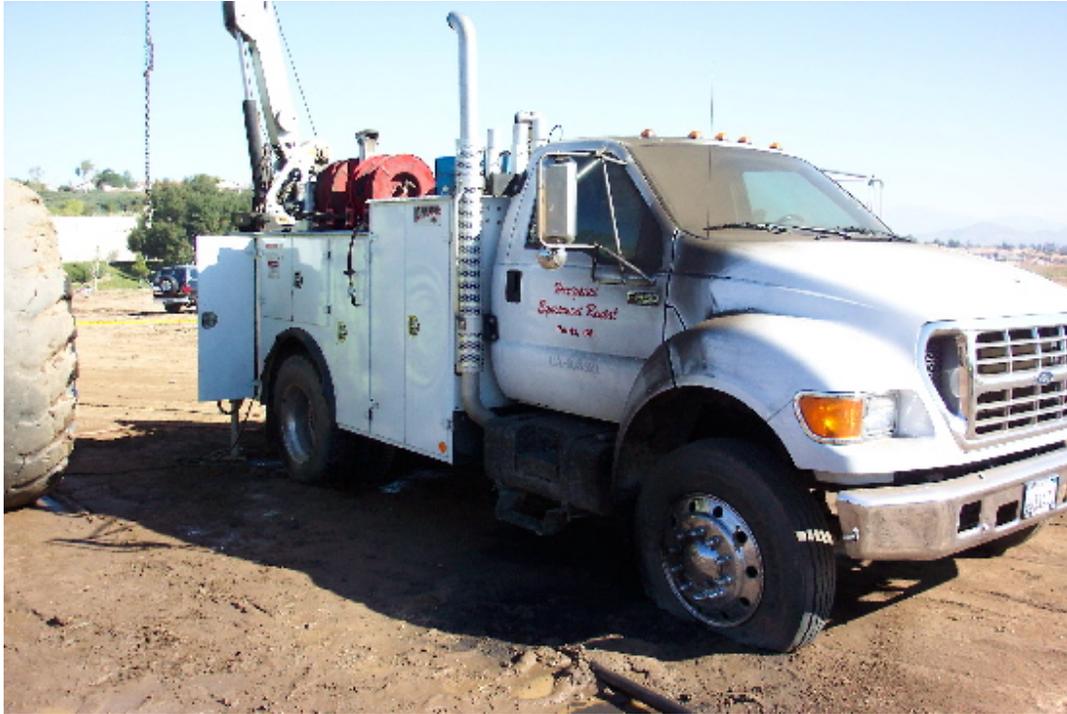
Exhibit 3. The victims' truck with the boom that made contact with the high voltage lines.

Discussion: The remote control system used on the truck-mounted crane was electrically connected to the crane. This system provided the "path to ground" which resulted in two fatalities. A remote control system which is electrically isolated from the crane would provide protection to a crane operator if contact with an energized overhead power line occurred. Electrical isolation could be accomplished by radio controls, fuse equipped control lines, fiber optic controls, insulated control boxes, etc. Manufacturers of crane systems should evaluate these options and incorporate an electrically isolated remote control system into the design of newly manufactured truck-mounted cranes. Manufacturers and their customers should cooperate in an effort to retrofit existing truck-mounted cranes with these systems, as well.
