SUBJECT: A forklift operator died when he was crushed in the mast of a forklift.

SUMMARY
California FACE Report #04CA012

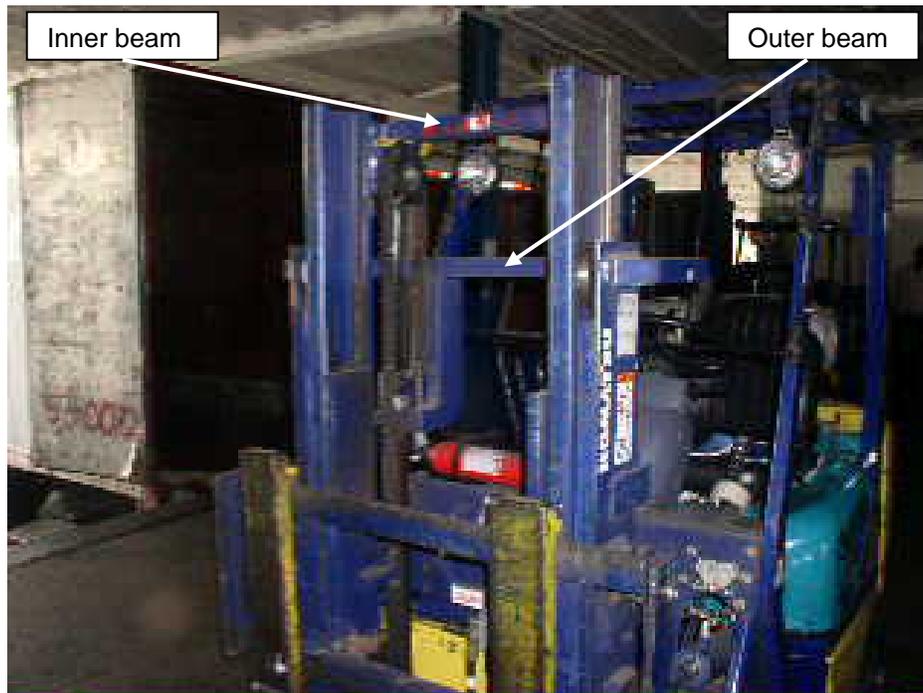
The site of the incident was a truck depot for the company where trucks exchange cargo for shipping. The machine involved in the incident was a forklift designed to enter the enclosed beds of trailers. The forklift was equipped with a seat belt. The forklift mast consisted of an outer mast which was stationary and an inner mast which was telescopic.

Exhibit #1: A picture of a forklift similar to the one involved in the incident.

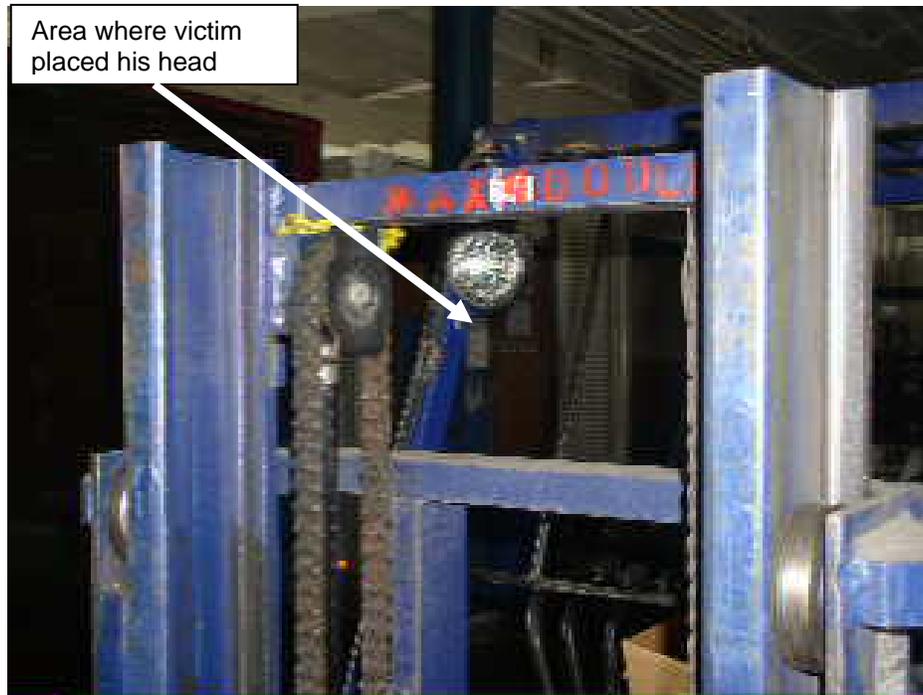
Although the incident was not witnessed, the position of the victim's body suggests that as he leaned forward and stuck his head between the beams of the outer and inner forklift mast, his right leg pushed the control lever forward. This caused the inner mast to come down on the victim's head before he could move out of the way.

Exhibit #2: A picture of the forklift mast showing where the victim placed his head.

Discussion: There are several devices which may have prevented this incident if they had been installed on the forklift. A screen (clear plastic or metal grate) in front of the forklift operator cabin would have prevented the operator from reaching forward between the masts. A safety interlock that requires the operator to engage two controls before moving the forks would have kept the mast from descending on the victim. A pressure interlock under the operator seat would have locked the controls in place when the pressure on the seat was released, or a sensor device could be attached to the seat belt of the forklift that when disconnected would shut off the power to the forklift. These are just some devices that, if installed on the forklift, might have prevented this incident from occurring.
