**SUBJECT:** A backhoe operator died when his backhoe pinned him against a retaining wall.

**SUMMARY**  
**California FACE Report #05CA001**

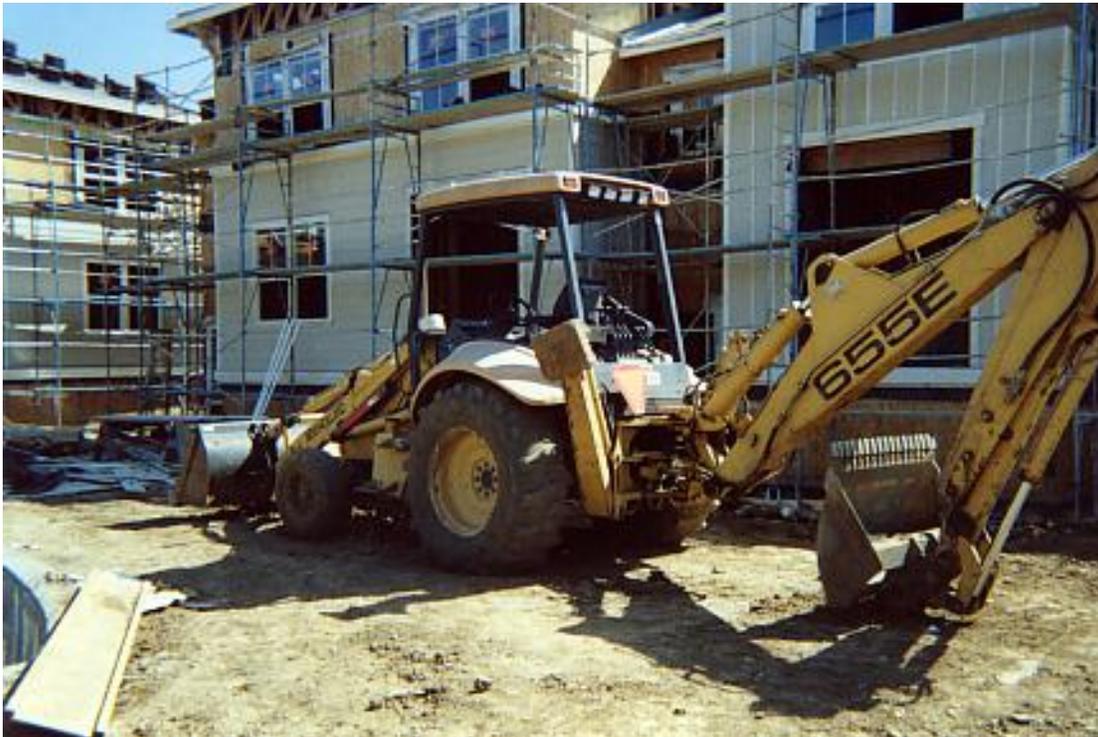
The site of the incident was a construction site of a housing complex. Behind a building under construction was a retaining wall which was 6½ feet high. At the bottom of the wall was a two-foot drainage ditch with a pipe that was to be covered with gravel and rock and then wrapped with landscaping fabric and backfilled. The machine involved in the incident was a backhoe tractor that was 24 feet long and weighed more than 14,000 pounds. The backhoe was equipped with a 1.3 cubic yard loader bucket, and a 24-inch heavy duty backhoe bucket. The parking brake was a disc on the transmission output shaft that was mechanically activated with a hand lever located on the right side of the operator's seat.

**Exhibit 1. The backhoe involved in the incident.**

**Recommendation #1: Ensure employees lower the loader and backhoe buckets to the ground when parking a backhoe unattended on an incline.**

Discussion: When parking a backhoe, it is recommended that the operator select level ground whenever possible, engage the parking brake, lower the loader and backhoe buckets, shift all controls to neutral, idle then shut off the engine, remove ignition key, and block and/or chock the wheels. When the backhoe has to be parked on an incline, then every effective mechanical

means to prevent the backhoe from moving downward must be taken. The lowering of the loader and backhoe buckets is one way to effectively prevent the backhoe from moving. When the buckets are lowered to the ground, they act like a barricade because the weight of the buckets creates drag to help prevent the backhoe from moving, even on an incline. When backhoe operators perform this precautionary function each and every time they get off their tractor, incidents such as this one could be prevented. Employers can enhance worker compliance with safe work practices through programs of task specific training, supervision, recognition, and progressive disciplinary measures.

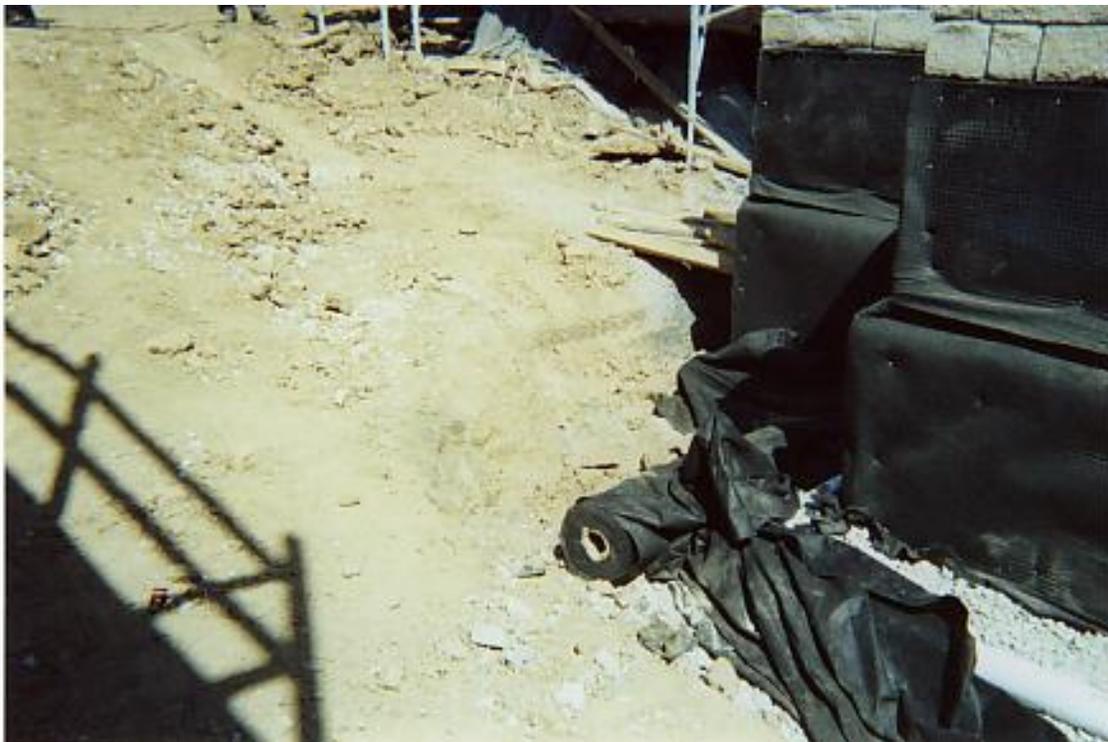
The victim, who was the operator of the backhoe, was bringing rock and gravel to be unloaded in the trench. He drove the backhoe to the trench and then parked it so the front bucket was at the end of the trench. The backhoe was on an incline that measured approximately 20 degrees. As the victim got off the backhoe, he left the front bucket that was full of rocks and gravel elevated, and set the parking brake. The victim and a co-worker used shovels to scoop the gravel and rock out of the bucket and then spread it over the pipe in the trench. The victim then began to lay down the landscaping fabric over the gravel and rock. He was bent over directly in front of the backhoe bucket when the backhoe started rolling forward and pinned the victim against the retaining wall. Another worker got on the backhoe and moved it in reverse to release the victim. This worker told the police that the backhoe's parking brake was engaged and the gear shifter was in 1<sup>st</sup> gear. A check of the parking brake showed that it was operational. The victim's supervisor was in the area but not within visual distance of the incident when it occurred. The paramedics were called and they treated the victim at the scene, and then transported him to a local hospital where he died from his injuries.

**Exhibit 2. The area where the incident took place, depicting the angle of the slope the backhoe was parked on.**

**Recommendation #2: Ensure employees block and/or chock the backhoe wheels when parked unattended on an incline.**

Discussion: Even when the parking brake is applied, equipment can move if there is not enough pressure applied. The manufacturer of the backhoe stated in its operators' manual that the parking brake was not designed to hold the backhoe in place when parked unattended on an incline. When equipment parked on inclines has the wheels chocked and the parking brake set, it is prevented from moving by effective mechanical means. Had the victim chocked the backhoe wheels, it would have prevented it from moving forward on the incline and this incident might have been prevented.

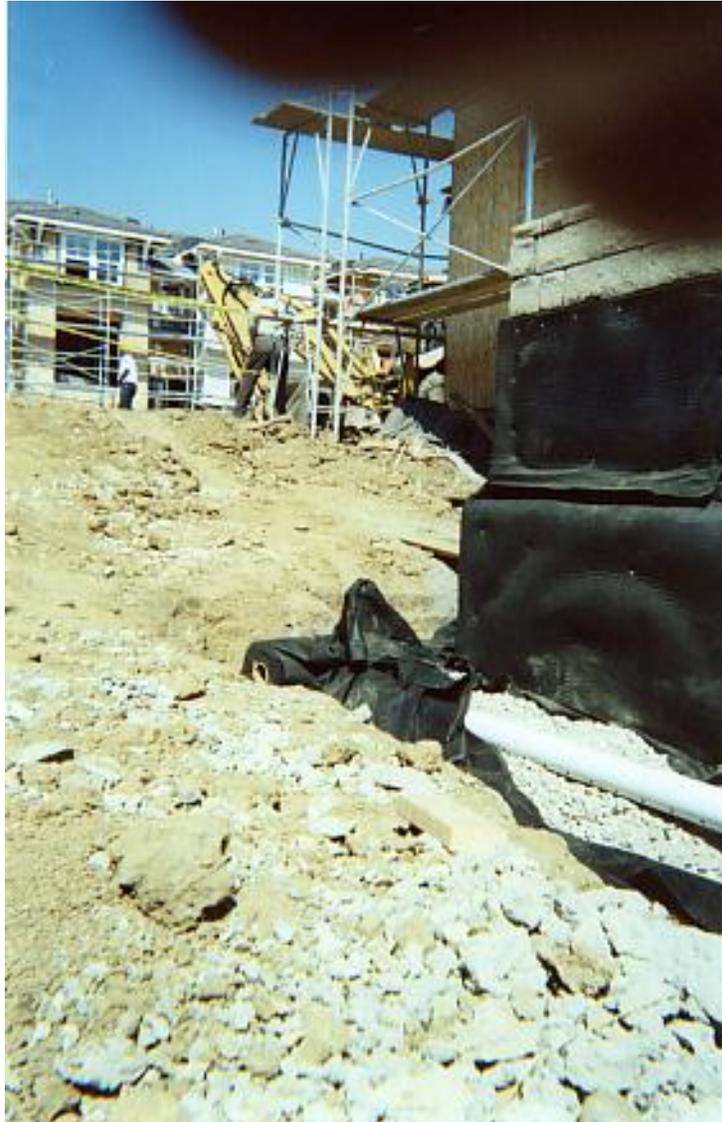
**Exhibit 3. A view of the retaining wall and the slope of the surface where the backhoe was parked when the incident occurred.**
