**SUBJECT:** A Maintenance Supervisor Dies When He Falls off a Ladder into a Hot Water Tank.

**SUMMARY**  
**California FACE Report #07CA005**

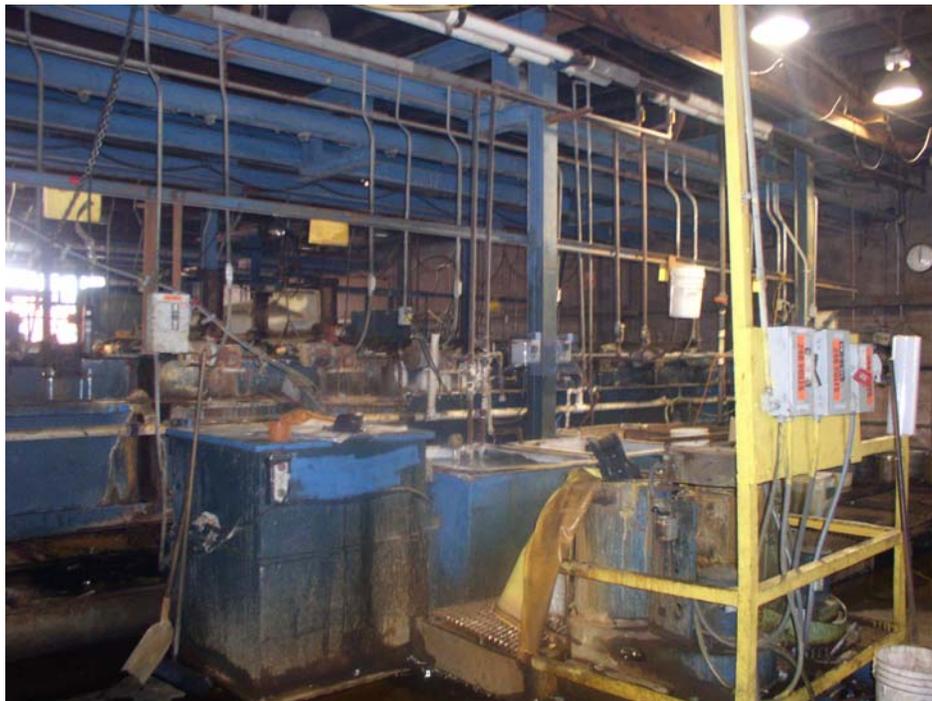
**Exhibit 1. The shop where the incident took place.**

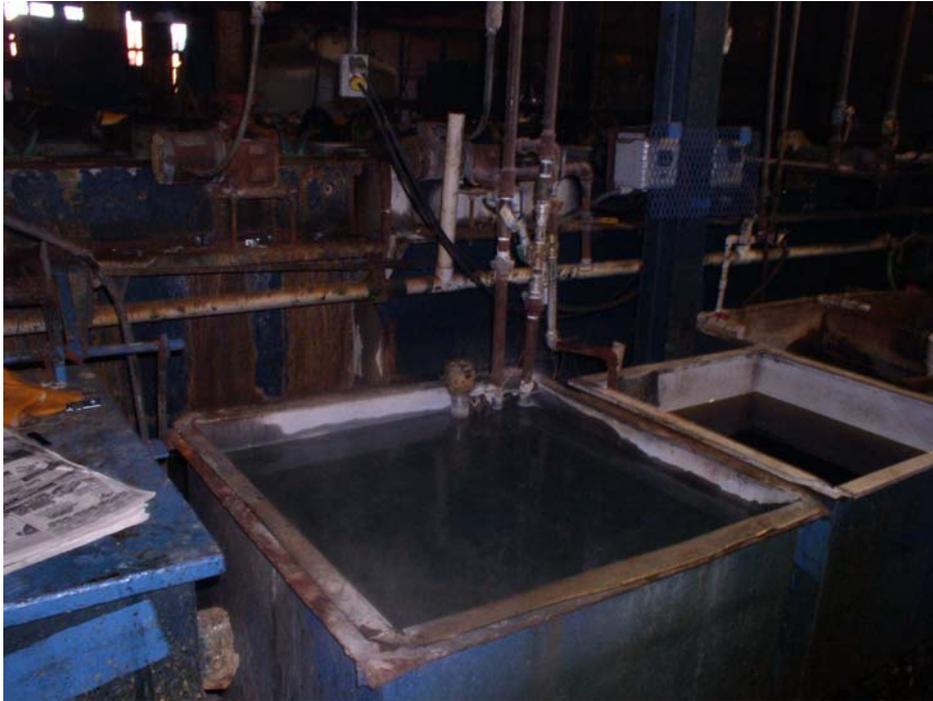
The site of the incident was the tank area of a metal finishing company. The hot water tank the victim fell into was three feet deep with a water temperature of approximately 160 degrees Fahrenheit. The tank was used for rinsing off parts that had been dipped in other chemical or acid tanks, and was not covered. On the day of the incident, the victim was responding to a service call involving a possible electrical short circuit in a dryer. With the help of an apprentice worker, the victim secured an extension ladder adjacent to the hot water tank in order to gain access to the conduit located above him. The victim used a 20-foot extension ladder with a 250-pound capacity that was manufactured in 2006. The victim ascended the ladder to the eighth or ninth rung and reached beyond the rails of the ladder to remove the cover plate on the conduit. He was about to check the wires with an electrical tester when he told the apprentice to go to the supply room for a part. It is not known if the victim slipped or received an electrical shock that may have precipitated his fall into the hot water tank. Other employees witnessed the victim exiting the tank by himself after approximately 10 seconds.

**Exhibit 2. The tank filled with hot water.**

Discussion: The tank involved in this incident was not covered to prevent objects or individuals from falling into it. When employees are required to work directly above open tanks, employers should ensure that the top of the tank is covered with a grating or grille with openings no larger than two inches and of sufficient strength to hold the weight of anything that may fall on it.

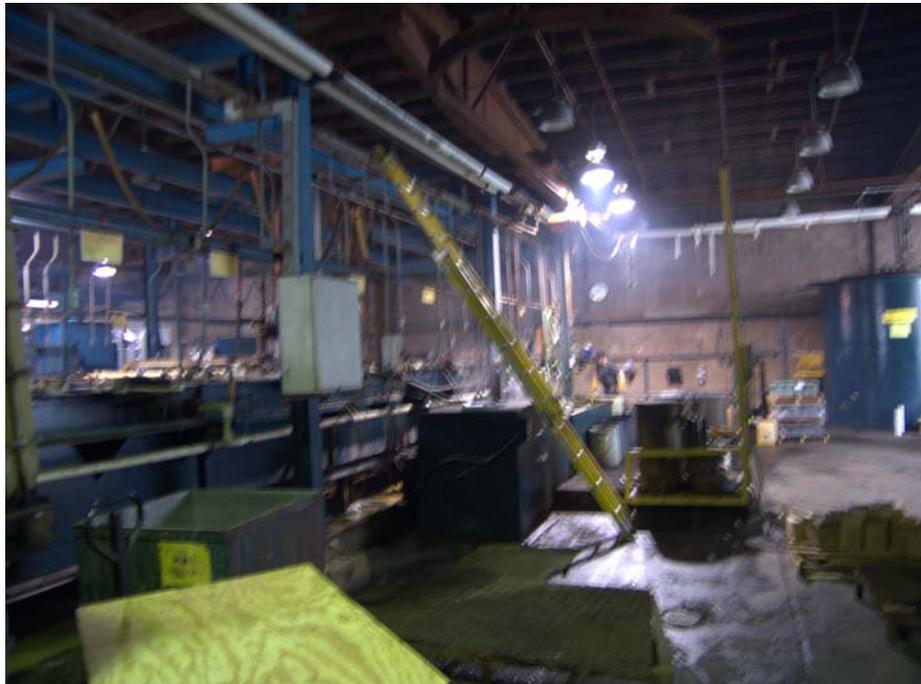
Discussion: The use of a ladder limited the work area of the victim to an arm's length on each side of the ladder. In order to reach the conduit, the victim needed to maintain his balance while holding the ladder with one hand. Although the fall was not witnessed, it is likely the victim lost his balance by attempting to exceed a safe reach. The use of mobile scaffolding or another type of work platform such as a scissor lift would have provided a stable work surface and enabled the repairs to be completed safely.

**Exhibit 3. The incident scene with the ladder in place.**

Discussion: The worksite should be evaluated for potential hazards prior to beginning any job or work task. Such an evaluation would have shown that a ladder was not the appropriate choice for the job. The electrical repair was located above the tank such that the use of a ladder required reaching beyond a safe distance.

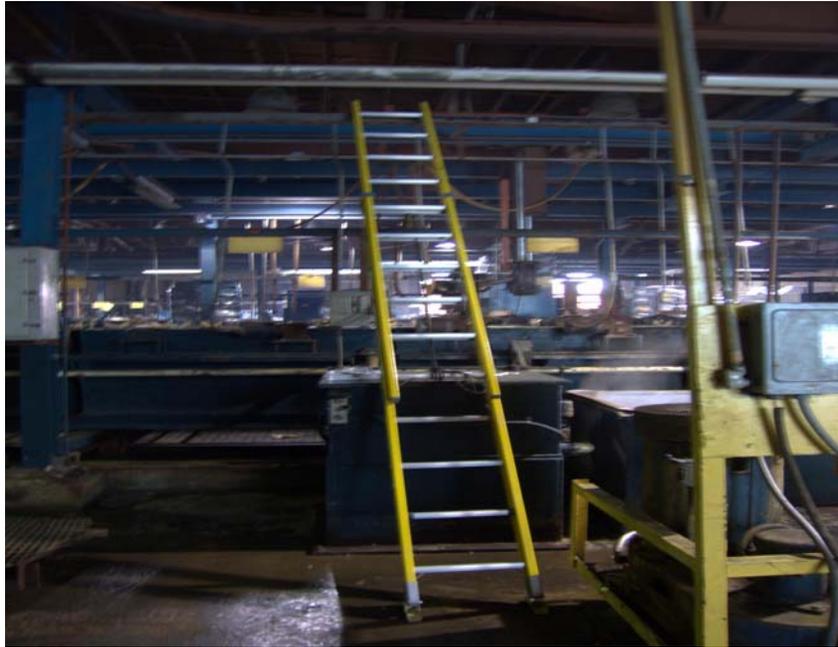
Exhibit 4. Alternate view of the ladder secured in place.
