**SUBJECT:** Truck Driver Dies When He Falls Off the Top of a Tank Trailer

**SUMMARY**  
**California FACE Report #08CA002**

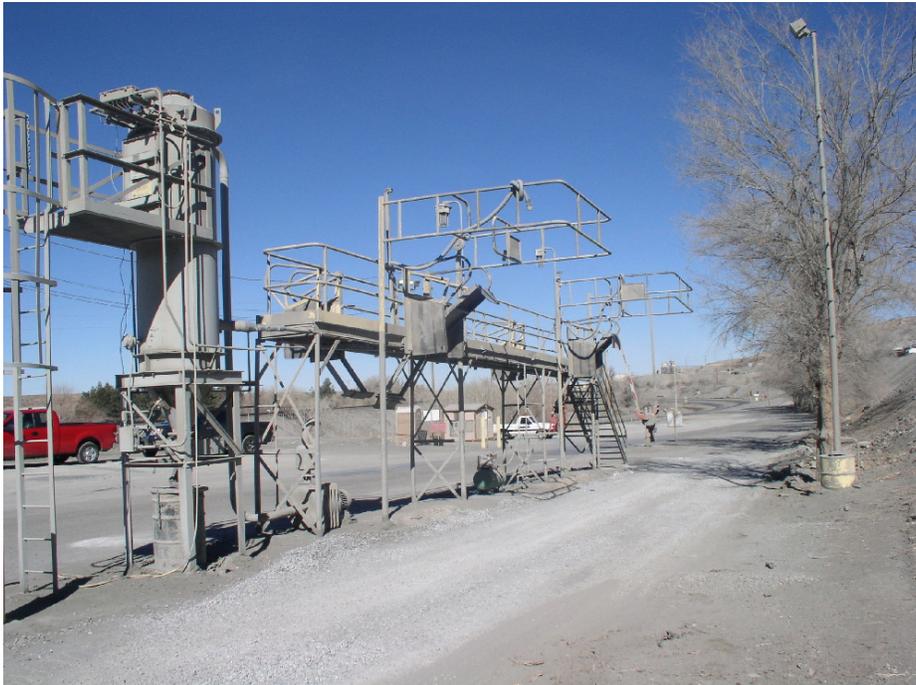
**Exhibit 1. The catwalk used by truck drivers to gain access to the top of their tank trailers.**

The site of the incident was a catwalk and gangway station at a cement plant. The station was designed to allow truck drivers to gain access to the top of their tank trailers to open or close the lid on top. After loading or unloading materials from their tank trailer, the drivers would park their trucks parallel to the catwalk in order to close the top lids. The catwalk was designed with gangways that were weighted on one end and extended in a perpendicular direction from the catwalk out toward the tank trailer (see exhibit 1). The gangway was designed to lower to the top of the tank trailer with the weight of an individual. A fixed guard rail extended out from the catwalk at each gangway (see exhibits 2 & 3).

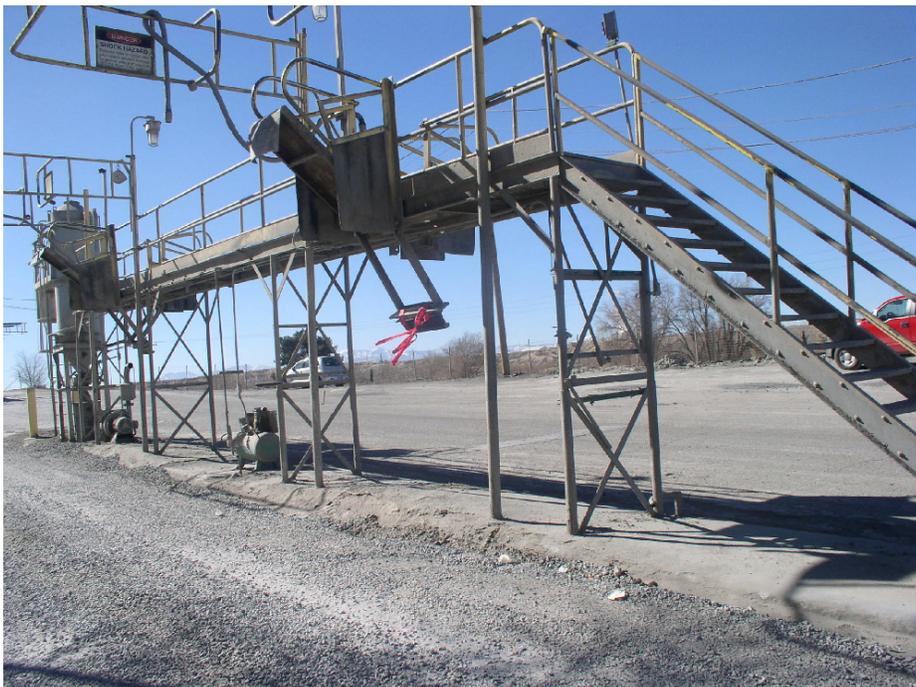
**Exhibit 2. The stairs used to gain access to the catwalk and the weighted gangway.**

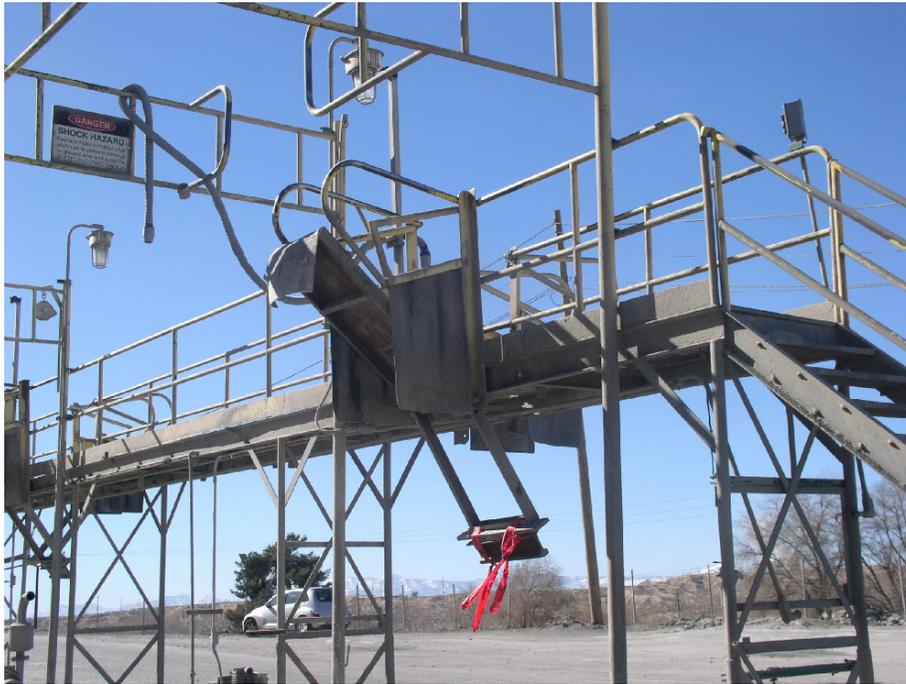
Depending on the tank trailer design and distance from the catwalk, with the gangway fully lowered to the top of the tank trailer there was a gap of approximately 24 to 36 inches from the bottom of the guardrail to the top of the tank trailer. On the day of the incident, the victim drove his tank trailer to the catwalk area in order to close the top lids. The victim parked his rig alongside the catwalk and under the weighted gangway. According to the victim's employer, the tanker was correctly parked next to the catwalk. The victim climbed the catwalk and walked out on the gangway to close the tank trailer lid. The victim fell approximately 12 feet from the gangway to the ground below. The victim may have slipped off the gangway while attempting to close the lid of the tank trailer.

**Exhibit 3. The weighted gangway and safety guardrail that extends over the top of tank trailers parked below.**

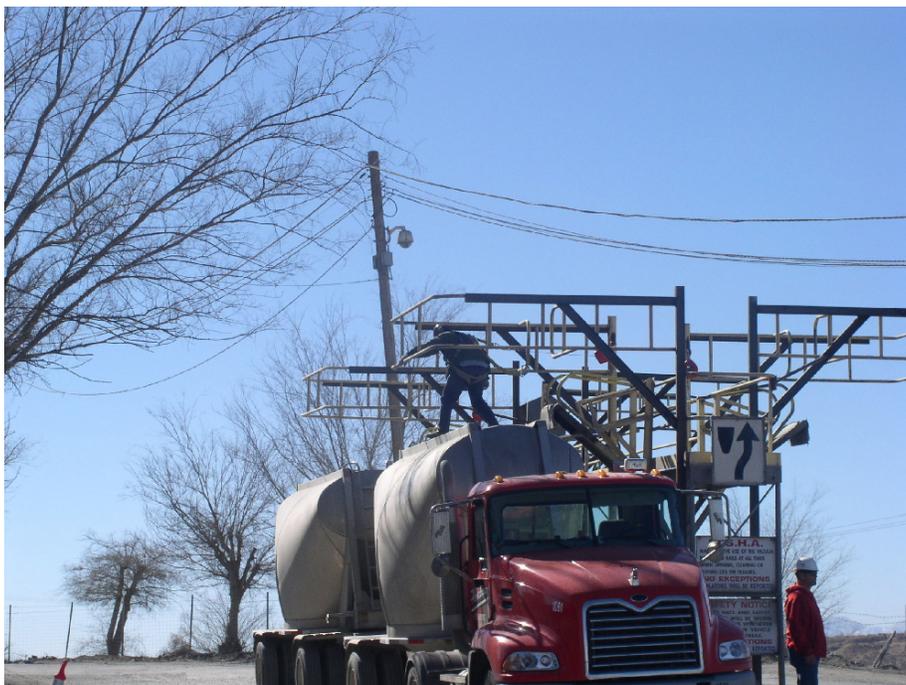
**Exhibit 4. An employee using the catwalk and gangway to gain access to the top of a tanker trailer to close the lid.**

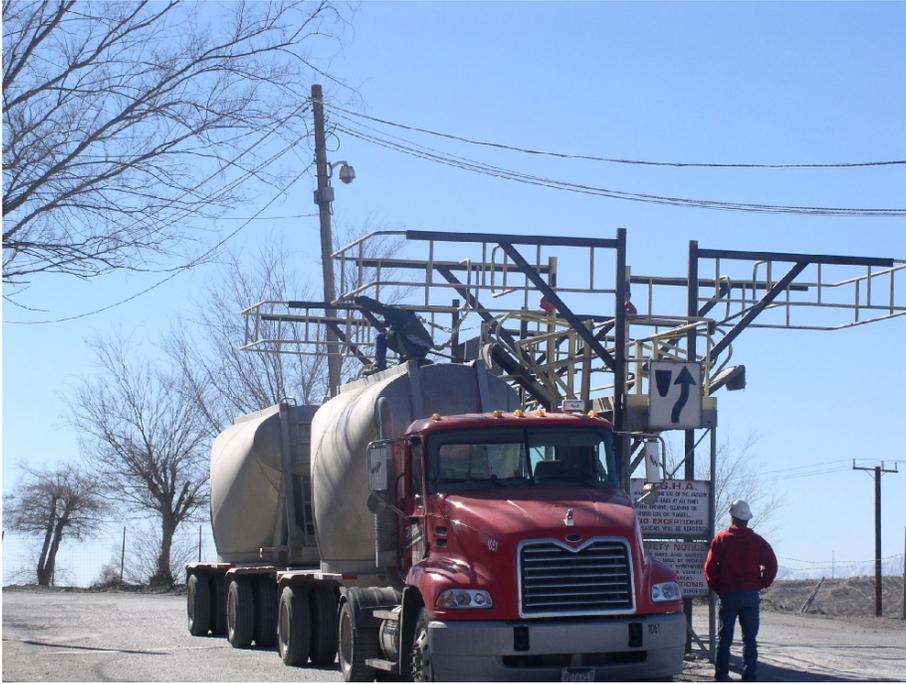
**Exhibit 5. An employee utilizing fall protection and the guardrail as he closes the lid on top of the tanker trailer.**

**Recommendation #1: Ensure that fall protection is used by drivers and other employees who use the catwalk and gangway to gain access to the top of tankers.**

Discussion: The design of a catwalk and gangway system to gain access to the top of tank trailers is one method of preventing falls from heights over 10 feet. In this case, the catwalk and gangway system, even when appropriately used, left a 24 to 36 inch gap between the tanker and the guardrail of the gangway. The use of personal fall protection provides an additional safety measure that can protect the driver when using catwalk and gangway systems that are not properly designed for their trucks. The use of fall protection would include the following:

- An approved safety harness with life line.
- One end of the life line attached to a fixed overhead anchorage or similar arrangement.
- The life line adjusted that the employee cannot fall more than a specified distance.
- Safety harnesses and life lines that are resistant to any deteriorating effects of the dusts, fumes, mists, vapors, or gases arising from the contents of the tank.

Had the victim been using fall protection (see exhibit 5), this would have prevented him from falling to the ground after slipping off the gangway.

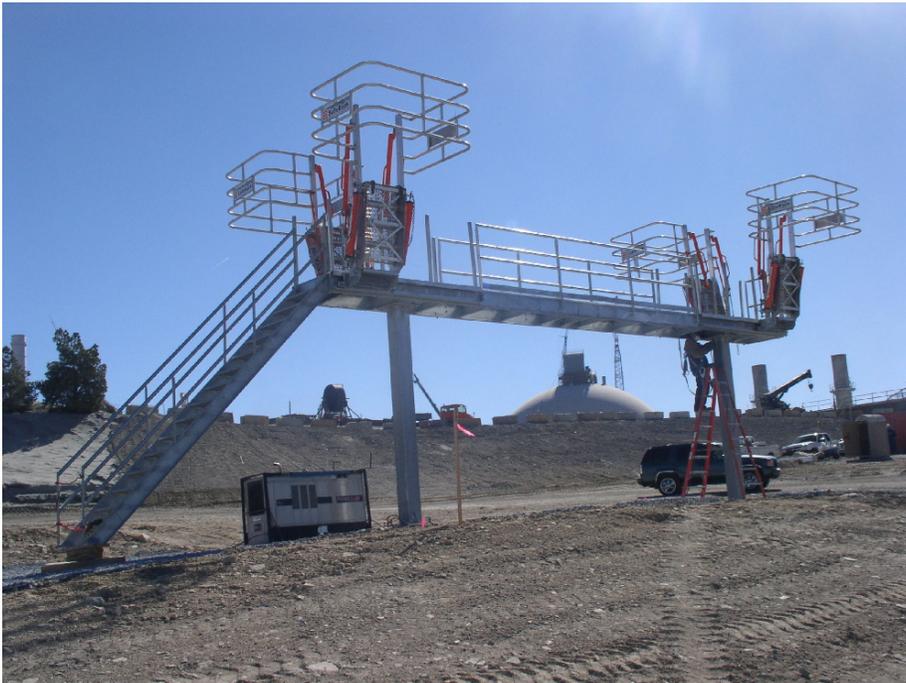
**Exhibit 6. A picture of the new catwalk and guardrail system.**

**Recommendation #2: Use a catwalk, gangway, and guardrail system that eliminates the gap between the tankers and the guardrail of the gangway.**

Discussion: Several manufacturers provide engineered systems for facilities that need to routinely provide access to the top of tanker trucks. In this incident, a system was used that did not adjust to the truck height and minimize the gap between the guardrail and the truck top. A guardrail system that can adjust to the height of the different tank trailers might have prevented this incident by minimizing or eliminating this gap. One such system has been installed by the facility where this incident occurred (see exhibit 6).
