**SUBJECT:** Print Machine Operator is Strangled When His Shirt is Caught on a Rotating Knob

**SUMMARY**  
**California FACE Report #09CA006**

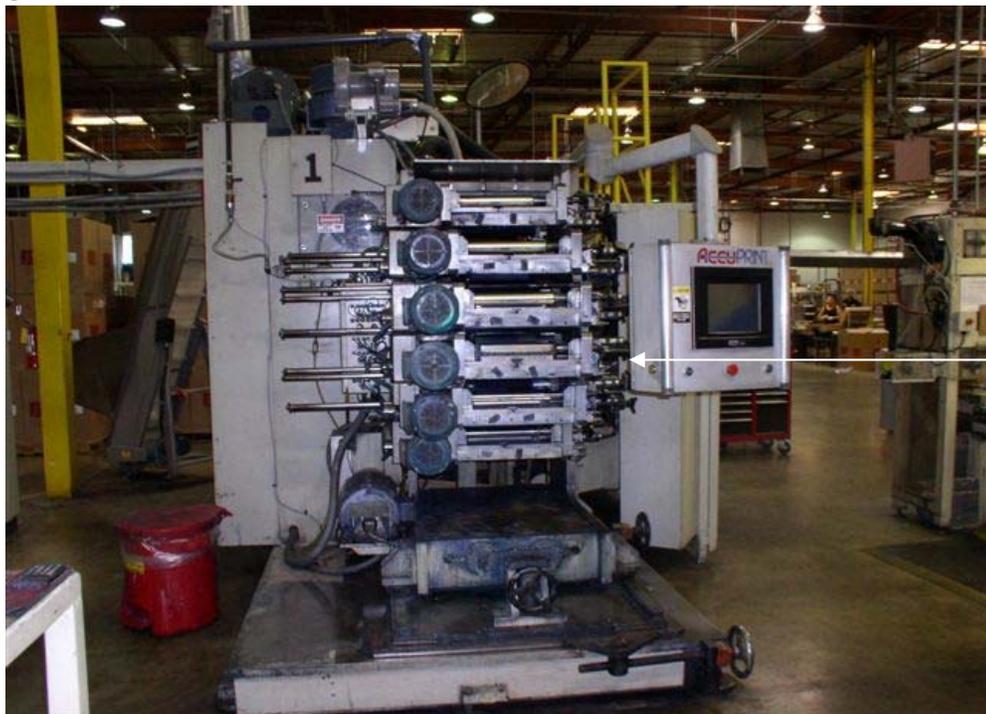
**Exhibit 1. The ink trays on the machine involved in the incident.**

The machine involved in the incident was an automated high-speed, six-color, off set printing machine that was used to decorate plastic squeeze tubes for cosmetic and personal care products. The machine had six trays, each containing different color inks. There were knobs on the end of the ink trays attached to the ink dab roller shafts. The knobs turned constantly while the printer was running. The design of the printing machine required the operator to work in close proximity to the rotating knobs to check on the flow of the ink. There were no guards or barriers preventing inadvertent employee contact with the rotating knobs or the pinch points on the ink trays.

Location of the ink tray knobs

**Recommendation #1: Employees are protected from moving parts by using printing machines designed with engineered safety features and/or appropriate guards.**

design so that employees cannot become entangled and risk injury or death. In this instance, the printing machine was not manufactured with guards over the rotating knobs, and there was no mechanism to ensure that the knobs stopped rotating when the employee checked the ink tray status. For circumstances where guarding is not practical, employers should consider whether a long handled tool is practical and safe to use to perform service or maintenance while the machine is running. The employer in this incident is currently testing a clutch-type mechanism that stops the rotating knobs during machine troubleshooting, cleaning, and set-up. If the employee had been using a printing machine that was designed to prevent inadvertent employee contact with exposed rotating knobs, the victim would not have become entangled with injuries leading to his death.

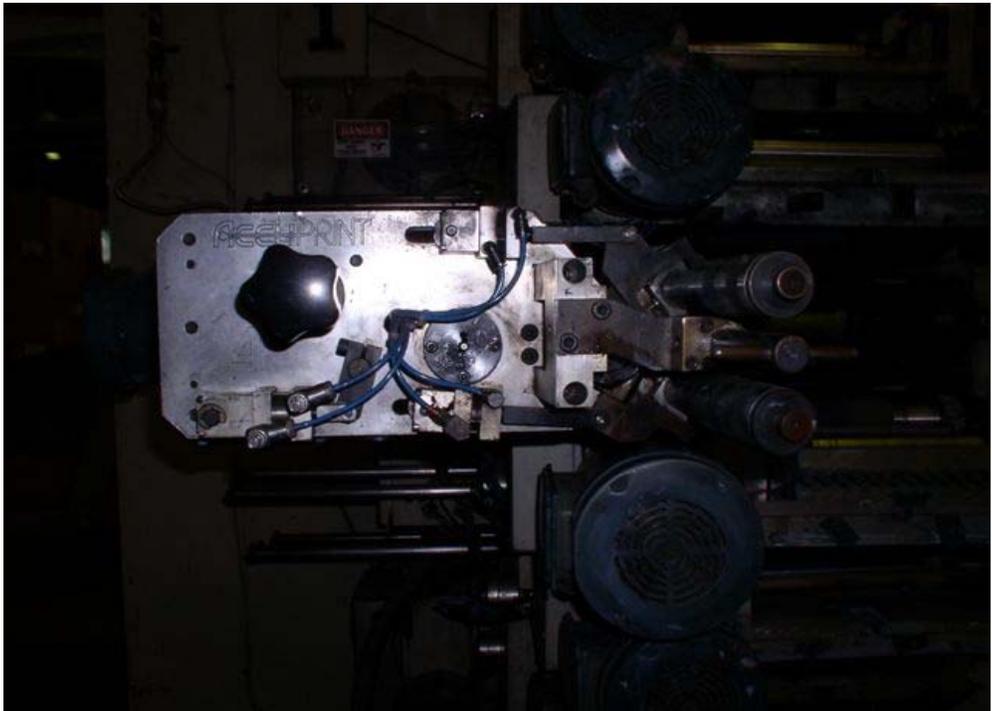
**Exhibit 3. A closer view of the knob the victim's shirt was entangled on.**

Discussion: In this incident, the victim's clothing was caught by a rotating knob when he was too close to the moving parts of the printing machine. Although this incident was not witnessed, the victim was probably checking the status of the ink trays while the machine was running. The victim was able to reach the computer screen of the machine and shut the machine off, but was unable to free himself from the rotating knobs. When employees work near moving machinery components, printing plant employers should ensure that safety features and appropriate guards are integral to printing machine
