**SUBJECT:** A Stagehand Falls from the Ceiling of an Amphitheater

**SUMMARY**  
**California FACE Report #12CA005**

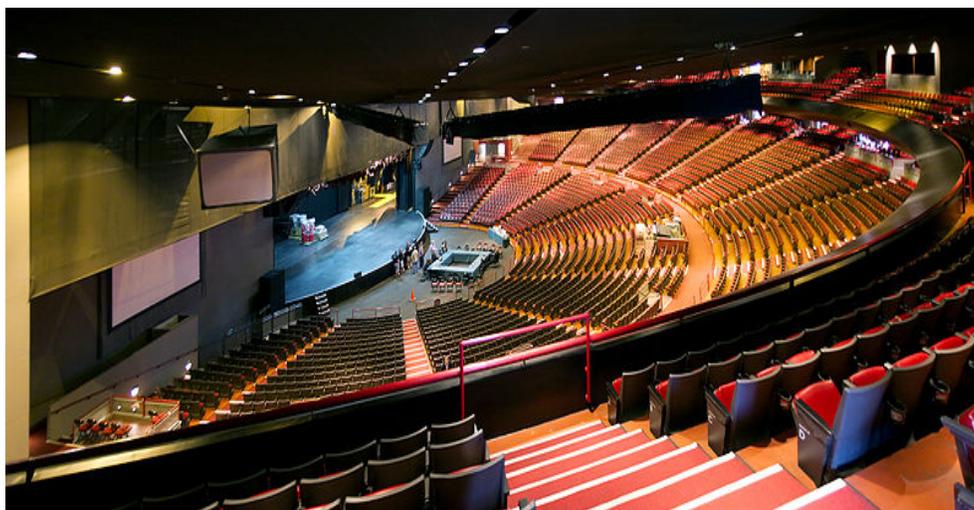
The incident scene was an indoor amphitheatre that seats up to 6,089 people (3,900 on the main level and 2,189 on the mezzanine).

**Exhibit 1. The indoor amphitheatre where the incident occurred.**

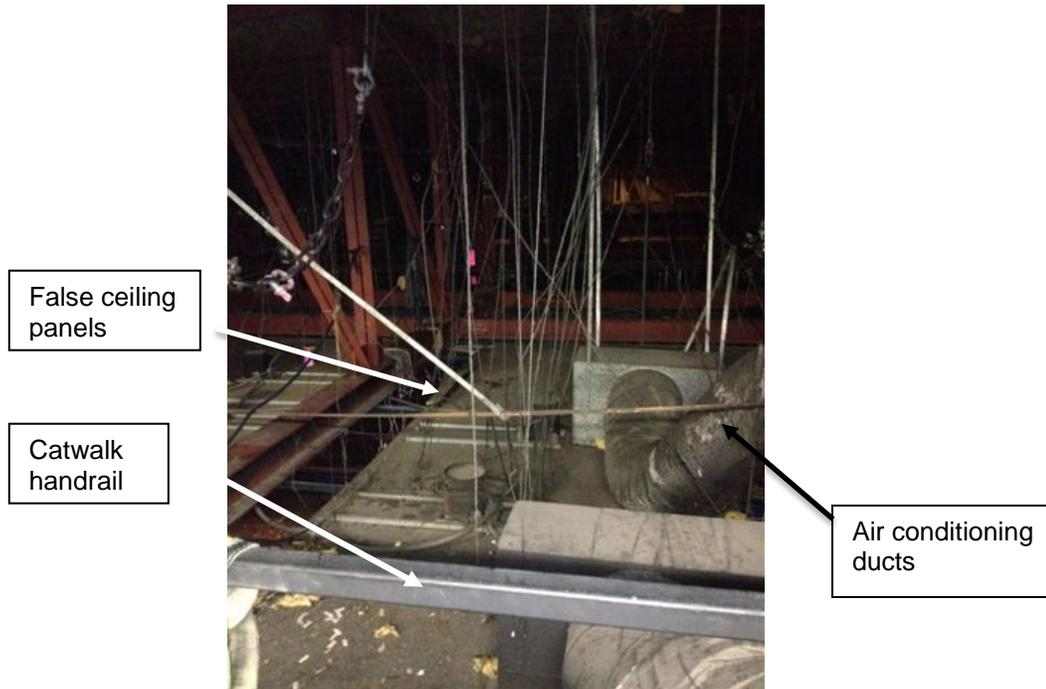
**Exhibit 2. The catwalk hand rail, air conditioning duct, and false ceiling panels where the incident occurred.**

The victim stepped off the air duct and onto a false ceiling panel. The panel gave way under his weight and the victim fell approximately 60 feet to the floor below. Other workers heard the victim fall and called 911. A medical evacuation helicopter transported the victim to the trauma center at a local hospital where he died from his injuries.

Discussion: In this incident, the victim was working at an elevated height of approximately 60 feet. Although the victim had a fall protection harness up in the ceiling area, he did not use this or tie off when he left the catwalk and walked over to remove the decorations. In addition, the victim walked on surfaces (duct work and the false ceiling) which were not designed to withstand his body weight. All workers must use approved personal fall restraint (PFR) or personal fall arrest (PFA) systems at elevations exceeding 15 feet above ground or whose work exposes them to falling in excess of 7½ feet from a structure or opening to the floor level below and where temporary guardrail protection is impractical.

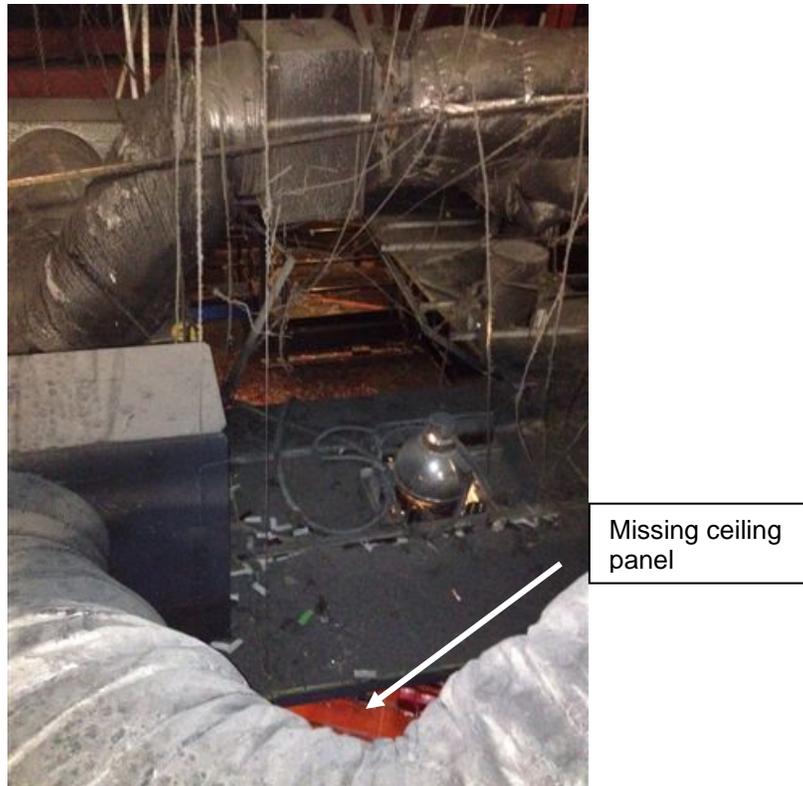
**Exhibit 3. The area where the victim fell.**

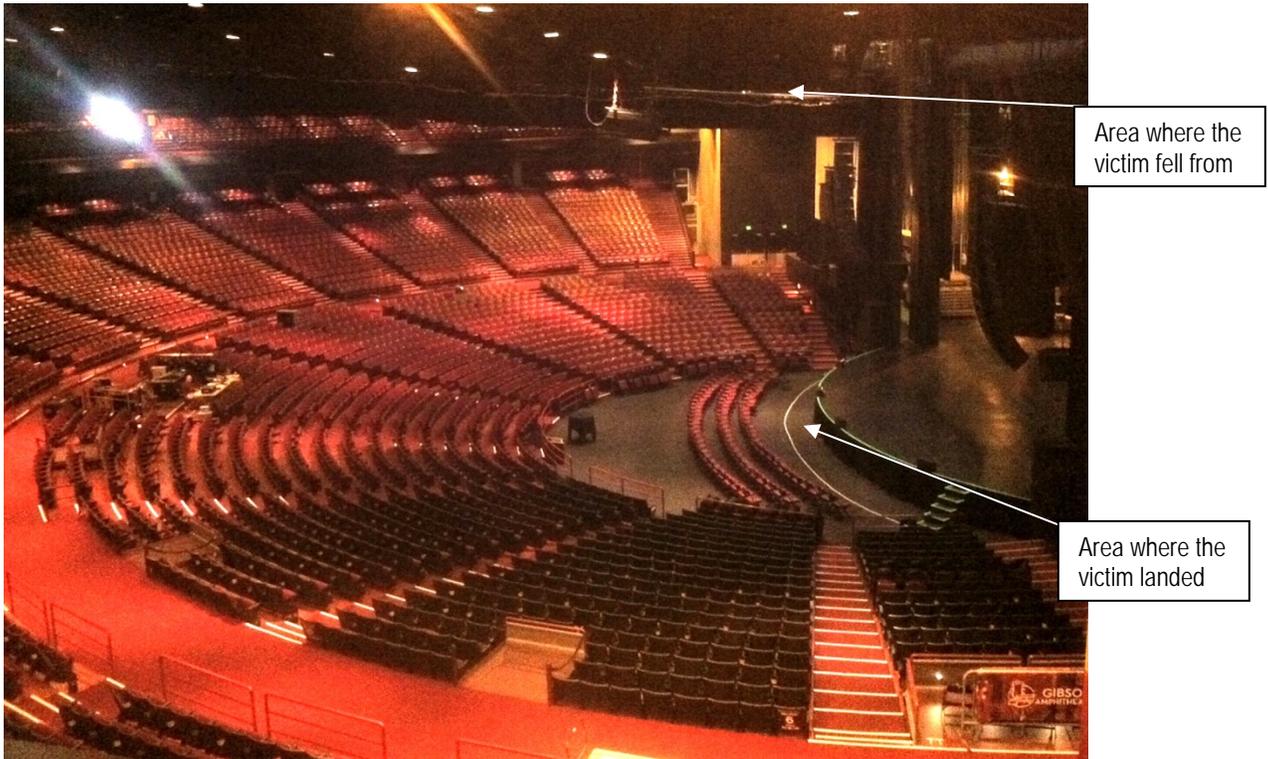
**Exhibit 4. The indoor amphitheatre depicting the ceiling height.**
