SUBJECT: A Construction Worker Dies When a Fully Extended Scissor Lift Falls Over

SUMMARY
California FACE Report #10CA008

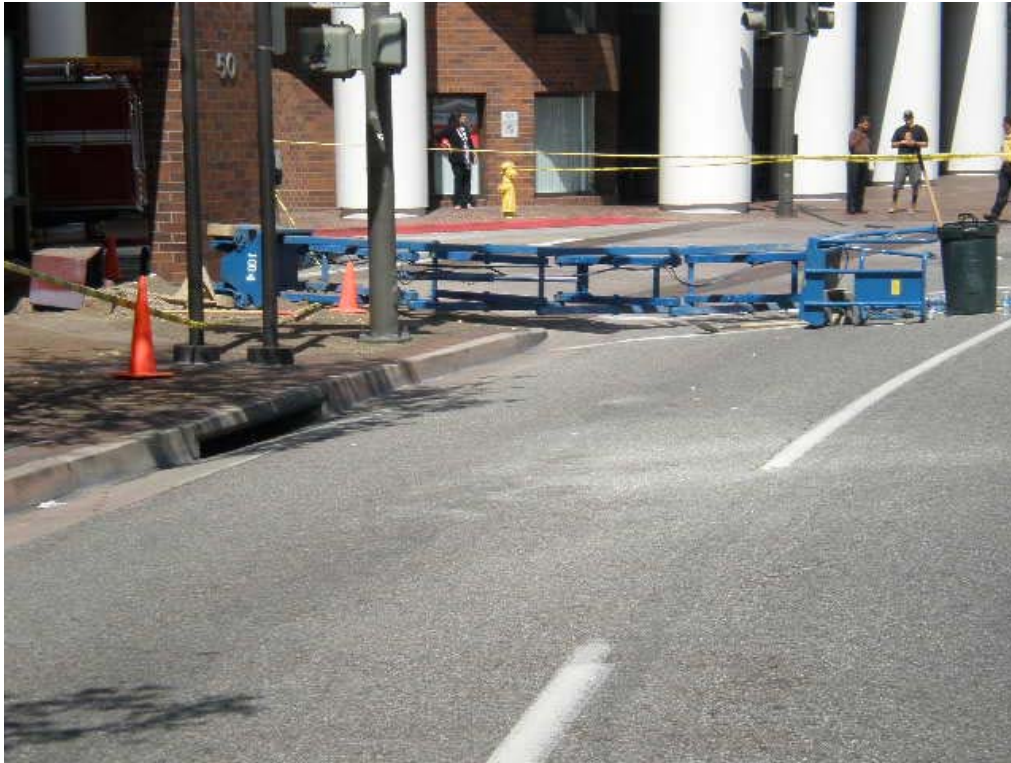
Exhibit 1. The toppled scissor lift.

Recommendation #1: Ensure that employees use scissor lifts that are the appropriate size and capacity for the job.

Discussion: In this incident, the superintendent rented a scissor lift that was too small for the job. A larger lift was to be delivered to the job site later that day, but the work crew proceeded to use the smaller one that had already been rented. In so doing, they most likely exceeded the maximum load capacity, creating an unstable condition. When the planter box was shifted onto the platform, the combined weight caused the scissor lift to topple. In using scissor lifts, it is necessary to assess the work process to ensure that the load movements do not exceed the equipment's capacity. In this incident, the load capacity of the smaller scissor lift was 500 pounds and was probably exceeded by the weight of three workers and the materials handled. If a larger scissor lift with outriggers or an industrial forklift had been used on this job, the planter box could have been removed safely.

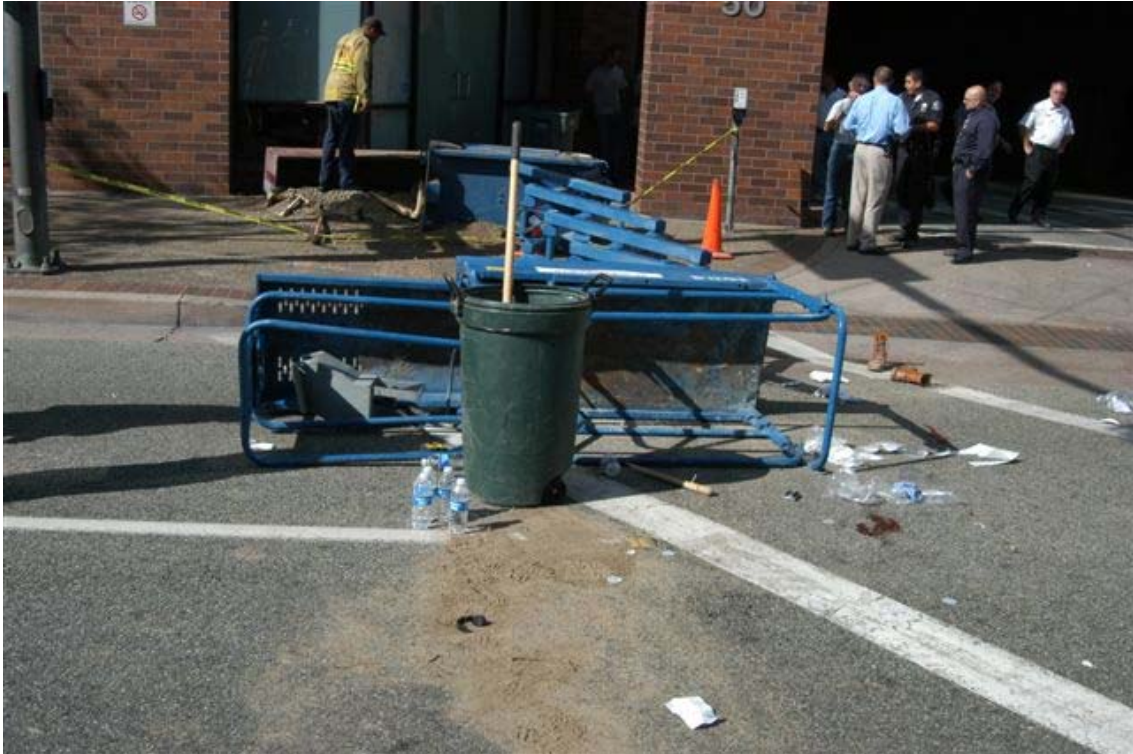
Exhibit 2. The work platform on the toppled scissor lift.

Recommendation #2: Ensure that employees are specifically trained on the appropriate load capacity and materials handling of scissor lifts.

Discussion: In this case, three employees proceeded to work from the platform of the smaller forklift with a load capacity of 500 pounds. While these employees had received general training within the past year, there is no evidence that they had received specific training on how to assess the load capacity and materials handling requirements of the scissor lift used in this incident. The rental equipment companies are only required to provide manuals, which they did in this instance. The scissor lift rented may not have been familiar to the workers. Had these employees received specific training on the load capacity and materials handling of the scissor lift in this incident, they may have realized that the smaller scissor lift was not appropriate for the job.

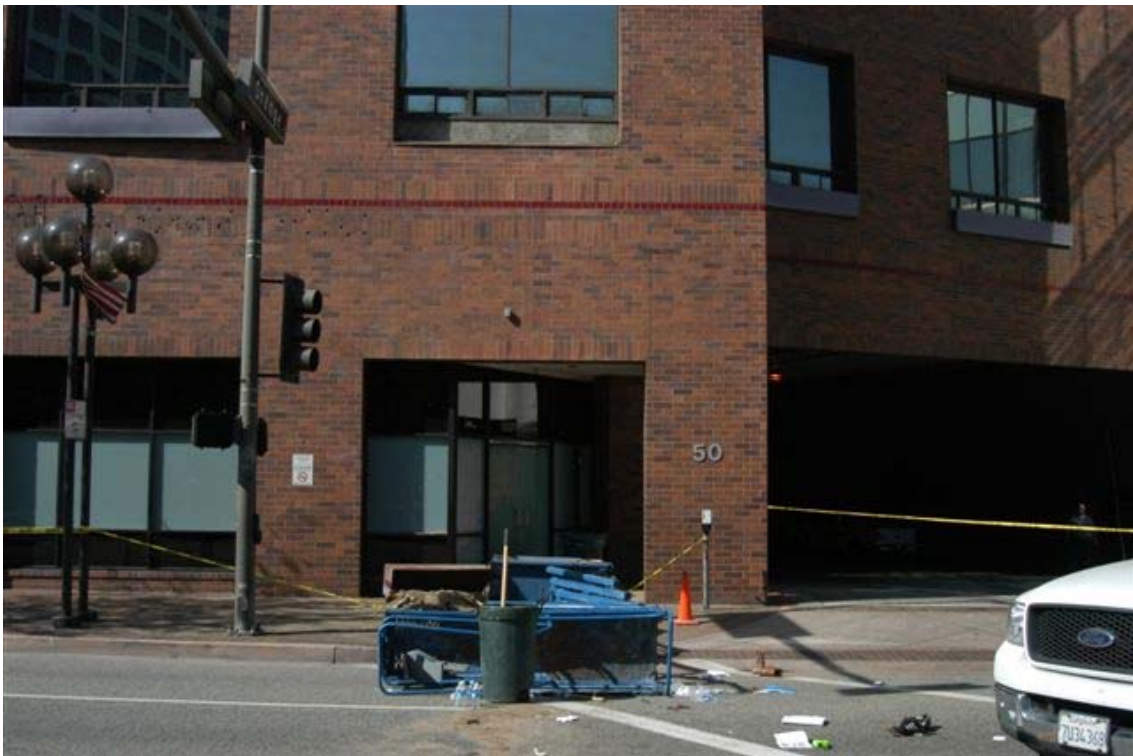
Exhibit 3. The building involved in the incident.

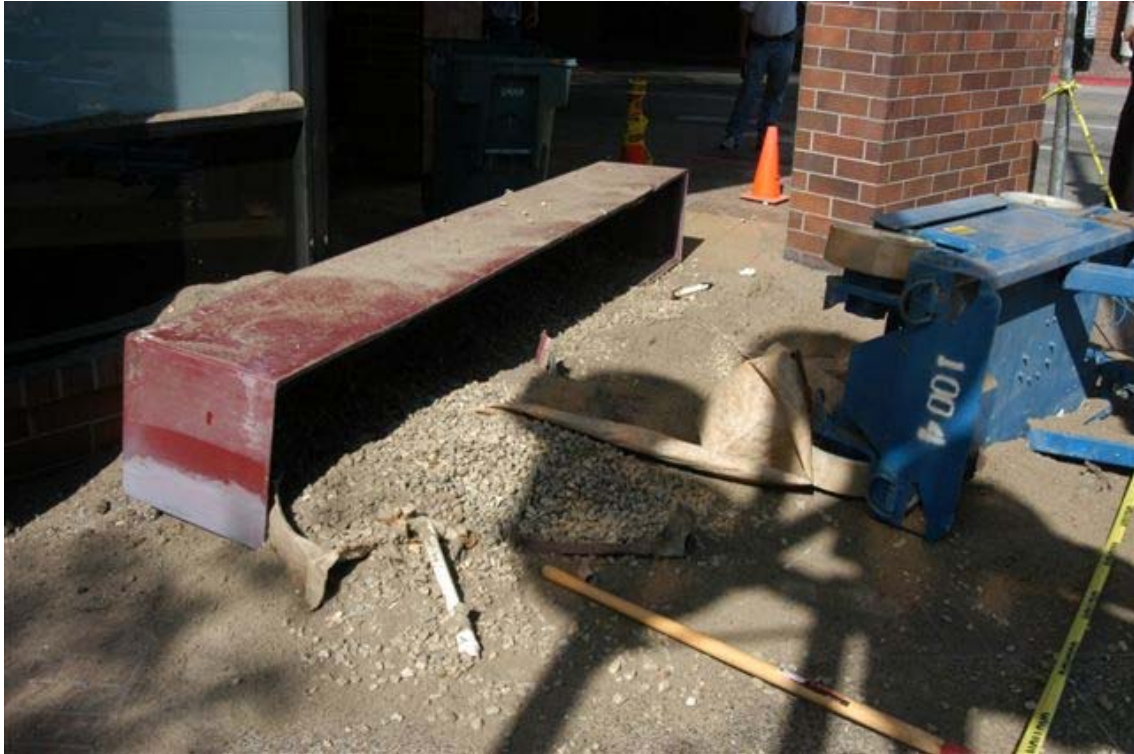
Realizing that the planter box would be too heavy to move with the soil in it, the work crew used shovels to remove some of the dirt into a plastic trash container that was placed on the scissor lift platform. According to the co-workers, they filled the plastic container with dirt and lowered the scissor lift to empty it, then raised the scissor lift up again to repeat the process. When the plastic container was filled the second time, the crew attempted to pull the planter box onto the scissor lift. The pulling motion on the planter box started an unstable rocking motion of the scissor lift. When the unbalanced planter box came loose of its foundation, it fell against the scissor lift, knocking it over. The scissor lift toppled to the ground, catapulting the three workers and the plastic

Exhibit 4. The planter box that knocked over the scissor lift.

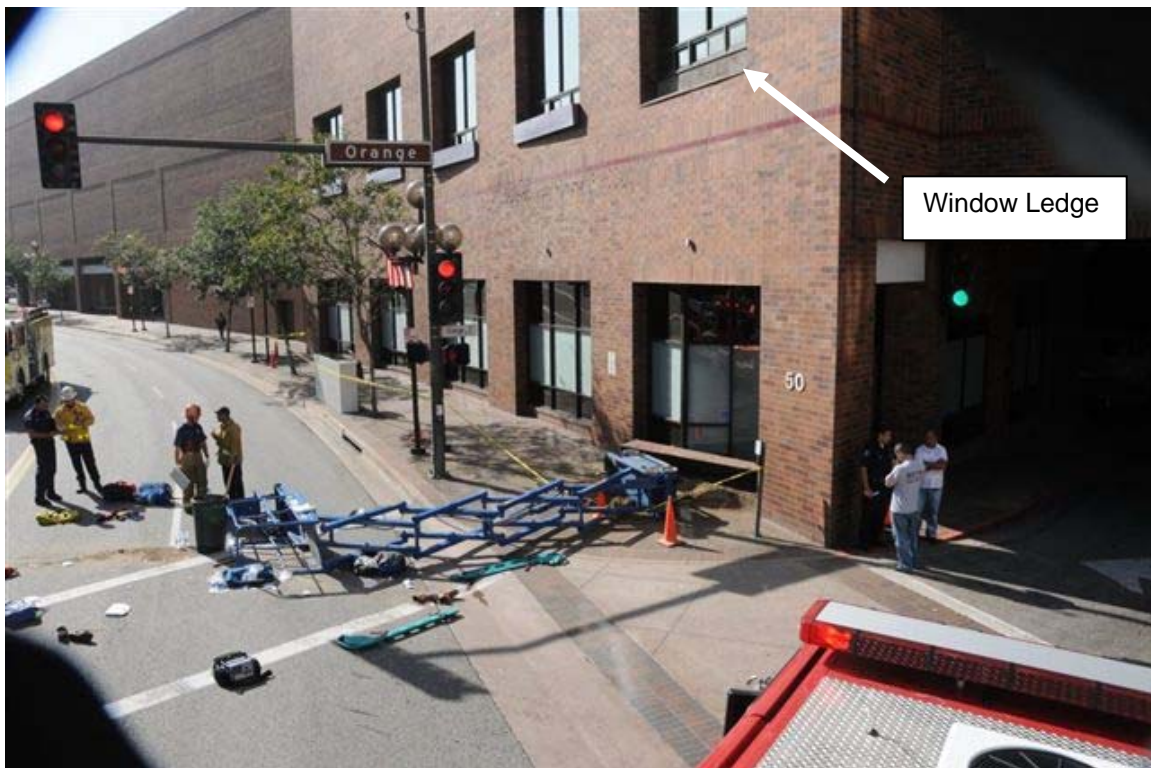
The location of the incident was a two-story enclosed parking structure at a shopping center. On each level of the structure were numerous fiberglass planter boxes filled with planting soil that measured 18 feet long, 24 inches wide, and 18 inches in height. The planter boxes had been in place for 20 years and had started slipping off their foundations. Concerns for public safety prompted the management of the shopping center to issue a work order to have the planter boxes removed. The victim's employer, who received the work order to remove the planter boxes, had their superintendent oversee the job.

Exhibit 5. The building's window ledge where the planter box was located.

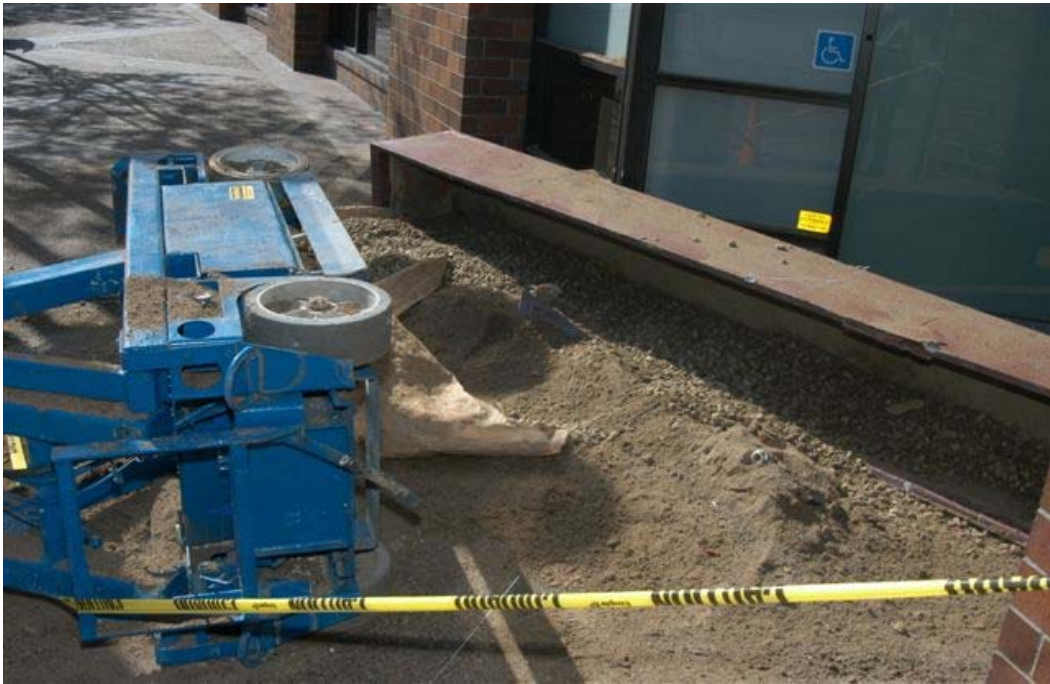
Exhibit 6. The dirt and gravel that was in the planter box when it fell off the ledge.

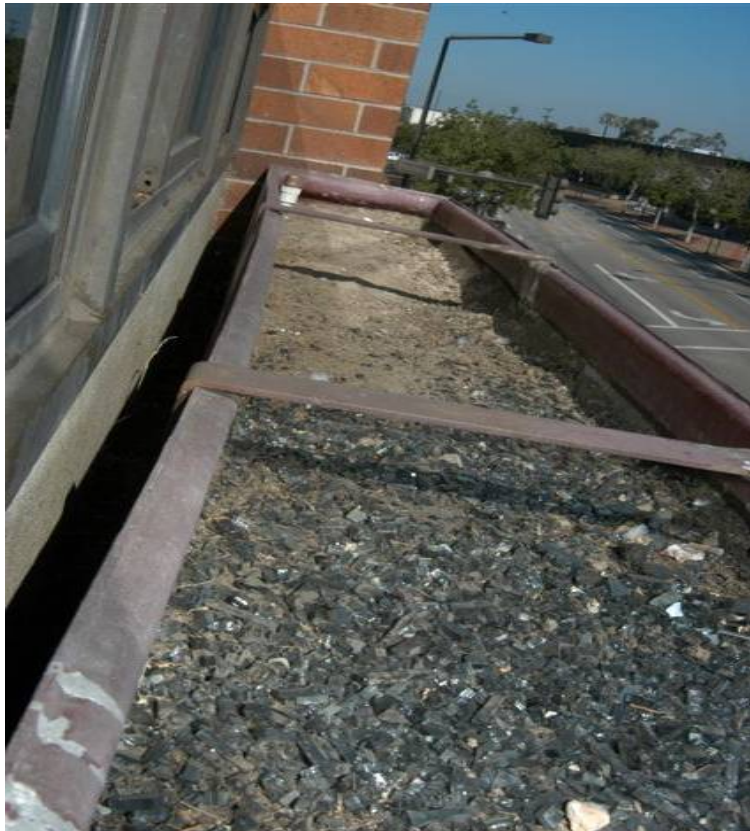
Exhibit 7. The separation between the building and another planter box.
